How Healthy is Furnace Brook

Marshfield High School, Marshfield, Massachusetts (2007). *How Healthy is Furnace Brook*. In Watershed Access Lab Projects. Project 86.

How Healthy Is Furnace Brook?

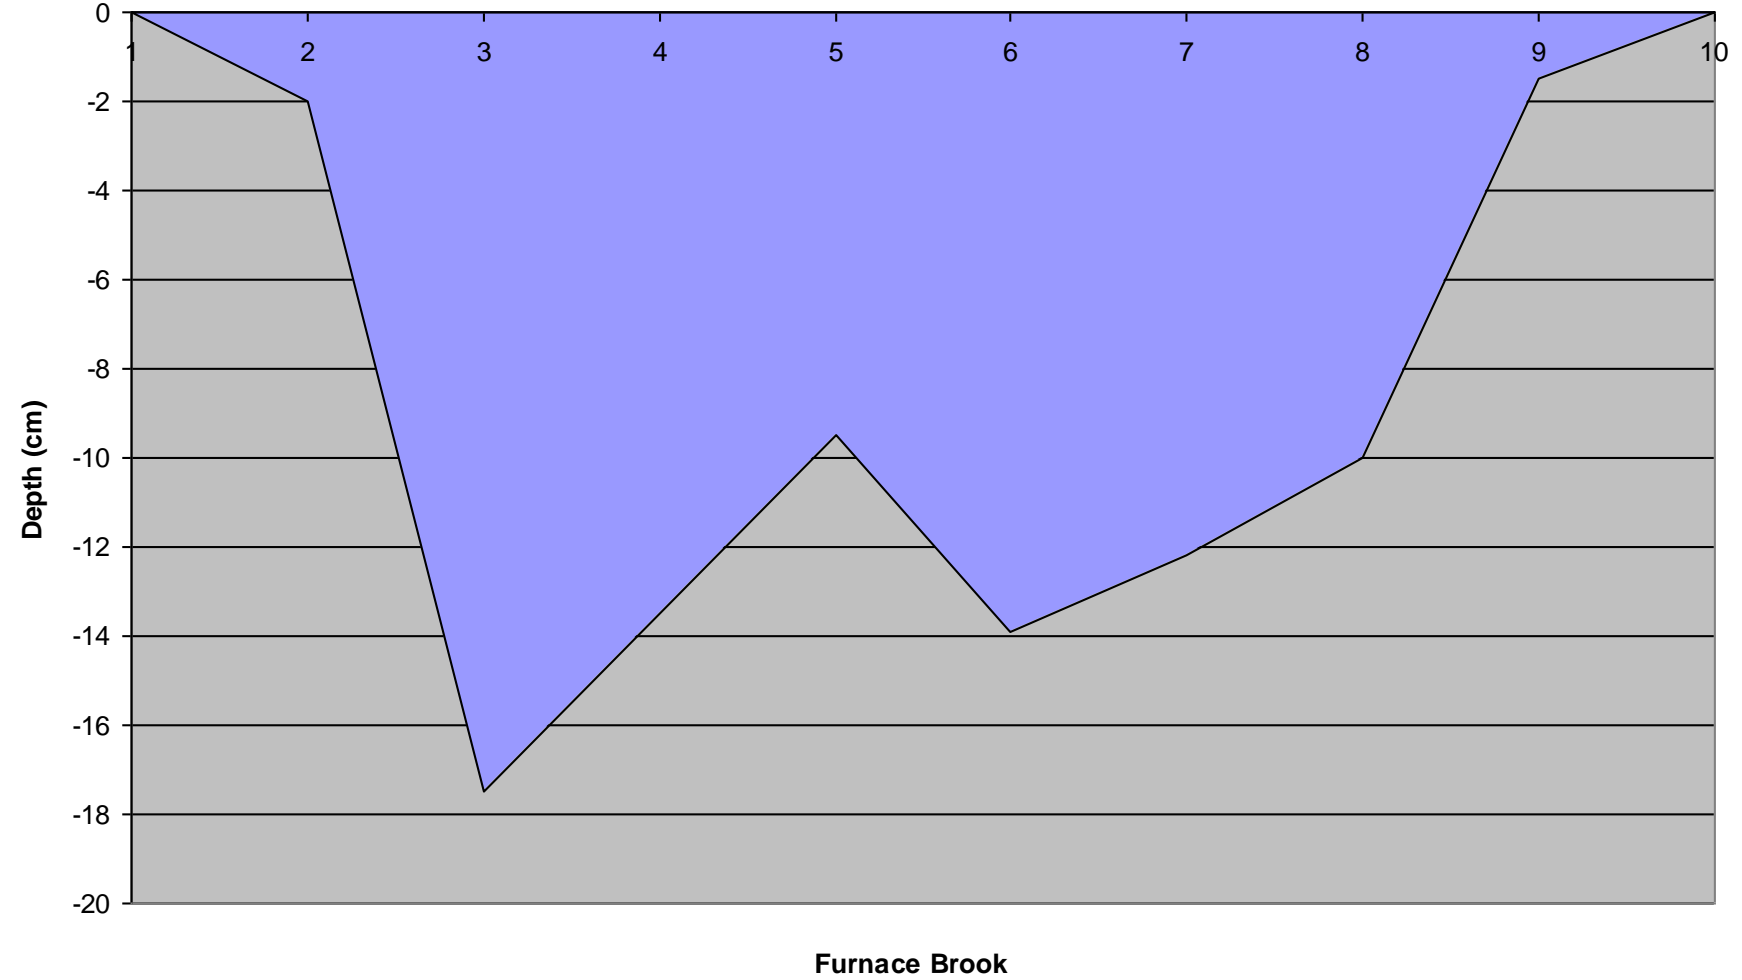
OLD MAINE

Old Maine Street 6.47 Fairly – Poor

Discharge- 495.30 L/S

River Miles- 9.84

Old Maine Depth Cross Sectional Profile

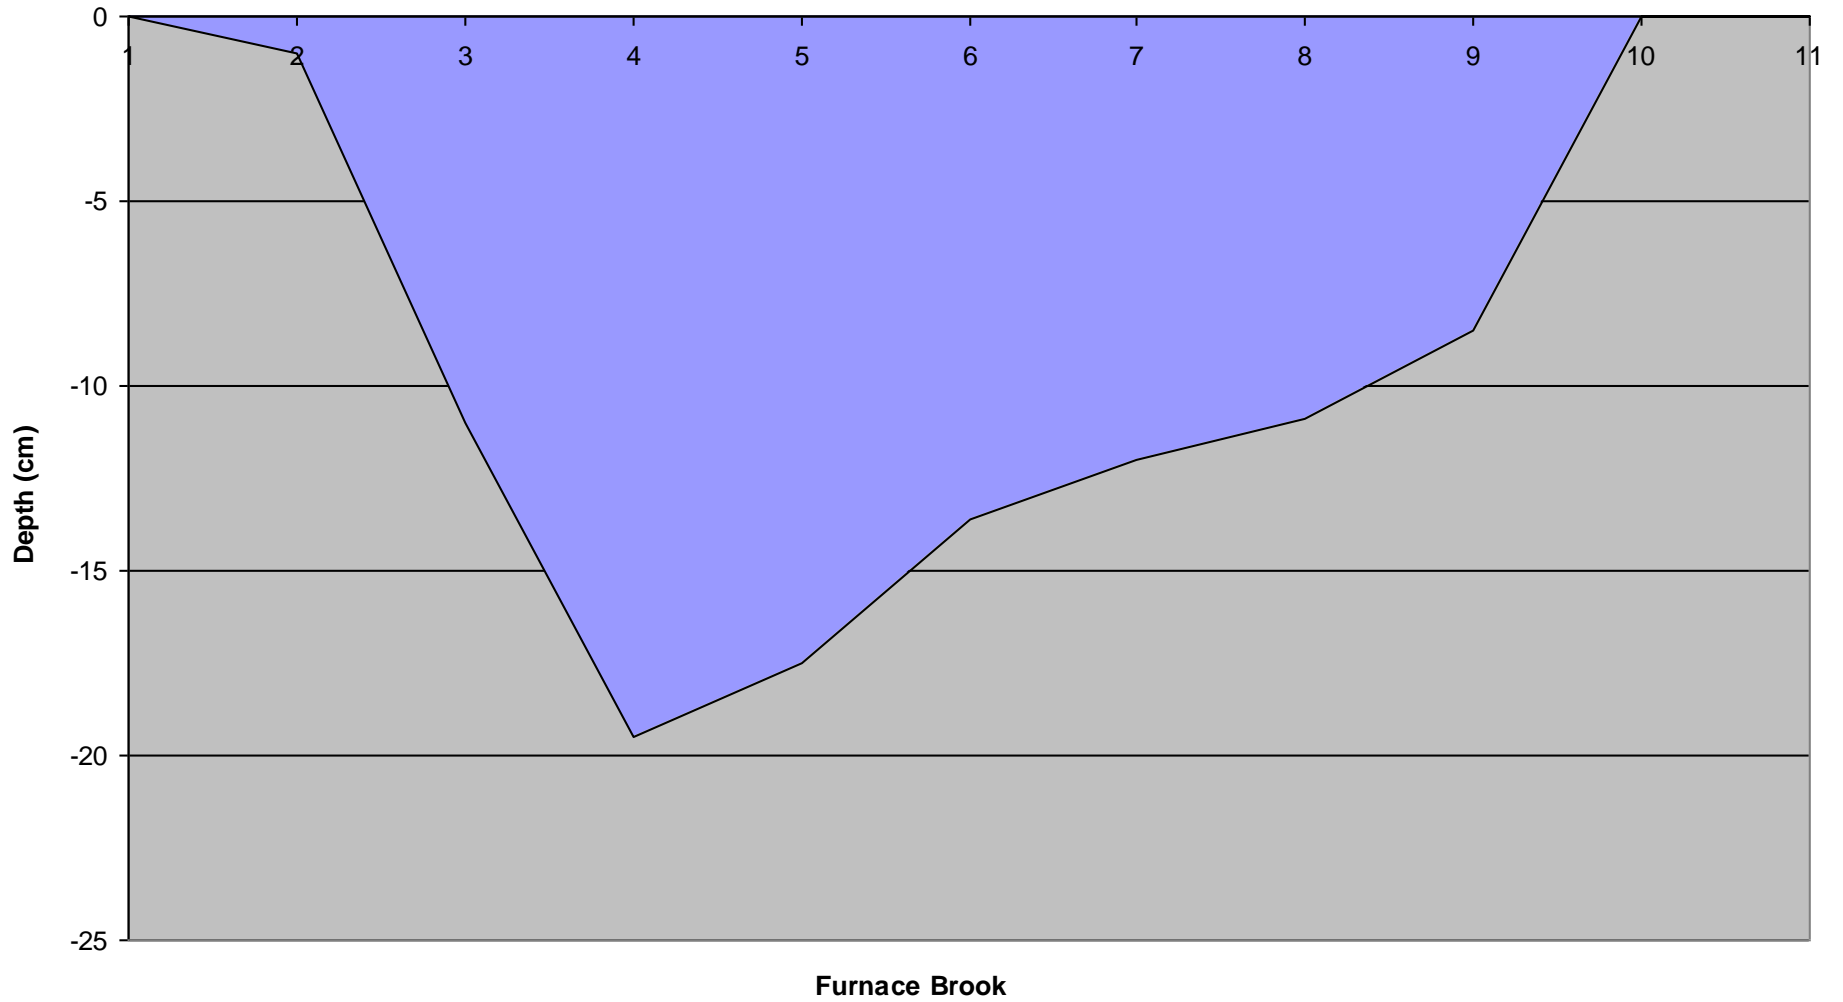
FURNACE STREET

Furnace Street 7.20 Poor

Discharge- 509.68 L/S

River Miles- 8.5

Furnace Street Depth Cross Sectional Profile

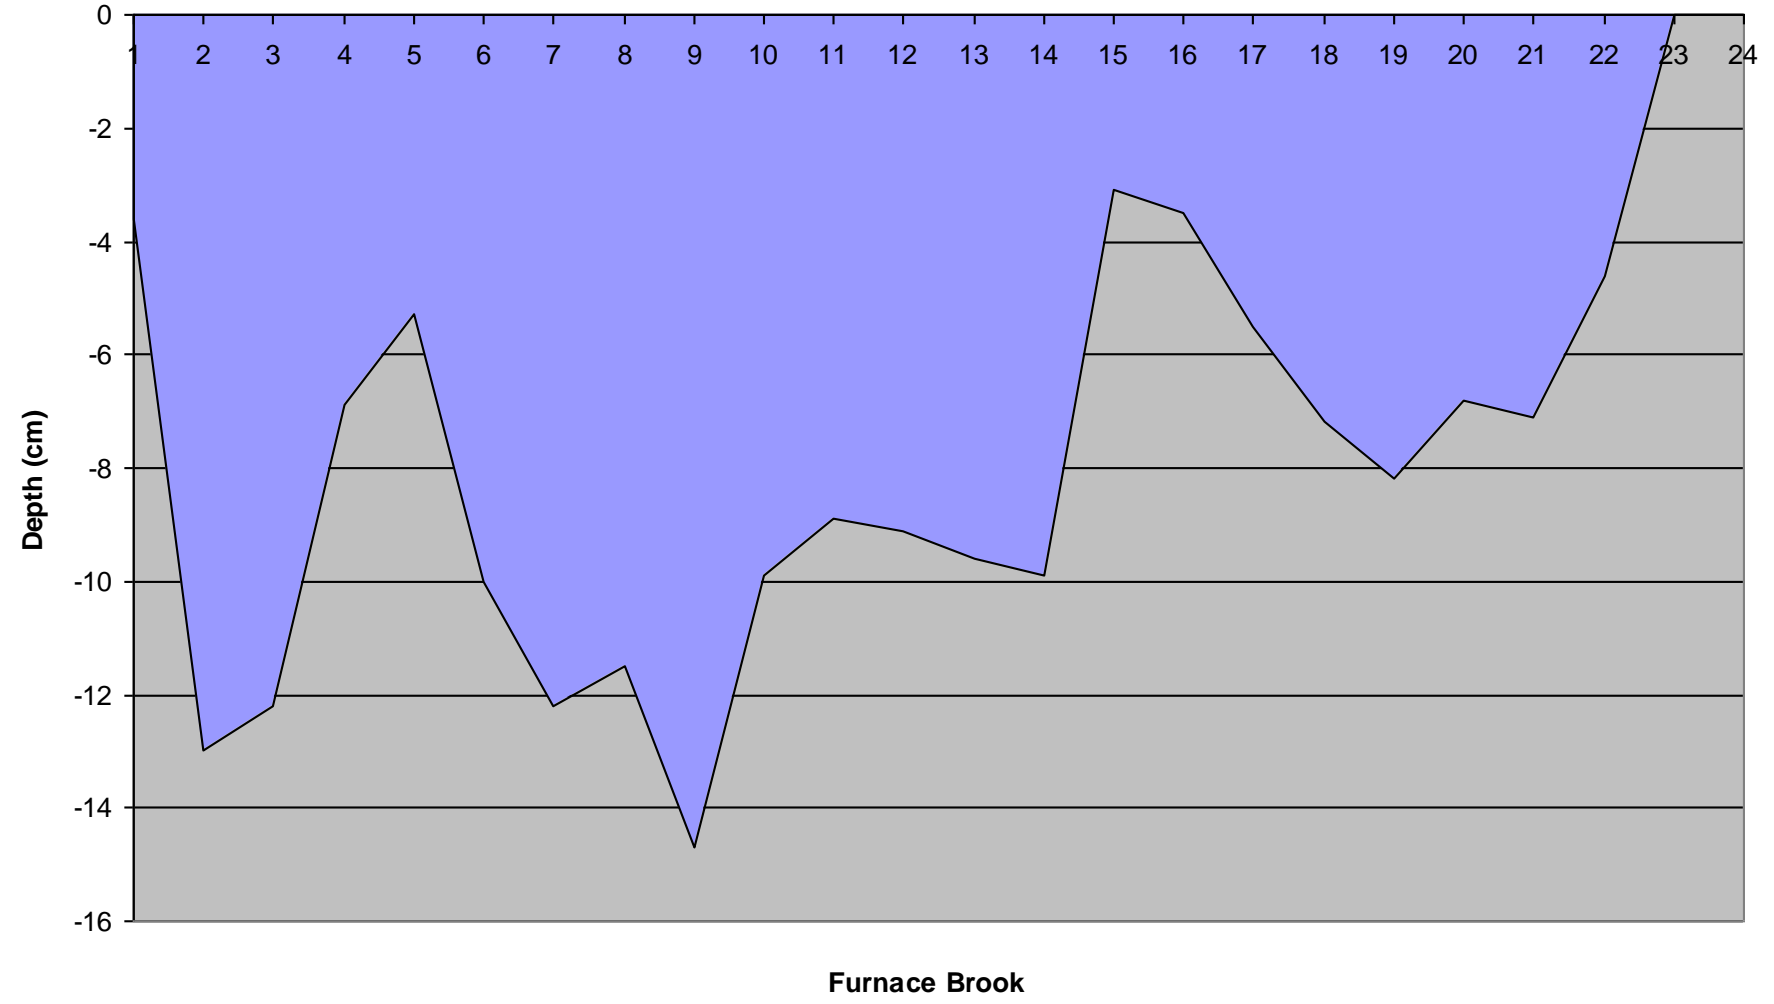
VETERANS PARK

Veterans Park

5.44

Fair

Discharge- 2738.56 L/S

River Miles- 7.3

Depth Cross Sectional Profile
