### The Quequechan River Project: A Study of the Effects of Burying a River Underground

Kuss Middle School, Fall River, Massachusetts (2004). *The Quequechan River Project: A Study of the Effects of Burying a River Underground*. In Watershed Access Lab Projects. Project 8.  
Available at: [https://vc.bridgew.edu/wal\\_projects/8](https://vc.bridgew.edu/wal_projects/8)

## The Quequechan River Project

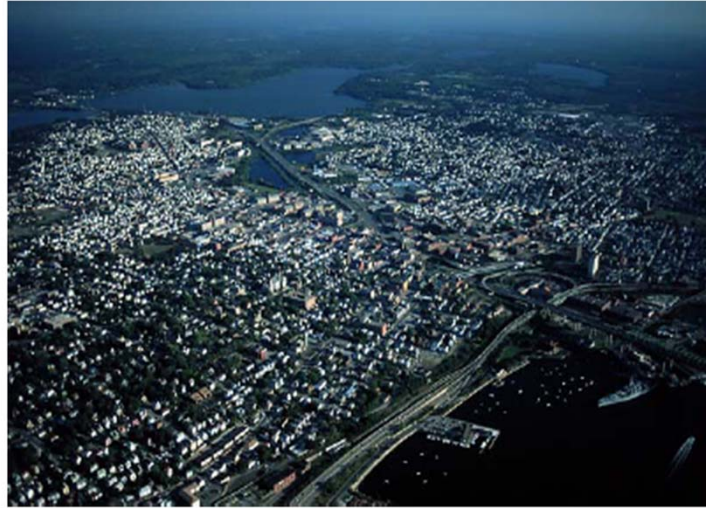
## Fall River from above

The Quequechan River runs through the heart of Fall River, flowing from the Watuppa Pond at the top left of the picture, underneath route 195, underneath city hall, until it is about 3 miles from the pond, when it flows down to Battleship Cove and the Taunton River at the bottom right of the picture.

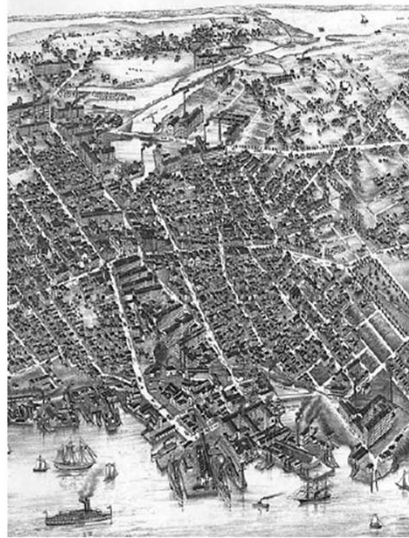
## Mills along the river

The young city grew up along the river, and Quequechan's power provided the energy to run the textile mills built along the river's edge. At the time of the civil war, Fall River was the largest textile producing city in the country. Unfortunately, with the advent of steam power, the river was increasingly ignored. It soon became nothing more than a dump for the mills that lined the river's shores. Few objected when it was covered over by a growing city!

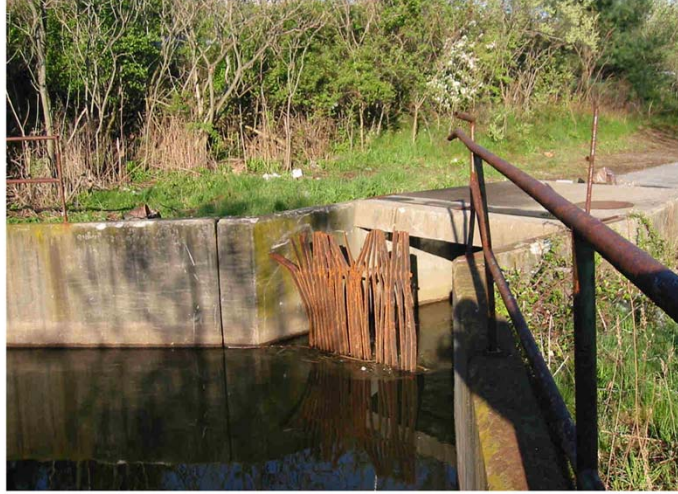
## The Culvert

As new sources of energy were found, and the mills no longer relied upon the river for power, the beautiful river and its spectacular falls were forced underneath the city until it re-emerges near the Taunton River. Here is a culvert where the river is forced to travel underground.

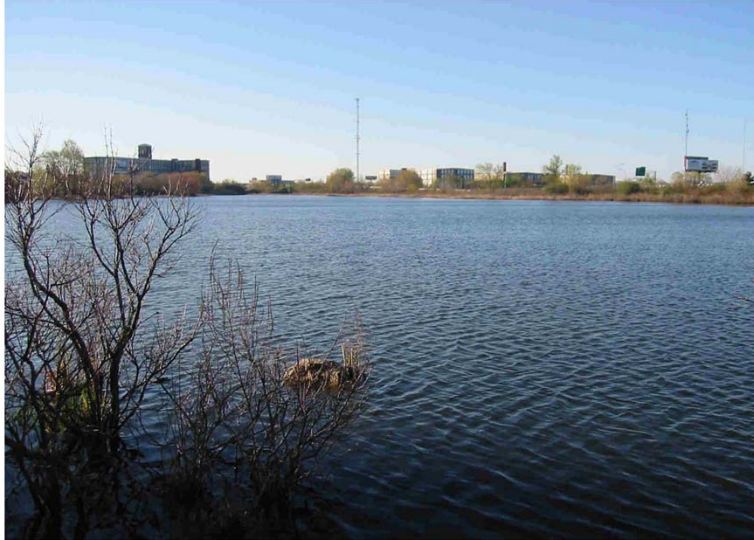
## Quequechan "Pond"

In front of the culvert there is almost no current flow, making it impossible for us to select a site upstream to study. We had to select a site that flows into Watuppa pond near the head of the Quequechan. In the distance you can see the highway and the mills that once got their power from the river.

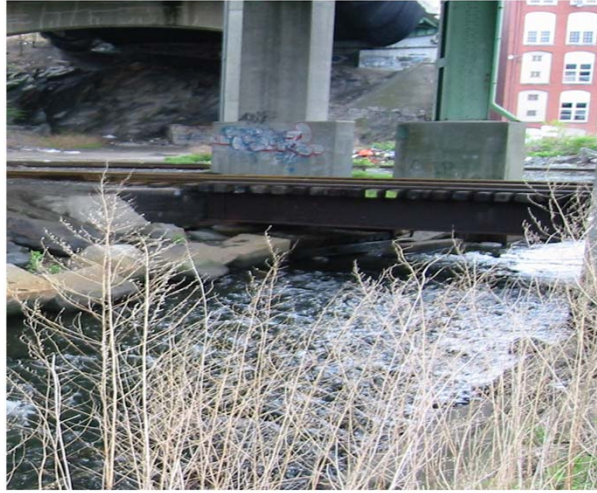
## Emerging River

Here the river emerges from underneath a textile mill in downtown Fall River. The supports for highway ramps and the Braga Bridge are decorated with graffiti.

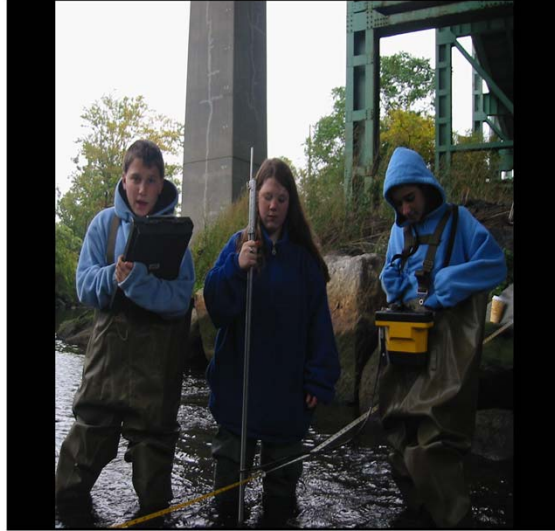
## Determining Flow

Evan, Sarah, and John collect flow data.

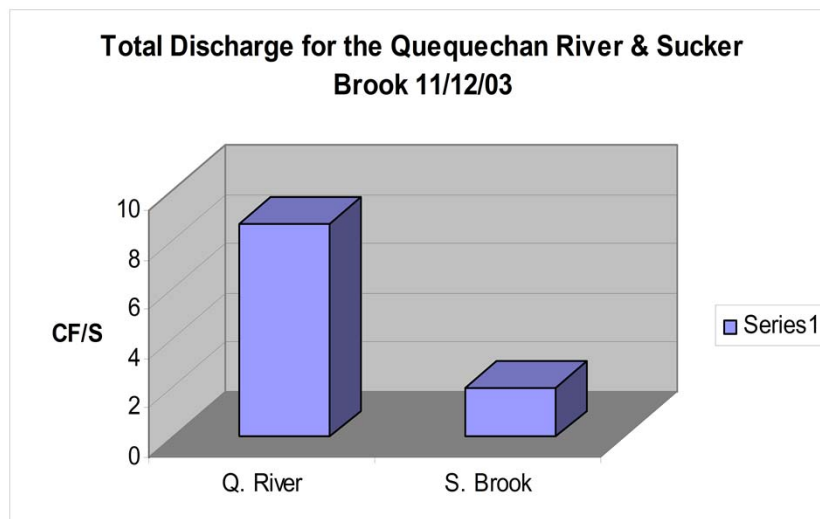
## Total Discharge

The total Discharge for the Quequechan River was 8.7 cubic feet of water per second. Total discharge for Sucker Brook was only 2 cfs. (You may remember that we measured the flow of the Q. River and S. Brook during a dry period. Measuring flow at such a time is not a normal flow and could skew our discharge and nutrient load.)

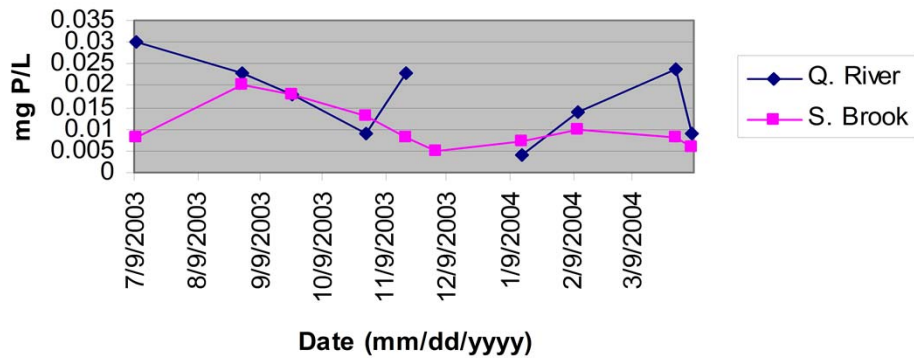
## Dissolved Phosphorus 7/03-4/04

The level of dissolved Phosphorus in both the Quequechan and Sucker brook was generally low. But there were three spikes in the Q. River in July and Nov and March.

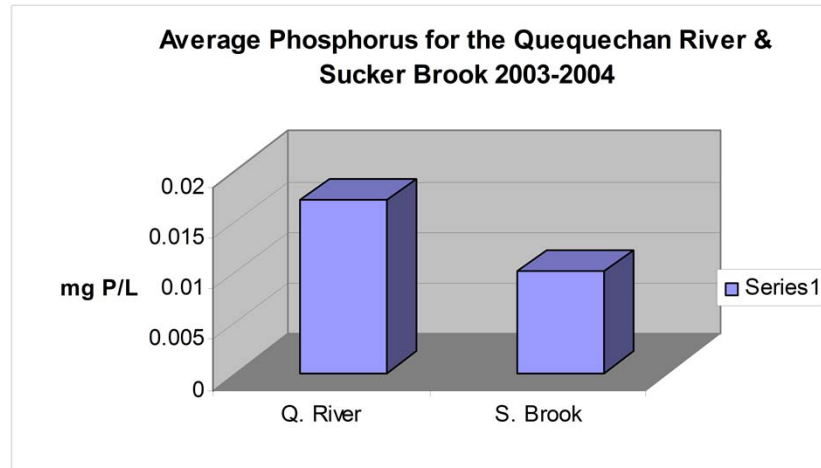
## Average Dissolved Phosphorus Levels 7/03-4/04

Average dissolved phosphorus levels were slightly higher at the Quequechan River than they were for the same time period at Sucker Brook.

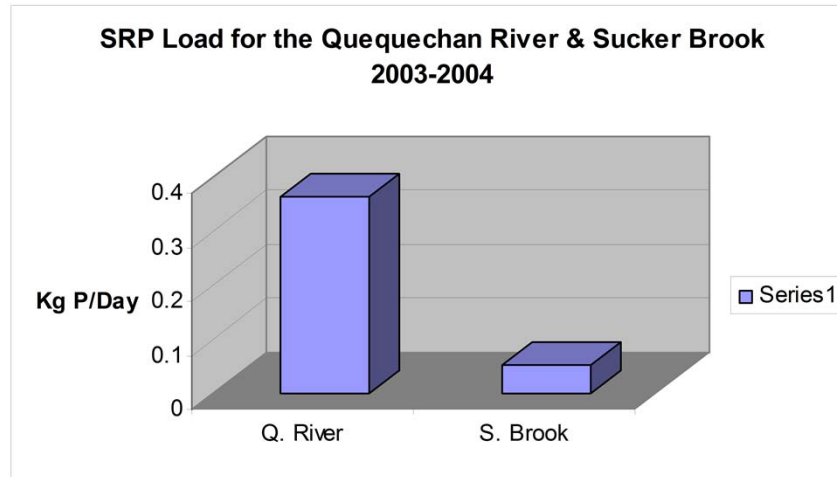
## Phosphorus Load 2003-2004

The Quequechan River carried a larger load of phosphorus because it had a much larger total discharge of water and a greater average concentration of dissolved Phosphorus.

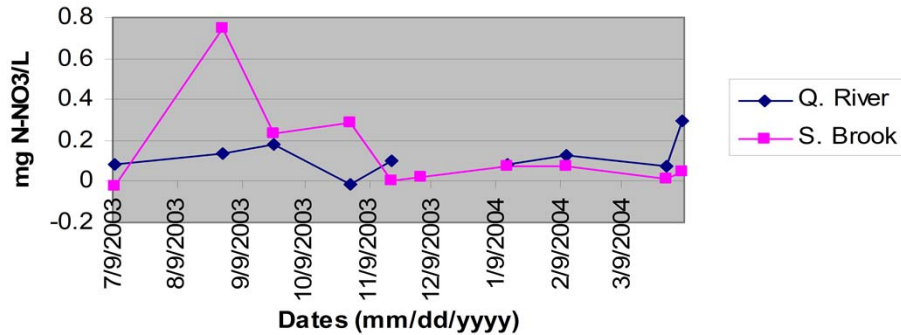
## Nitrogen Concentrations 7/03-4/04

Once again this year, Sucker Brook had high nitrogen levels in Aug. then it dropped down to more acceptable levels by Sept.. This high level in Aug. may indicate septic tank overflow from summer cottages around a pond located above the sample site.

- ◆ However, a high reading of 0.8 mg/L of N-NO<sub>3</sub> in August at Sucker Brook could be the result of vacationers staying at summer cottages around an upstream pond. Septic systems may have flowed into the brook.
- ◆ Phosphorus and Nitrogen levels were both fairly low at both the Quequechan River and Sucker Brook.

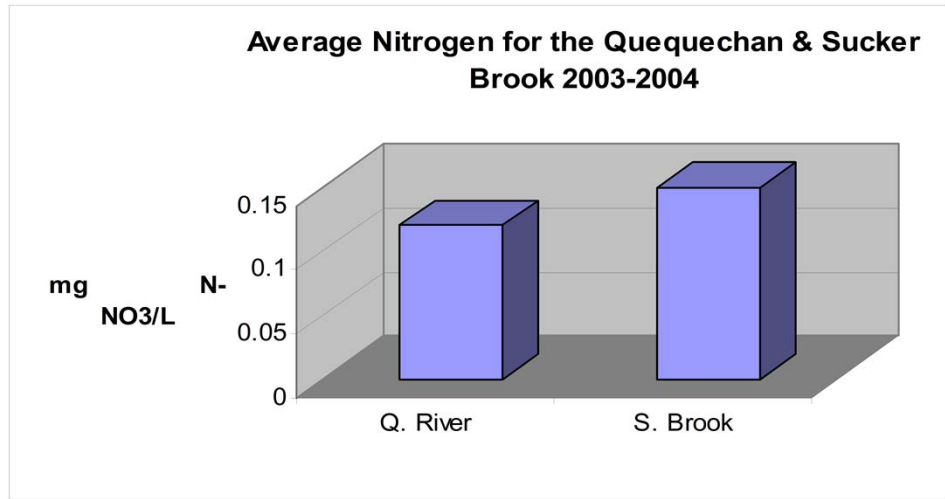
## Average Nitrogen Levels 7/03-4/04

Concentration levels of nitrogen were higher at Sucker Brook than they were over the same time period at the Quequechan River mainly due to the high summer concentrations at the brook.

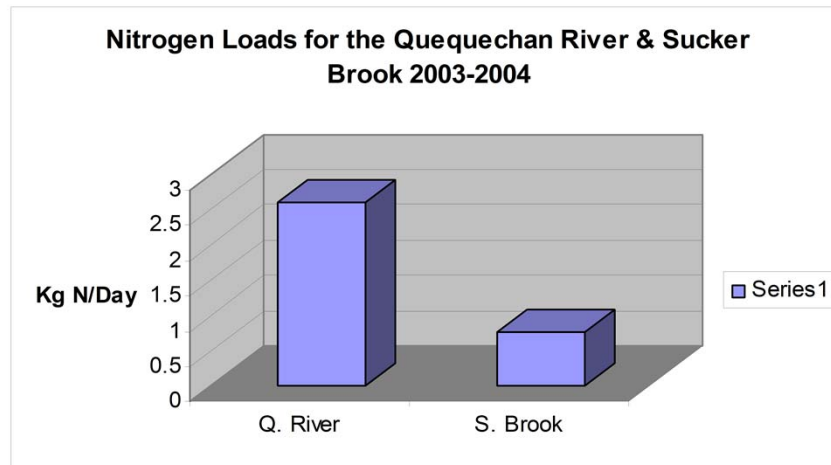
## Nitrogen Load

The nitrogen load is much greater for the Quequechan River even though its ave. % concentration was less than Sucker Brook's because the river's higher discharge of water. (Load #'s are based on the flow data we gathered on 10/12/03 at Q. river & 11/19/03 at S. brook).

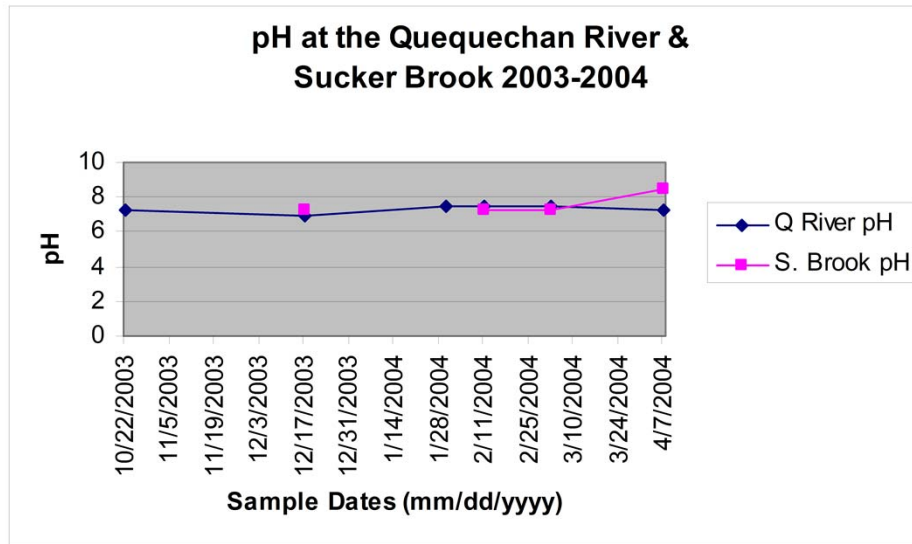
## pH 10/22/03-4/7/04

Both the Quequechan River and Sucker Brook had slightly Alkaline pH readings. (We recalibrated our pH meter every time we used it, but perhaps we should have crosschecked our data with a chemical pH test).

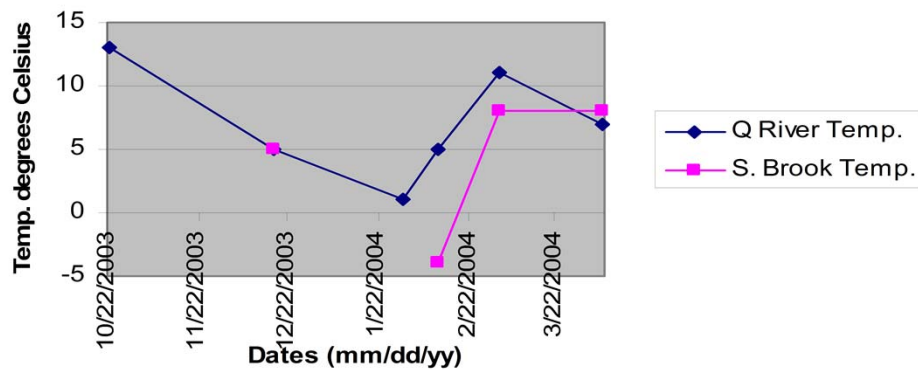
## Temperature 10/22/03-3/22/04

The average temperature was 7 degrees Celsius for the Q. River and 4.25 degrees Celsius for Sucker Brook. (The pond-like part of the Q. river above the culvert probably heats up the Q. river more than S. brook which would make the brook water colder).

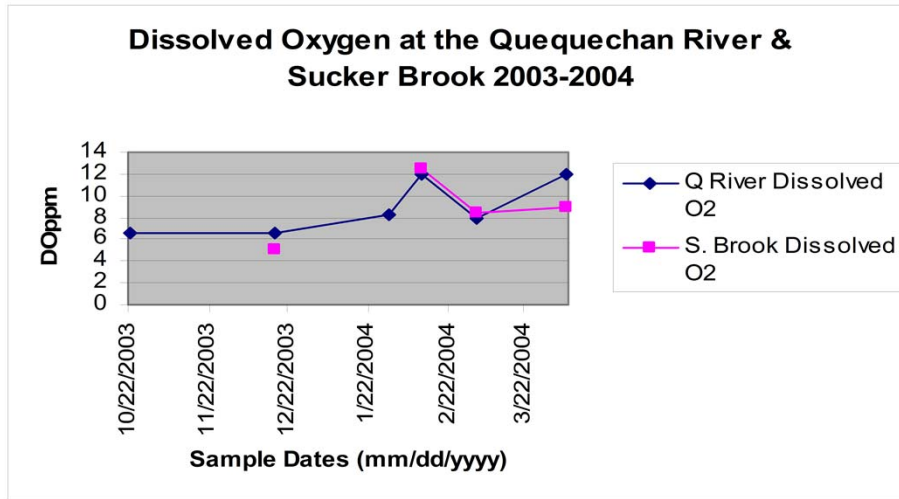
## Dissolved Oxygen 10/22/03-3/22/04

The average dissolved oxygen was 8.9 parts per million for the Quequechan River, and 8.8 ppm for Sucker Brook.

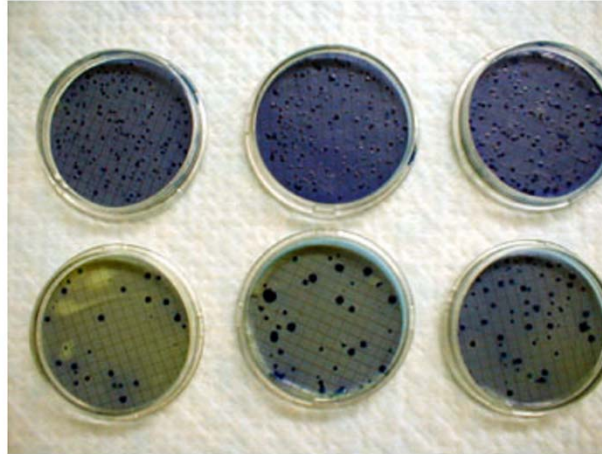
## Fecal Coliform Bacterial Growth 3/17/04

While the results for fecal coliform bacteria at Sucker Brook were negative, we had an average of 9000 to 11,500 colonies in a 100 milliliter sample from the lower (under the Braga Bridge) Quequechan River!

State health officials consider levels over 200 fecal coliform colonies/100 milliliters of water to be an unacceptable level of bacteria at swimming areas.

The Quequechan River showed an extremely high level of bacteria indicating a serious pollution problem.

The test sample was collected after a major rain storm. It could be that city sewers overflowed into the river as a result of the storm, pouring sewerage into the river.

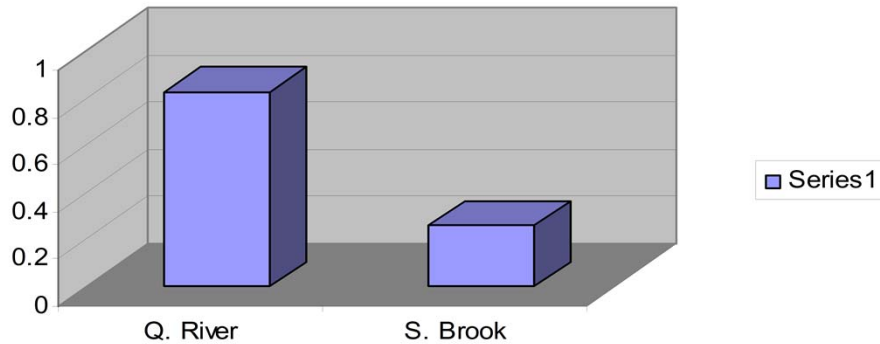
## Percent Dominance

83% of the organisms we found at the Quequechan River were scuds. (tolerant of pollution) 26% of the organisms we found at Sucker Brook were scuds.

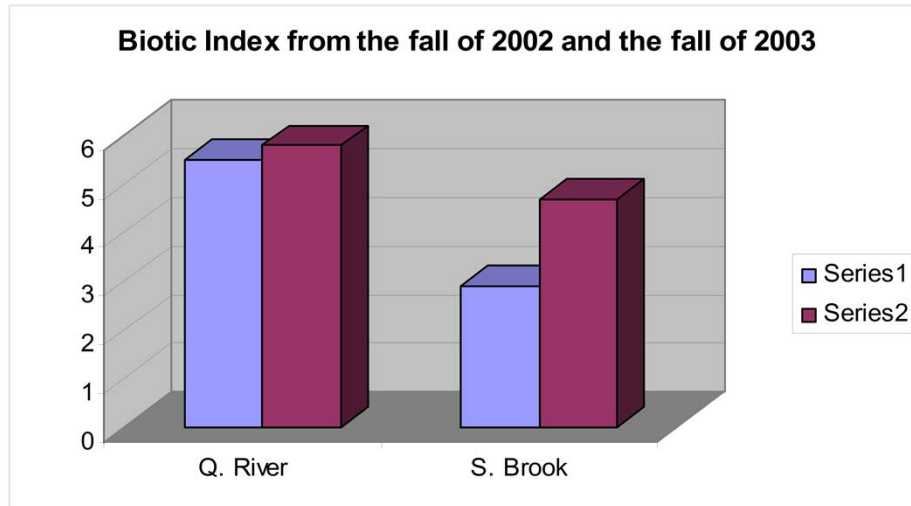
## Biotic Index for 2002 & 2003

This graph shows a slight decline in the quality of organisms living in the Quequechan River from last year, and a dramatic decline of quality organisms for Sucker Brook.

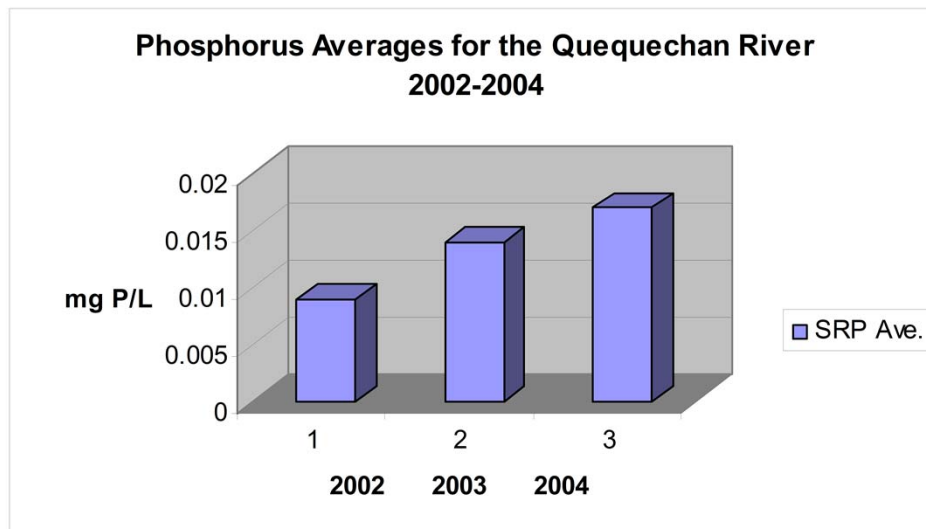
## Historical Averages for Phosphorus in the Quequechan

This graph shows a steady increase in dissolved phosphorus levels in the Quequechan River from 2002 to 2004.

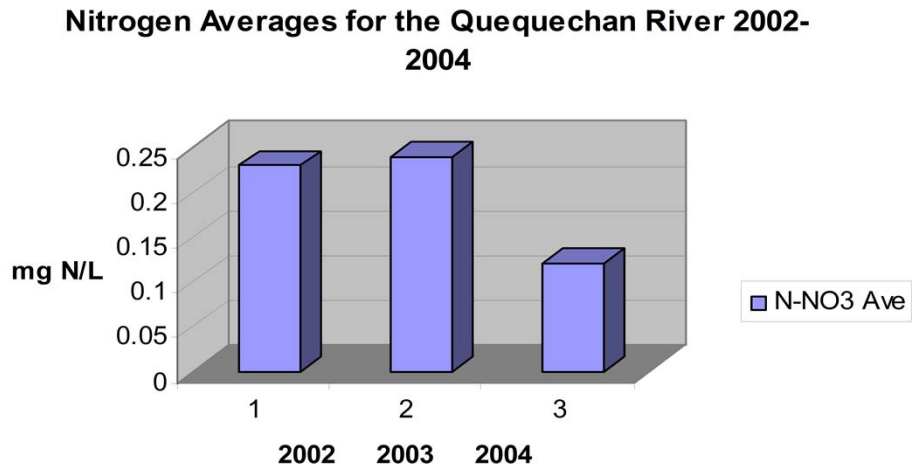
## Historical Averages for Nitrogen in the Quequechan River

This graph shows an encouraging decline in Nitrogen concentration in the Quequechan this year.

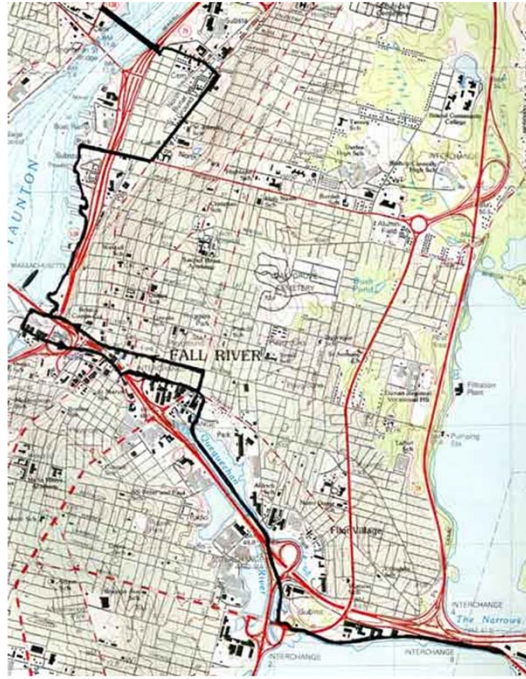
## Bike Path Plan

Last fall Urban River Visions and Green Futures, a local environmental group, sponsored a cherette about the Quequechan River. A comprehensive plan was created which included the plan for a bike path along the river that you see here. The master plan also includes a landing area for canoes, a circuit walk around part of the river, and daylighting the river and its spectacular waterfalls.
