Cleaning the Quequechan River

Kuss Middle School, Fall River, Massachusetts (2005). *Cleaning the Quequechan River*. In Watershed Access Lab Projects. Project 26.
Available at: https://vc.bridgew.edu/wal_projects/26

Cleaning The Quequechan

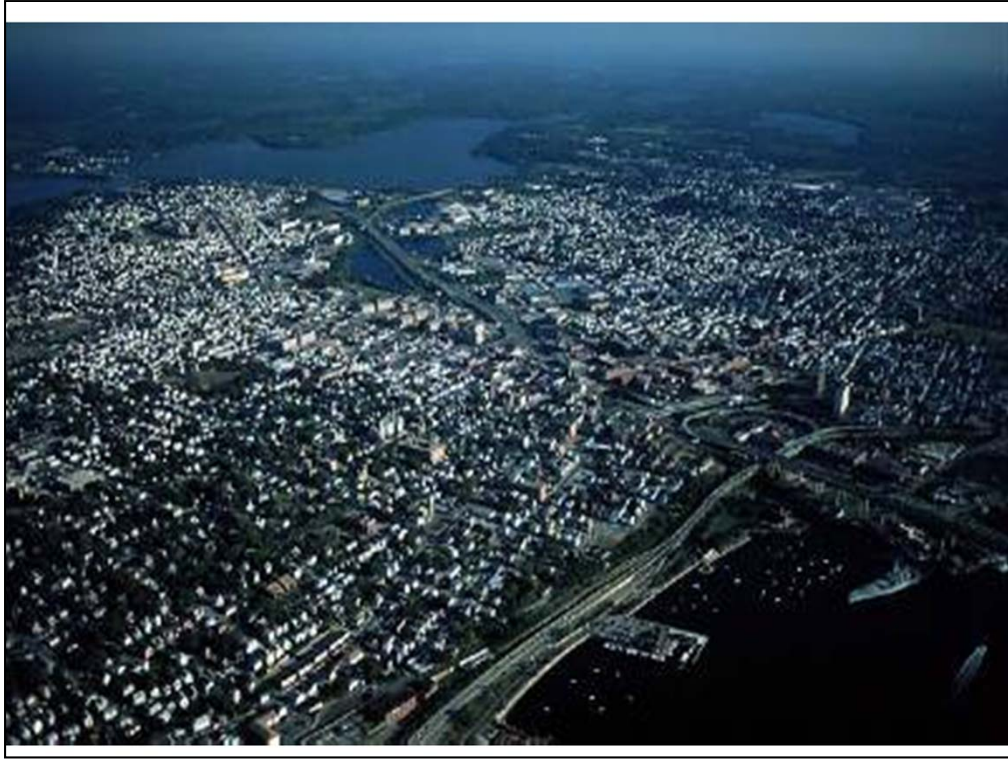
The Quequechan River runs through the heart of Fall River, flowing from the Watuppa Pond at the top left of the picture, underneath route 195, underneath city hall, until it is about 3 miles from the pond, when it flows down to Battleship Cove and into the Taunton River at the bottom right of the picture.

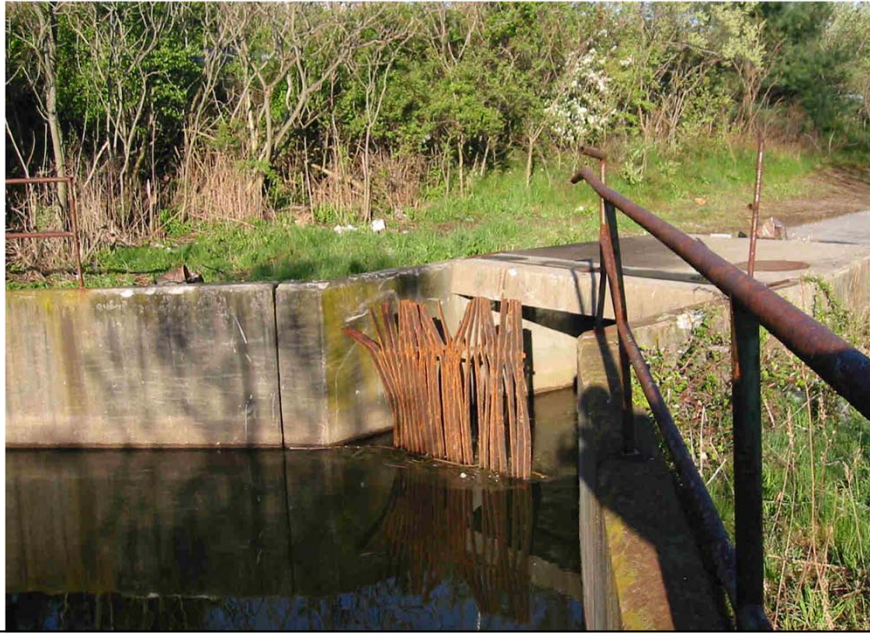
The Culvert

As new sources of energy were found, and the mills no longer relied upon the river for power, the beautiful river and its spectacular falls were forced underneath the city until it re-emerges near the Taunton River. Here is a culvert where the river is forced to travel underground.

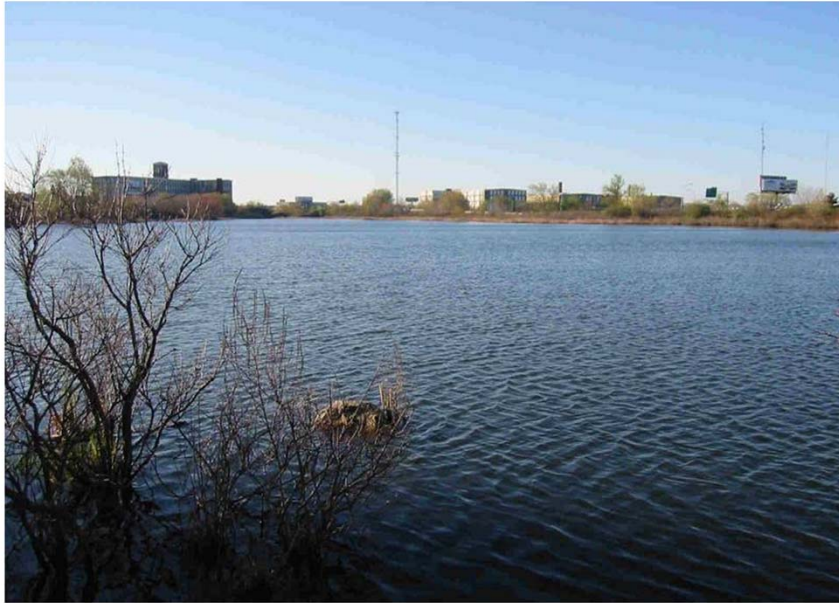
Quequechan “Pond”

In front of the culvert there is almost no current flow, making it impossible for us to select a site upstream to study. We had to select a site that flows into Watuppa pond near the head of the Quequechan. In the distance you can see the highway and the mills that once got their power from the river.

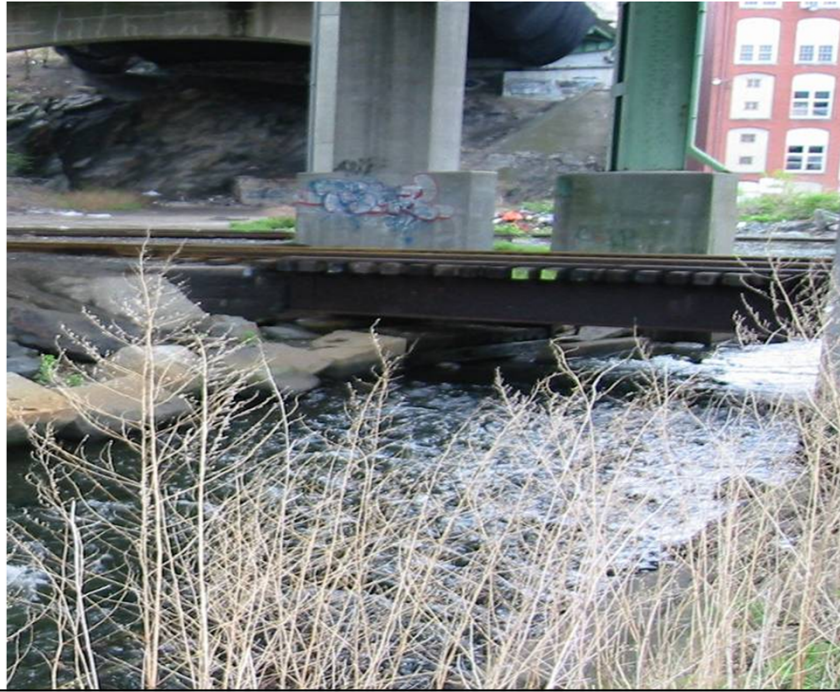
Emerging River

Here the river emerges from underneath a textile mill in downtown Fall River. The supports for highway ramps and the Braga Bridge are decorated with graffiti.

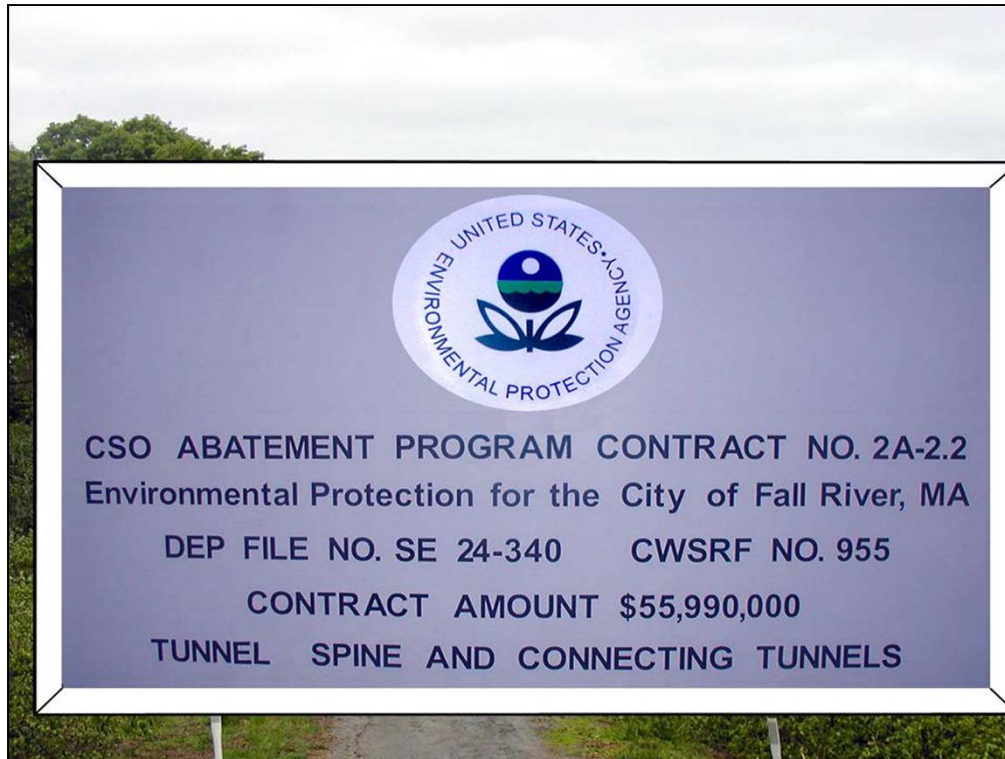
One way the city is trying to improve the Quequechan is by building a huge tunnel to capture sewerage that, until now, would flow directly into the river during storms. The tunnel project is a 56 million dollar effort to protect the Quequechan River and Mt. Hope Bay into which the Quequechan flows.

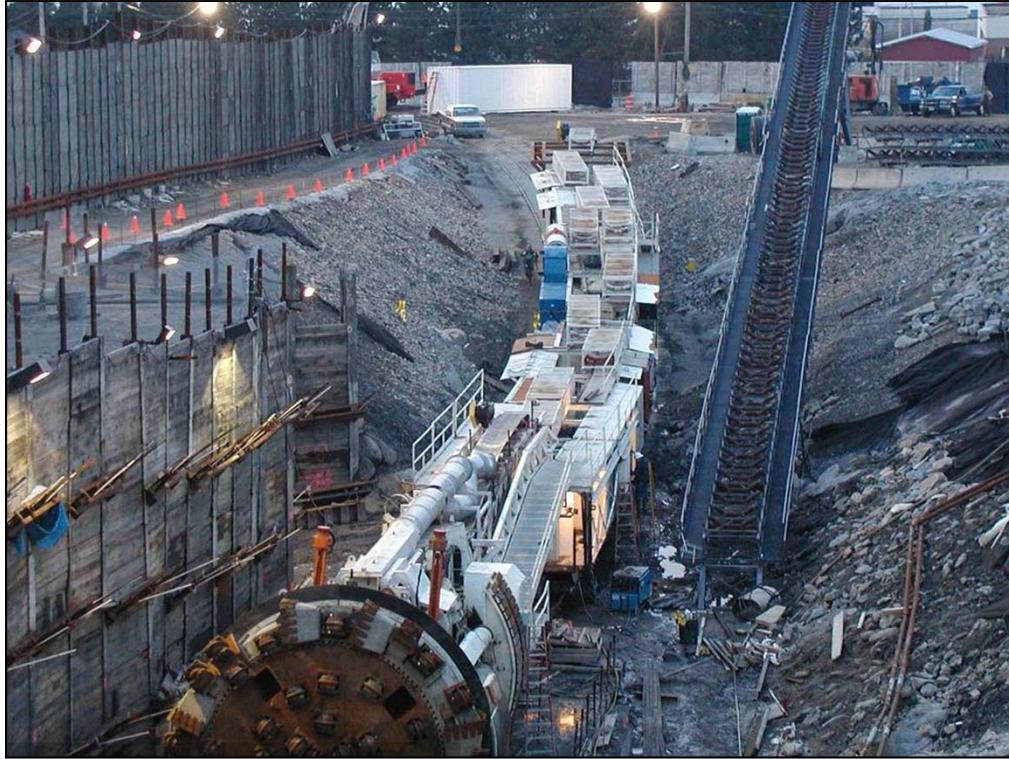
This is the machine that cut the tunnel through solid granite across the width of Fall River.

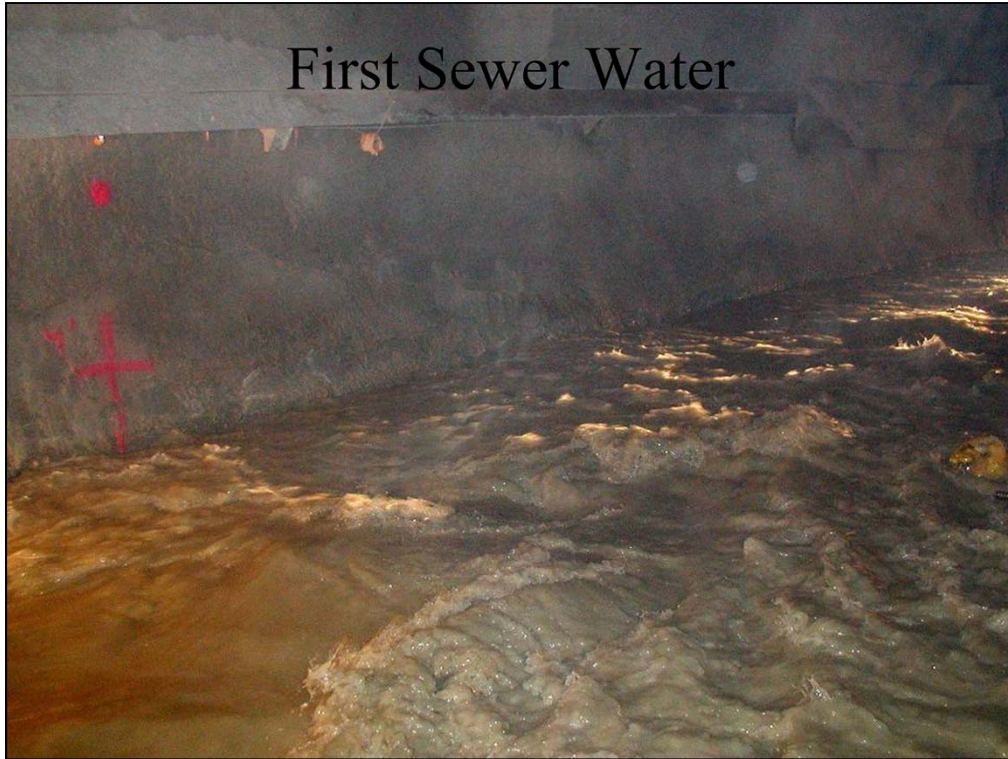
Here the first sewer water flows through the new tunnel on its way to the holding tank next to the Fall River wastewater treatment plant.

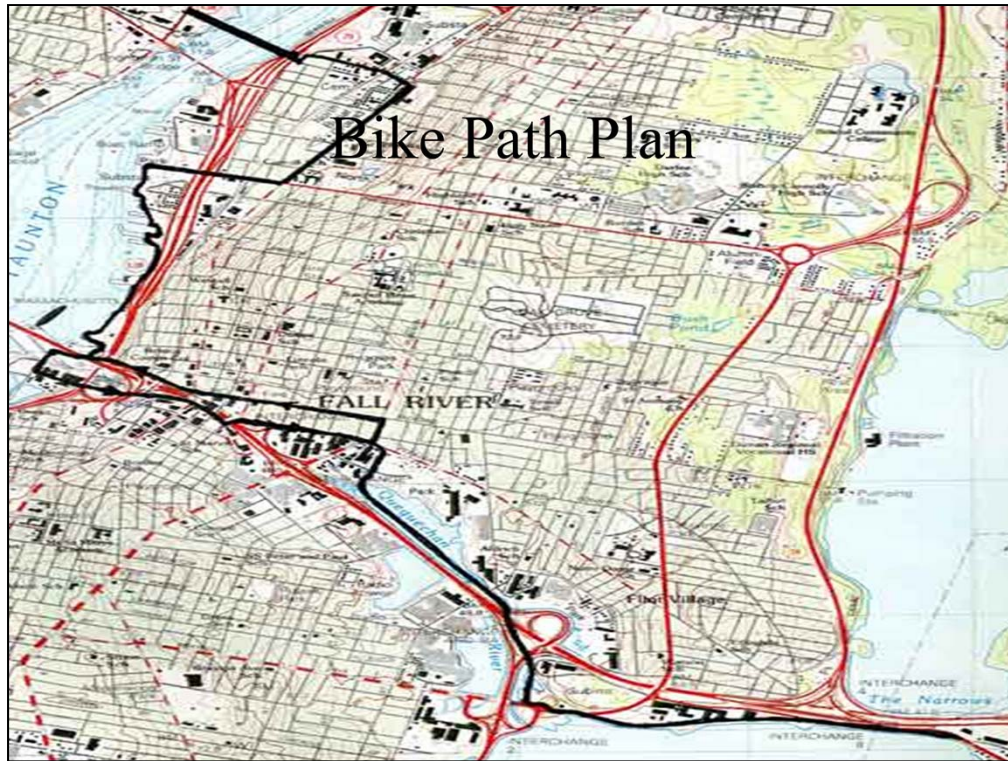
Urban River Visions and Green Futures, a local environmental group, sponsored a charrette about the Quequechan River. A comprehensive plan was created which included the plan for a bike path along the river that you see here. The master plan also includes a landing area for canoes, a circuit walk around part of the river, and daylighting the river and its spectacular waterfalls.
