The Ten Mile River Study

North Attleboro High School

This study was done to test the Ten Mile River. A series of chemical, physical, and biological tests were performed at two different sites along the river to see if the Ten Mile River fits the Class B Warm Water Standards as set forth by the State of Massachusetts.

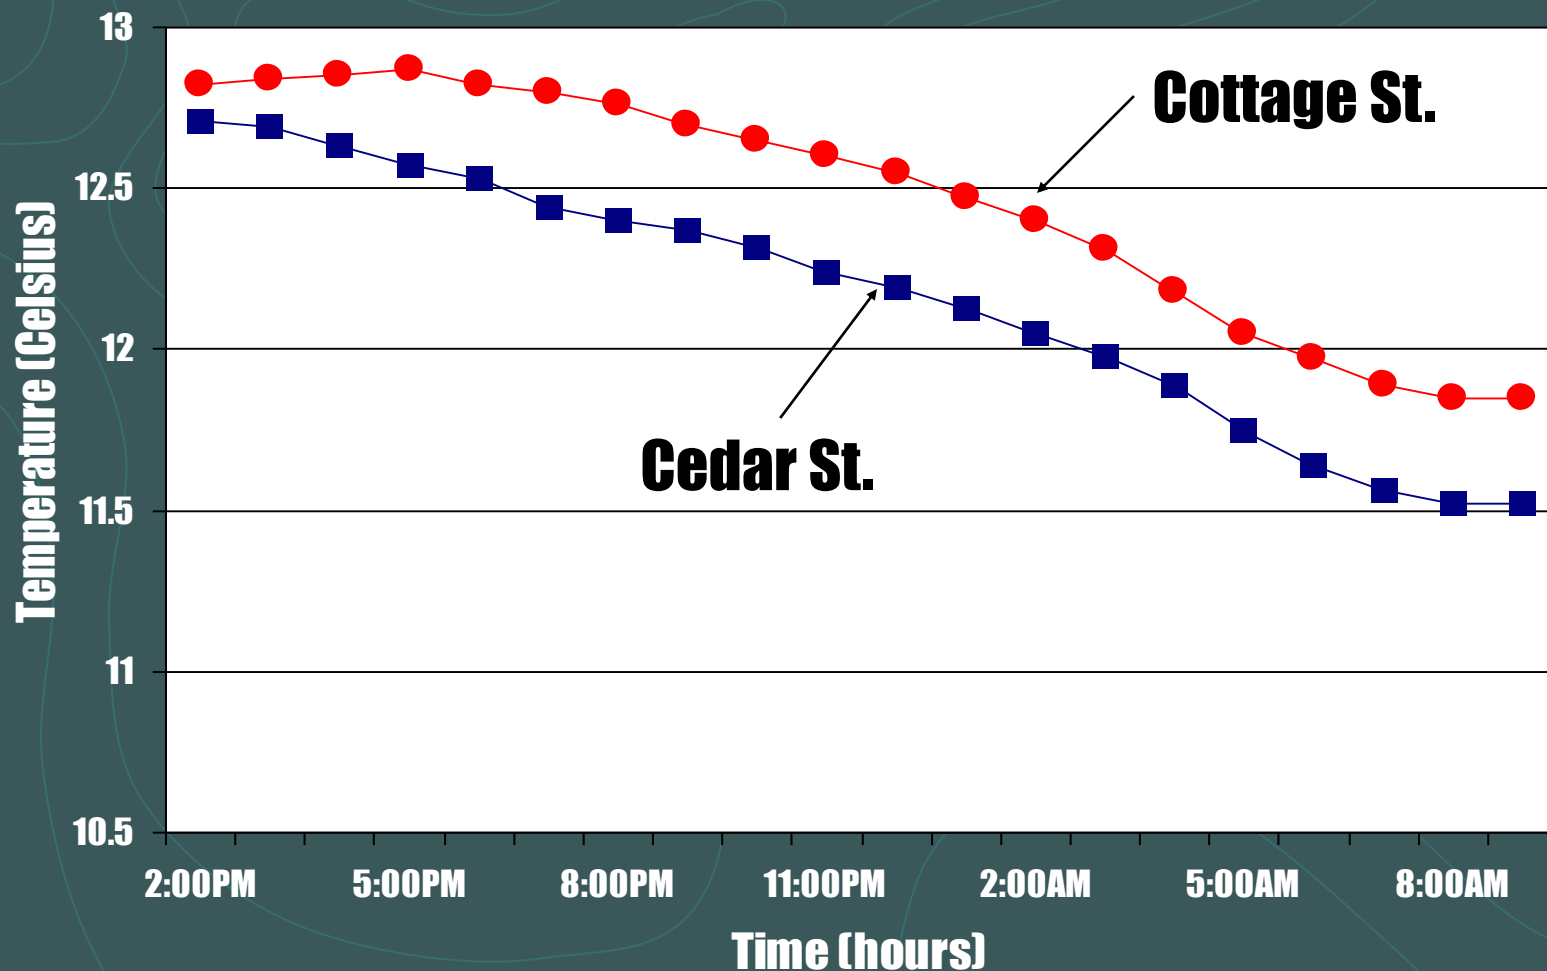
Comparison of Temperature Cottage St. and Cedar St. 10/20/04-10/21/04

***MA Class B Standards state that the temperature shall not exceed 28.3°C**

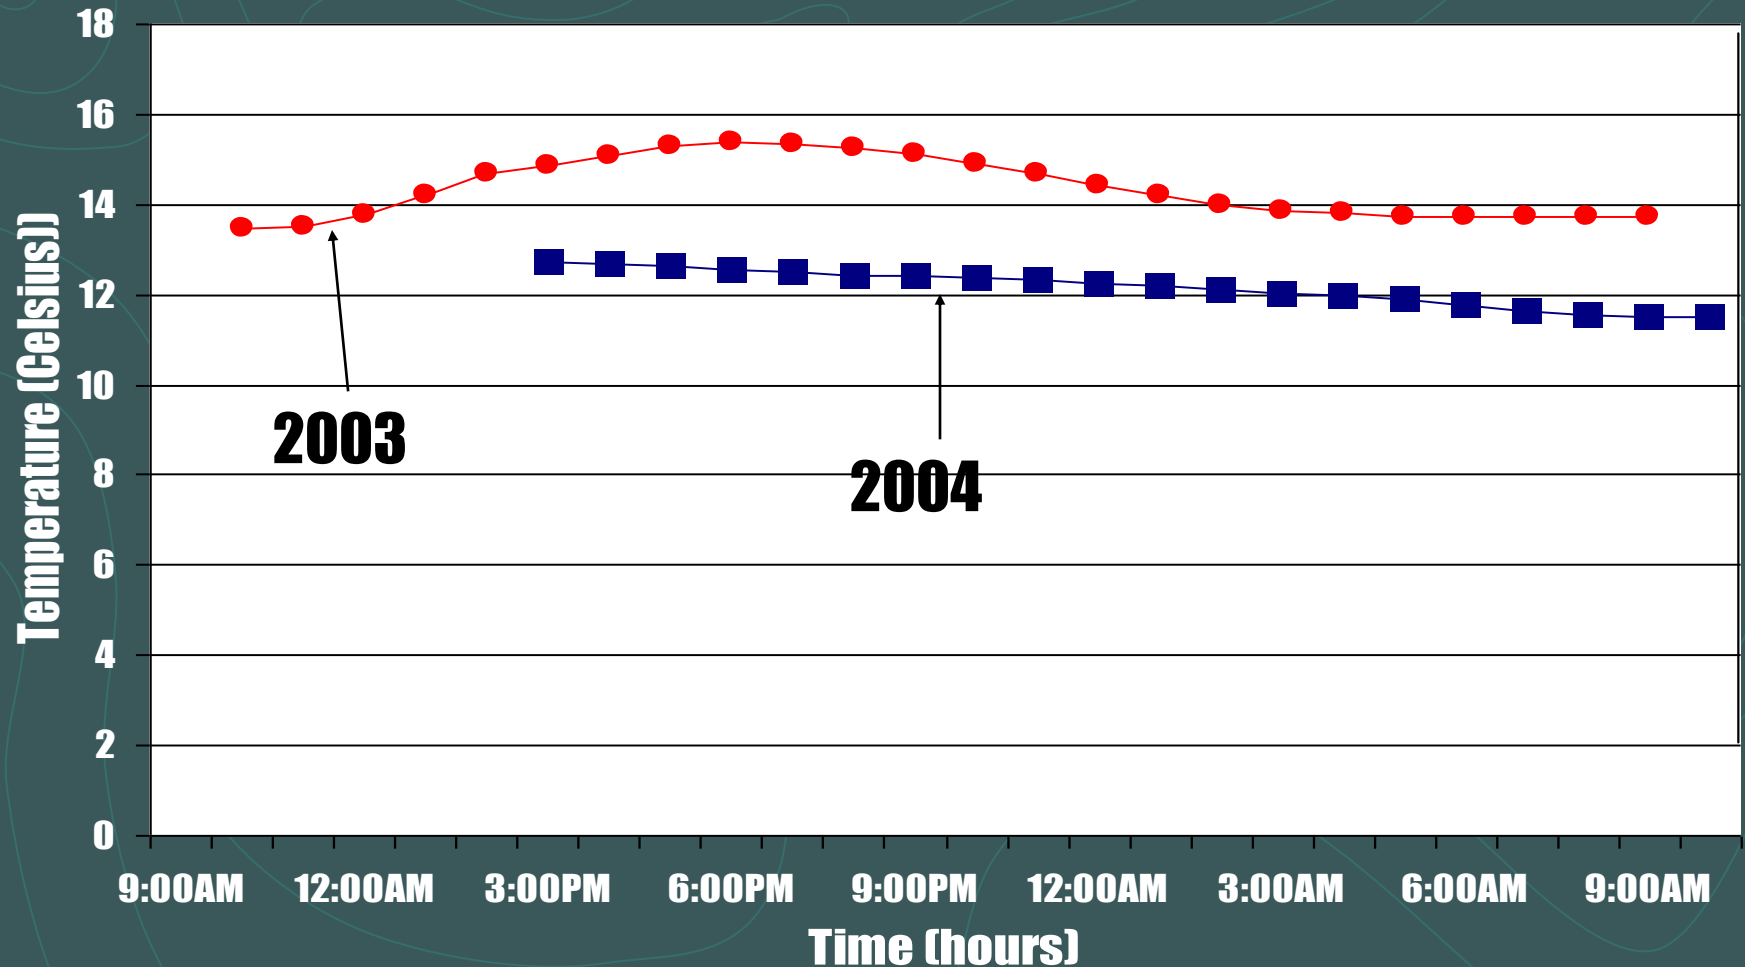
Comparison of Temperature Cedar St.

10/9/03-10/10/03 and 10/20/04-10/21/04

***MA Class B Standards state that the temperature shall not exceed 28.3°C**

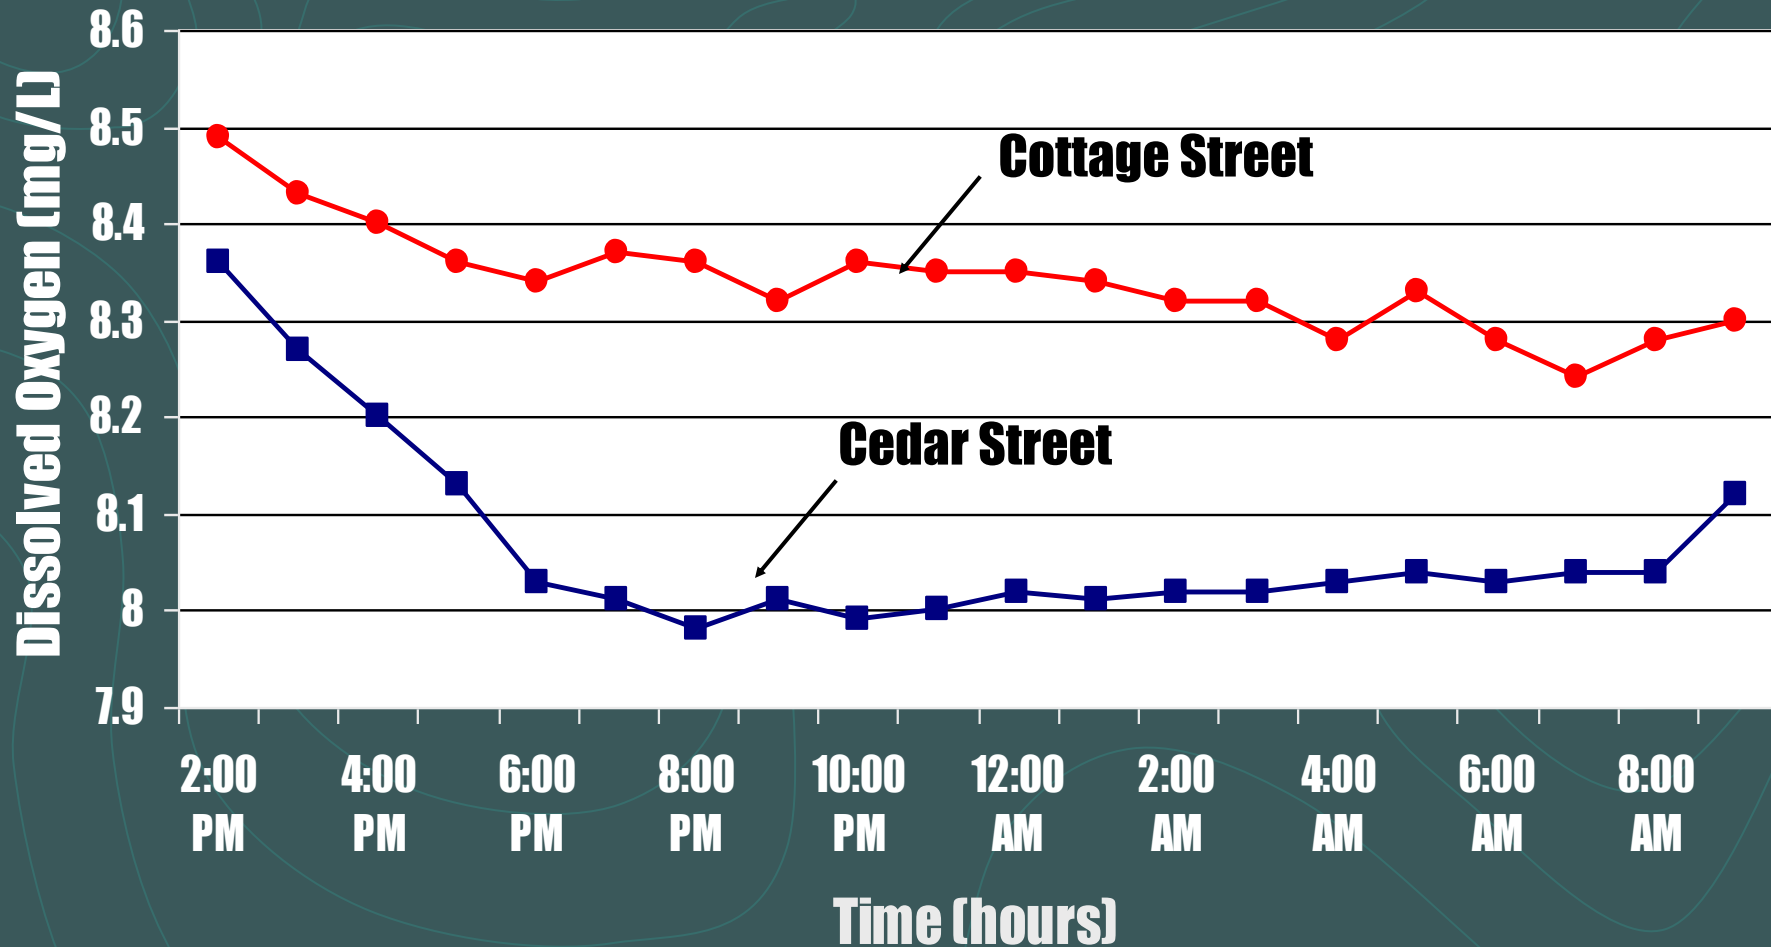
Comparison of Dissolved Oxygen Cottage St. and Cedar St. 10/20/04 - 10/21/04

***MA Class B Standards require Dissolved Oxygen to be 5.0 mg/L or higher**

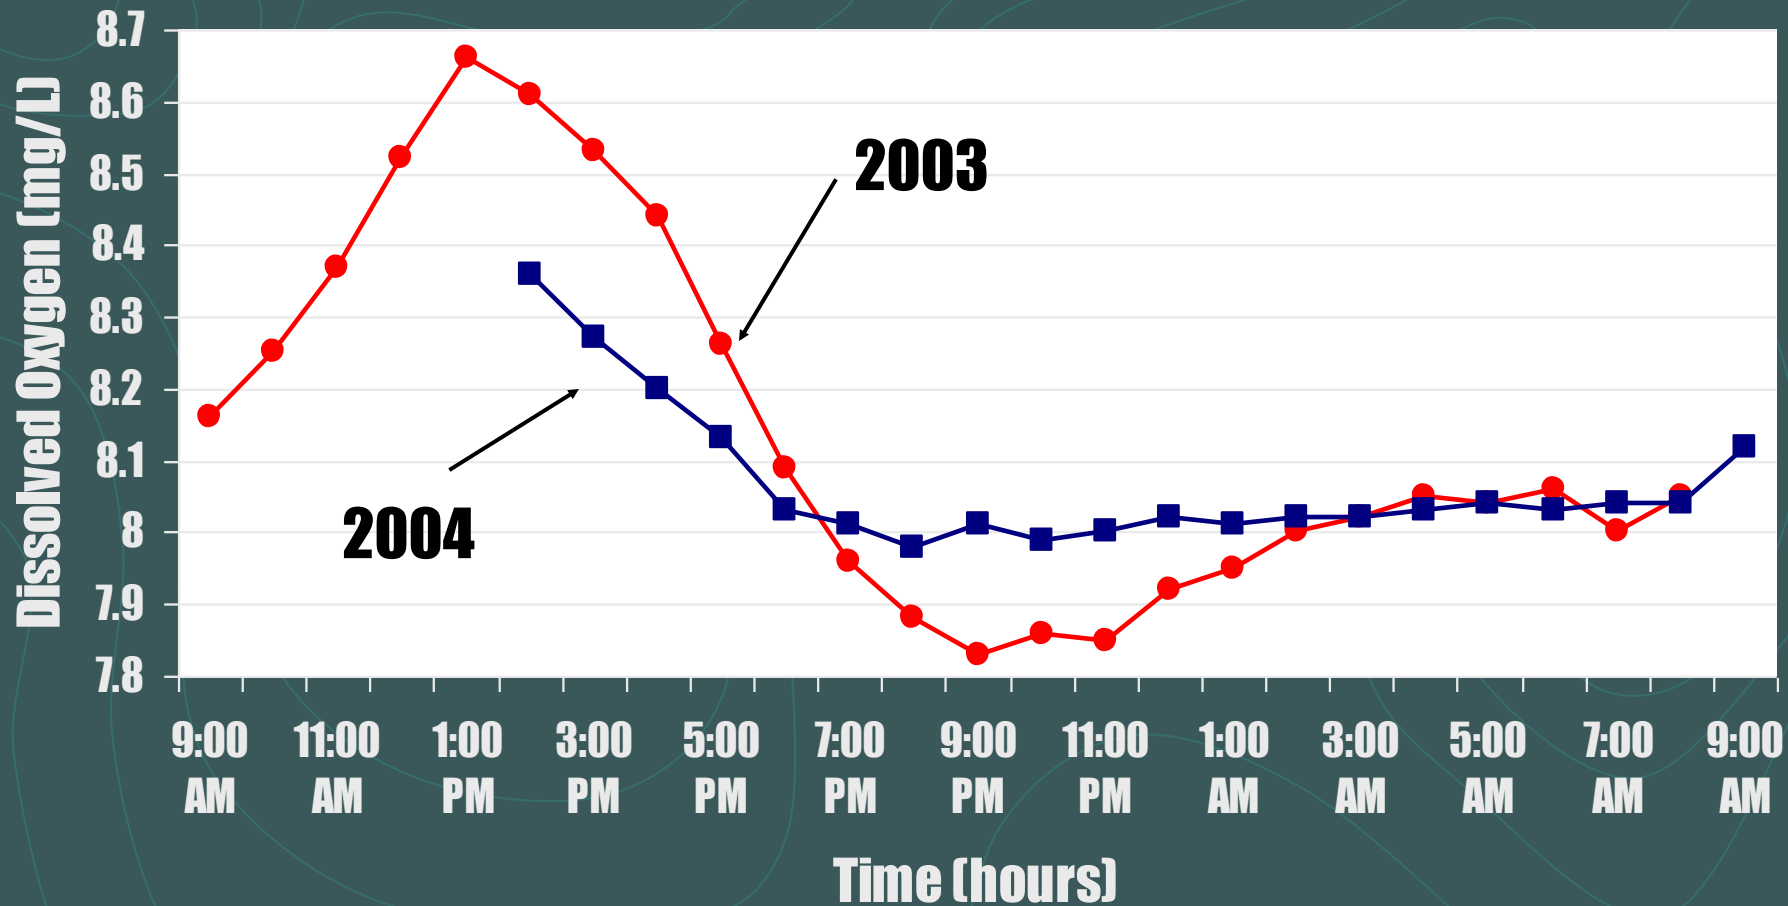
Comparison of Dissolved Oxygen Cedar St. 10/9/03 - 10/10/03 and 10/20/04 - 10/21/04

***MA Class B Standards require Dissolved Oxygen to be 5.0 mg/L or higher**

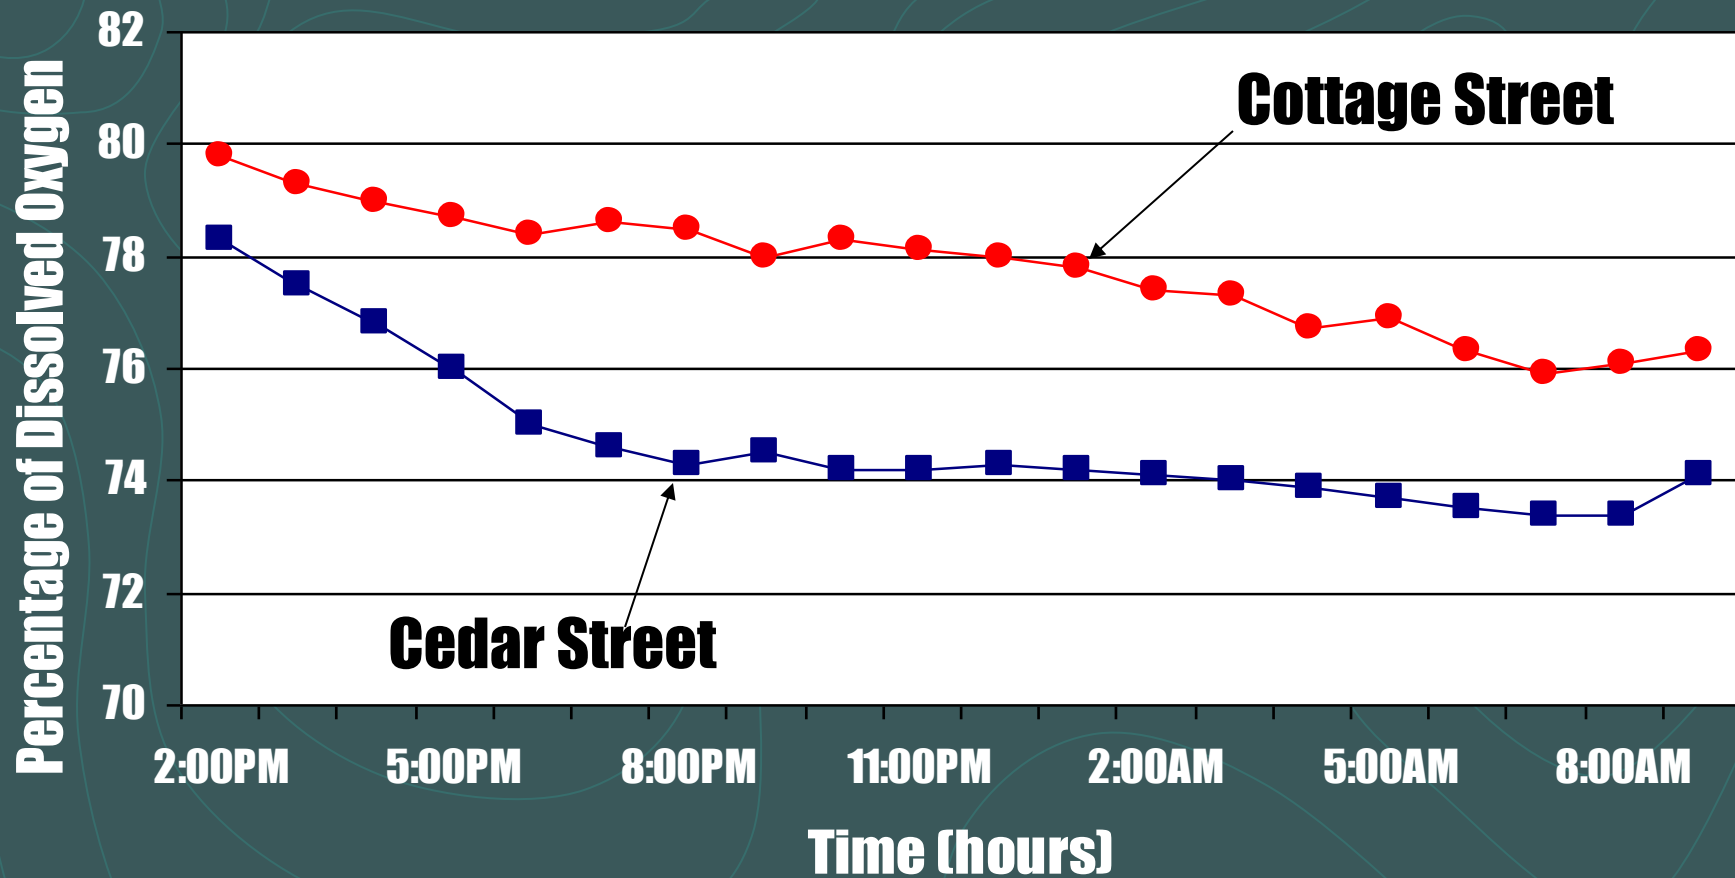
Comparison of the Percentage of Dissolved Oxygen Cottage St. and Cedar St. 10/20/04 – 10/21/04

***MA Class B Standards state that the percentage of Dissolved Oxygen should not be lower than 60%.**

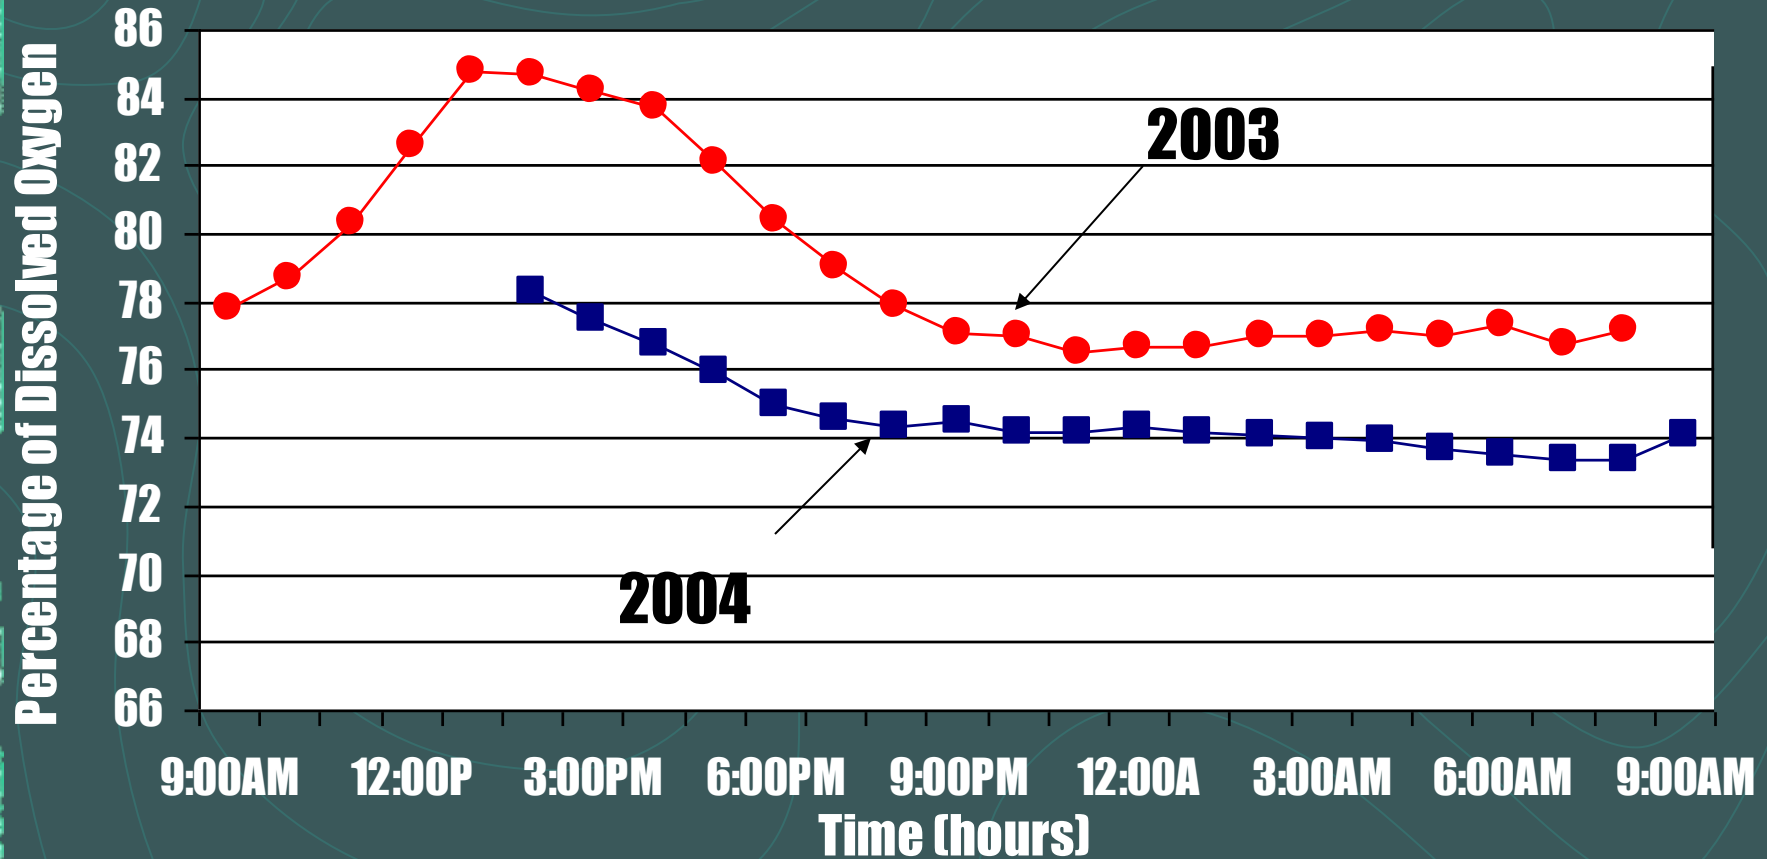
Comparison of the Percentage of Dissolved Oxygen Cedar St.

10/9/03 – 10/10/03 and 10/20/04 – 10/21/04

*MA Class B Standards state that the percentage of Dissolved Oxygen should not be lower than 60%.

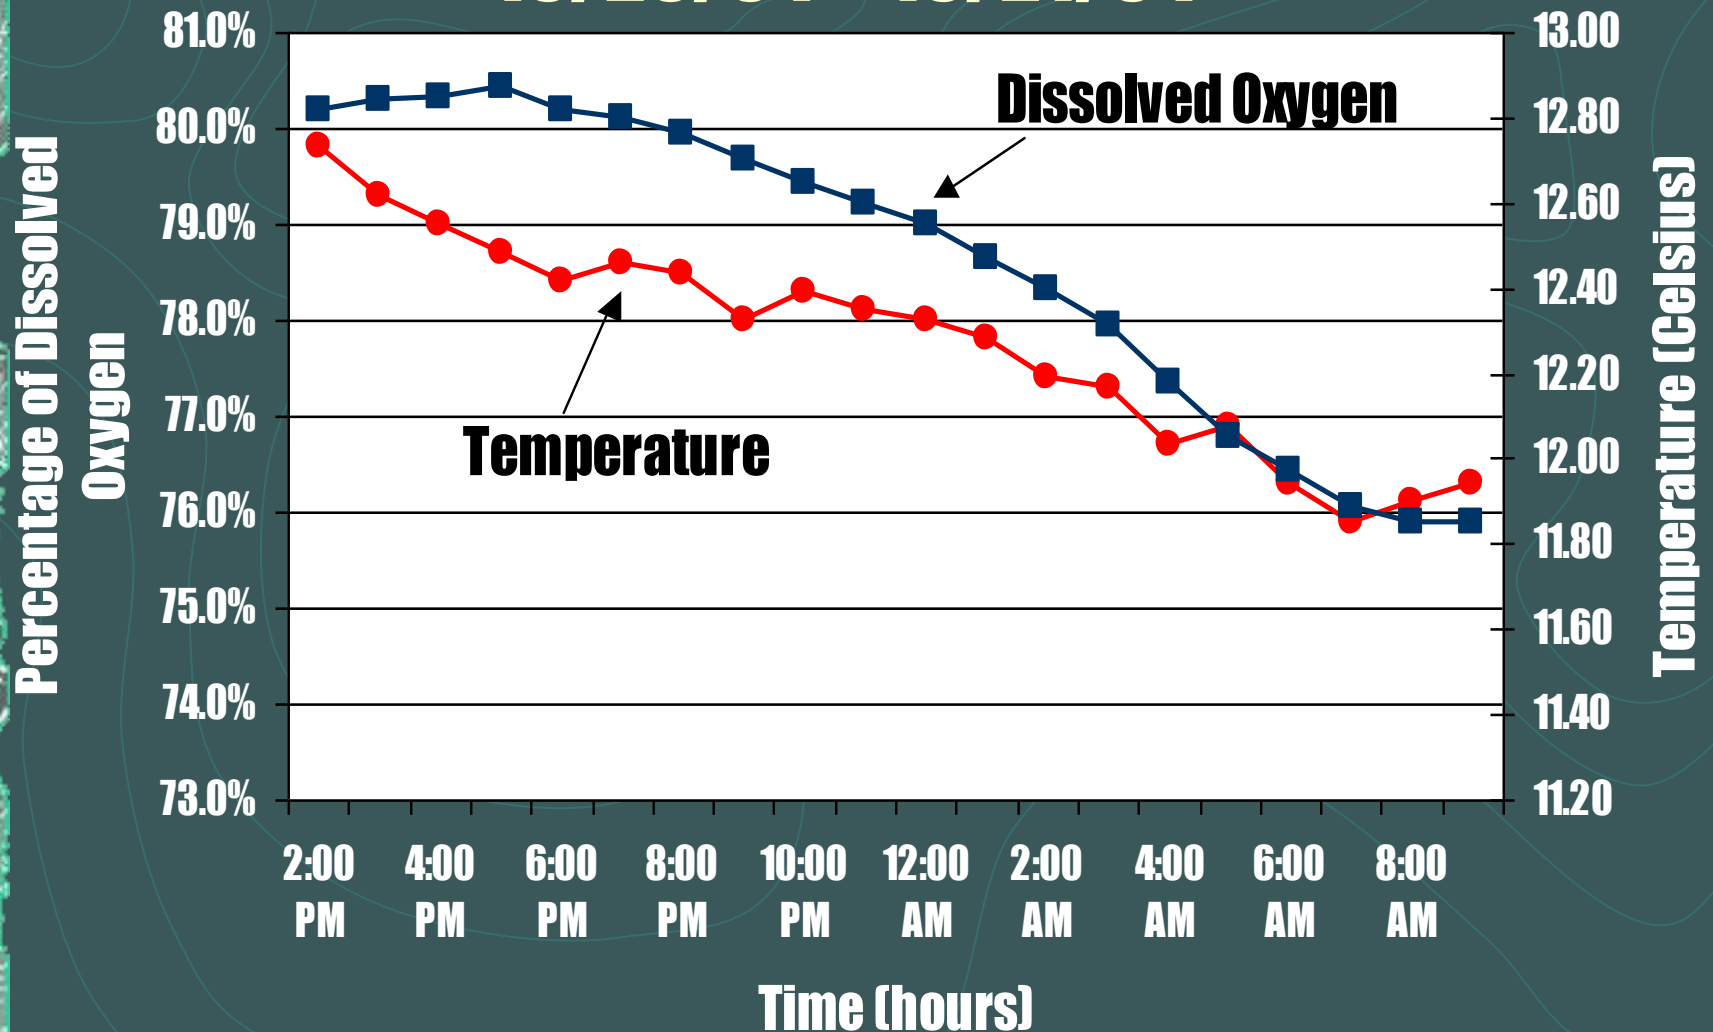
Comparison of Temperature and Percentage of Dissolved Oxygen at Cottage Street 10/20/04 – 10/21/04

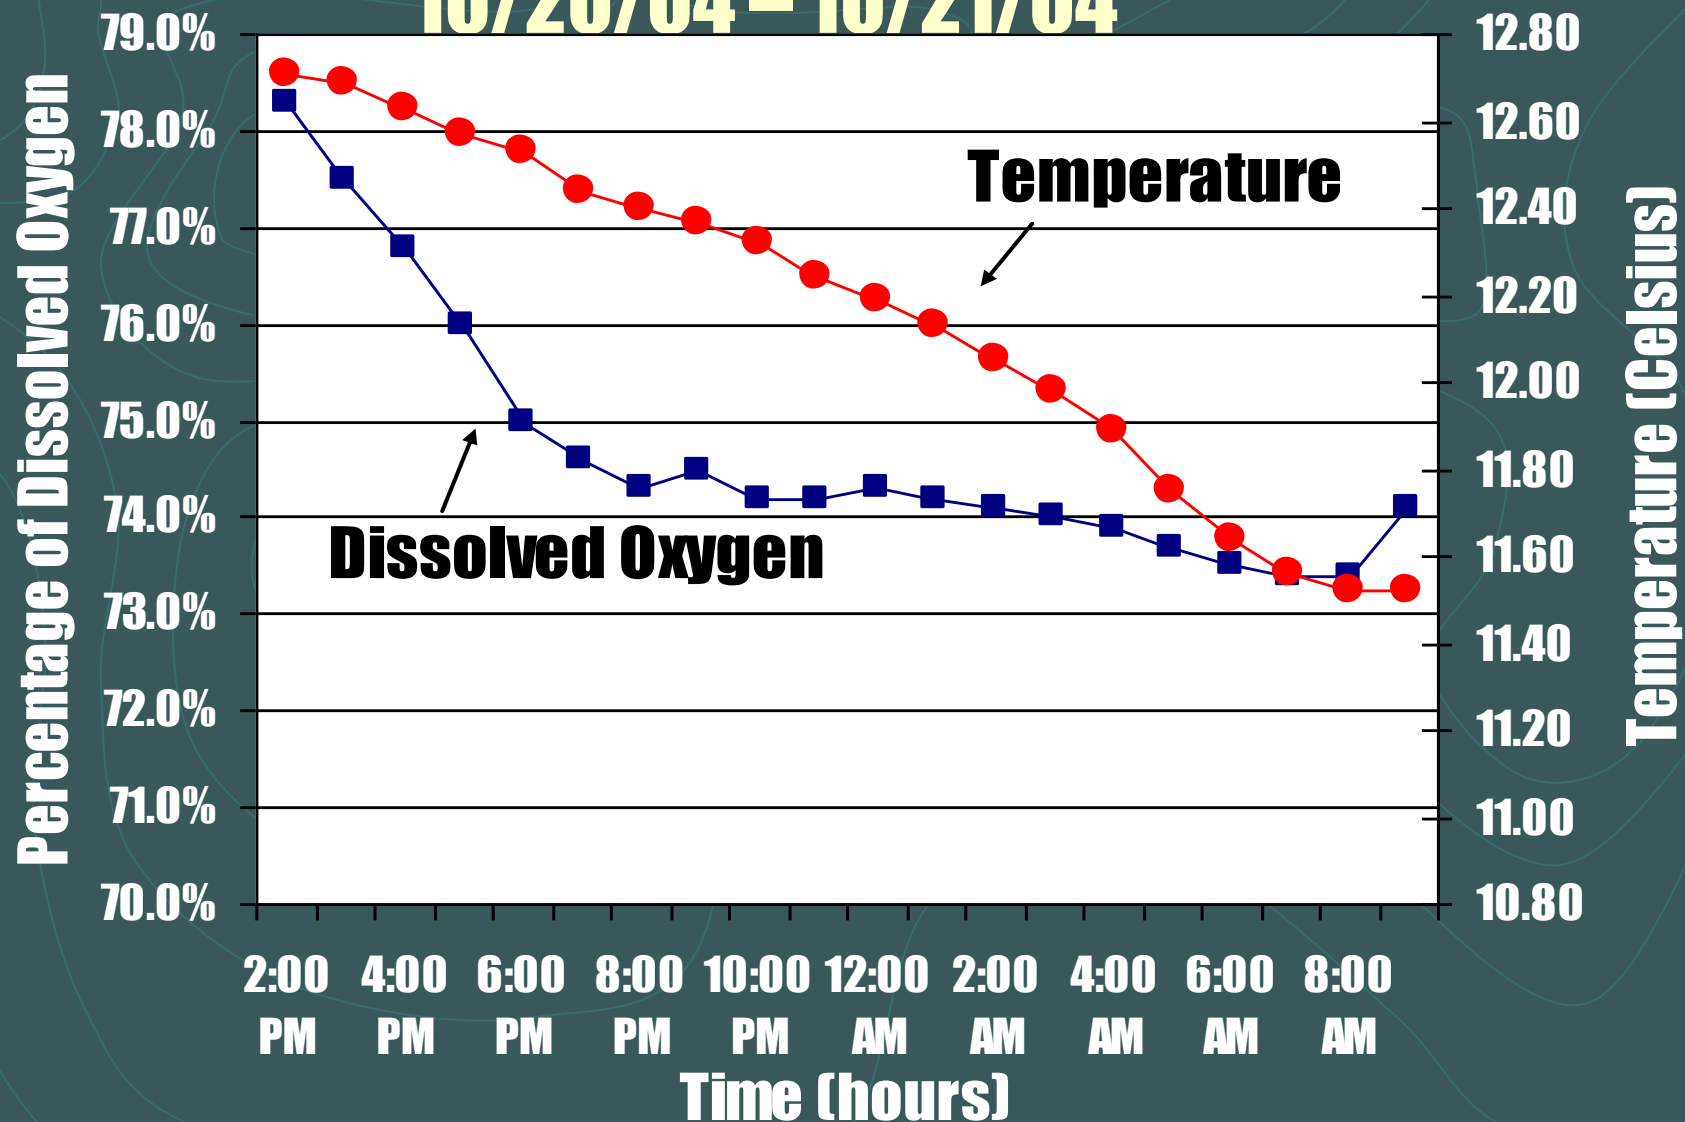
Comparison of Temperature and Percentage of Dissolved Oxygen at Cedar Street 10/20/04 – 10/21/04

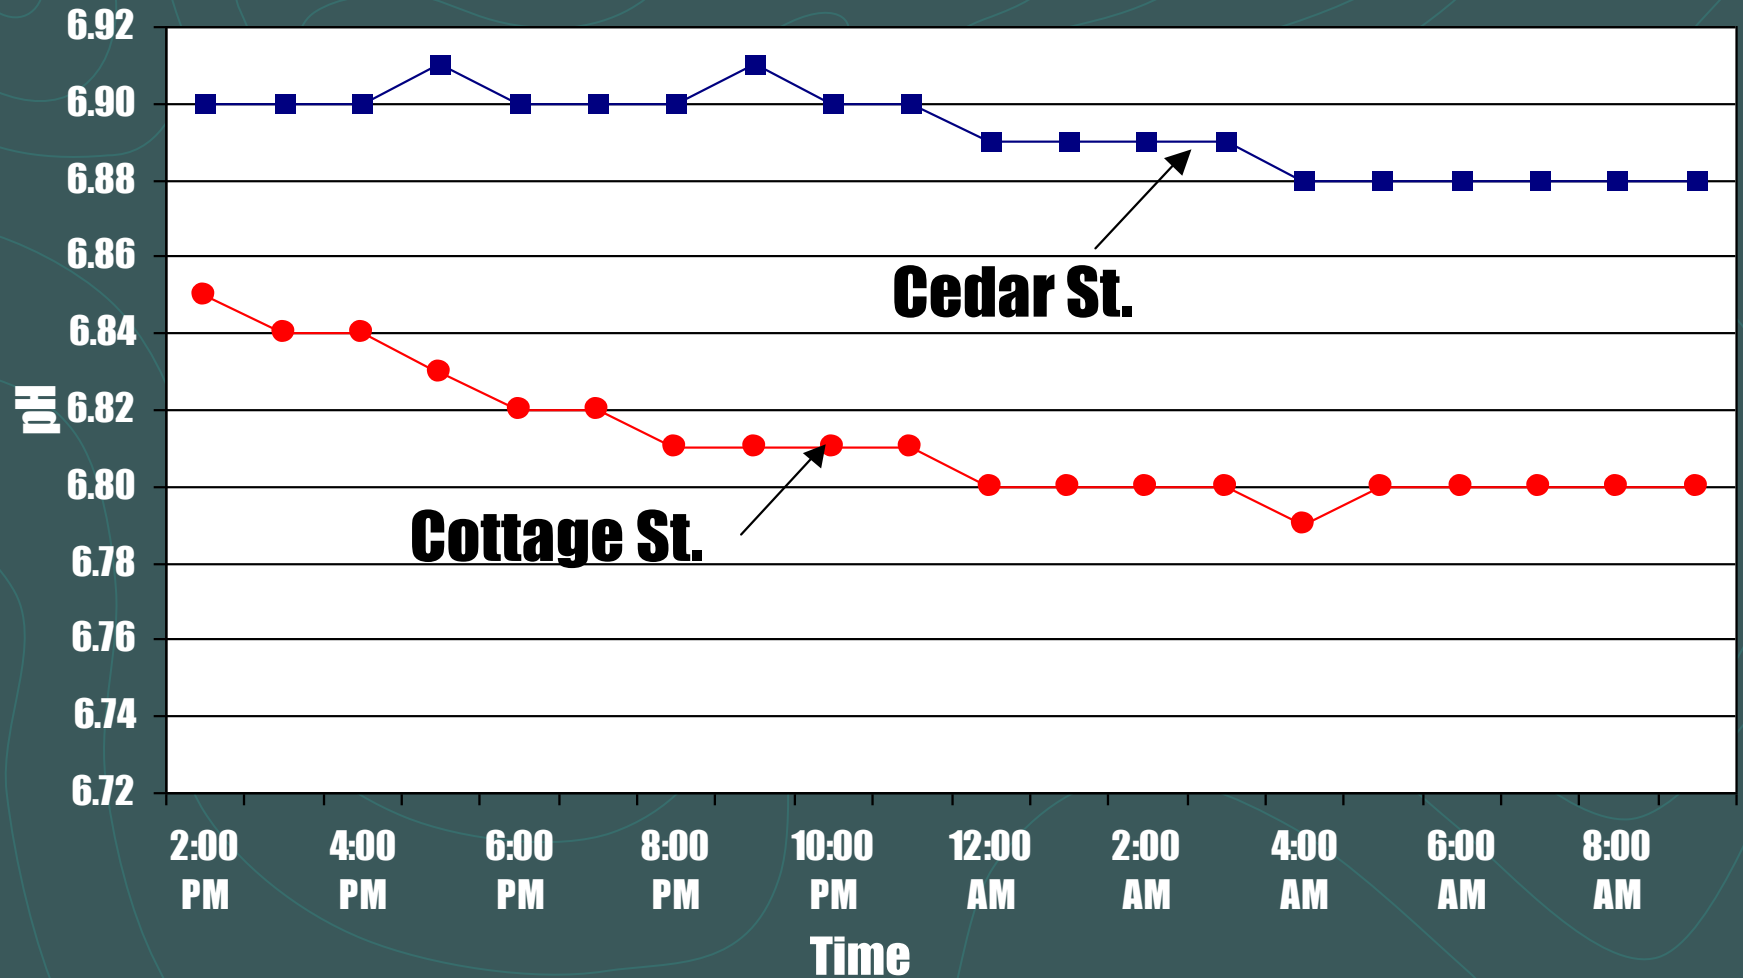
Comparison of pH Cedar St. and Cottage St 10/20/04 - 10/21/04

***MA Class B Standards require pH values to be between 6.5 and 8.3**

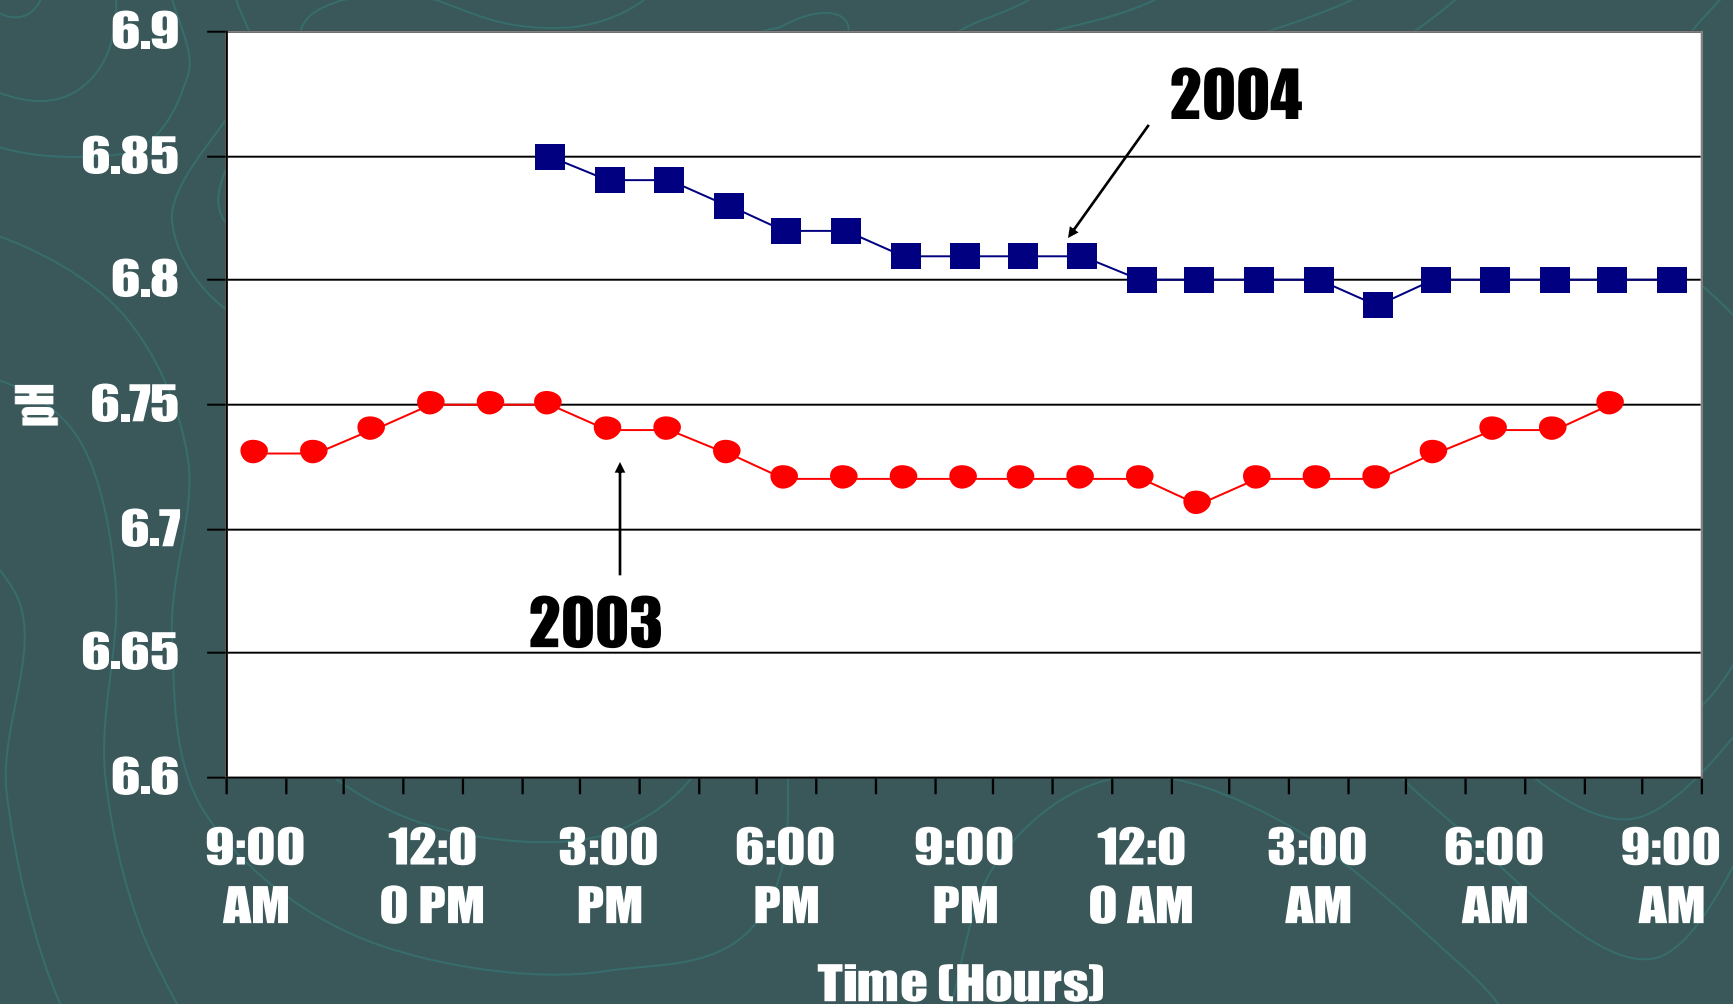
Comparison of the pH Cedar Street 10/9/03-10/10/03 and 10/20/04-10/21/04

***MA Class B Standards require pH values to be between 6.5 and 8.3**

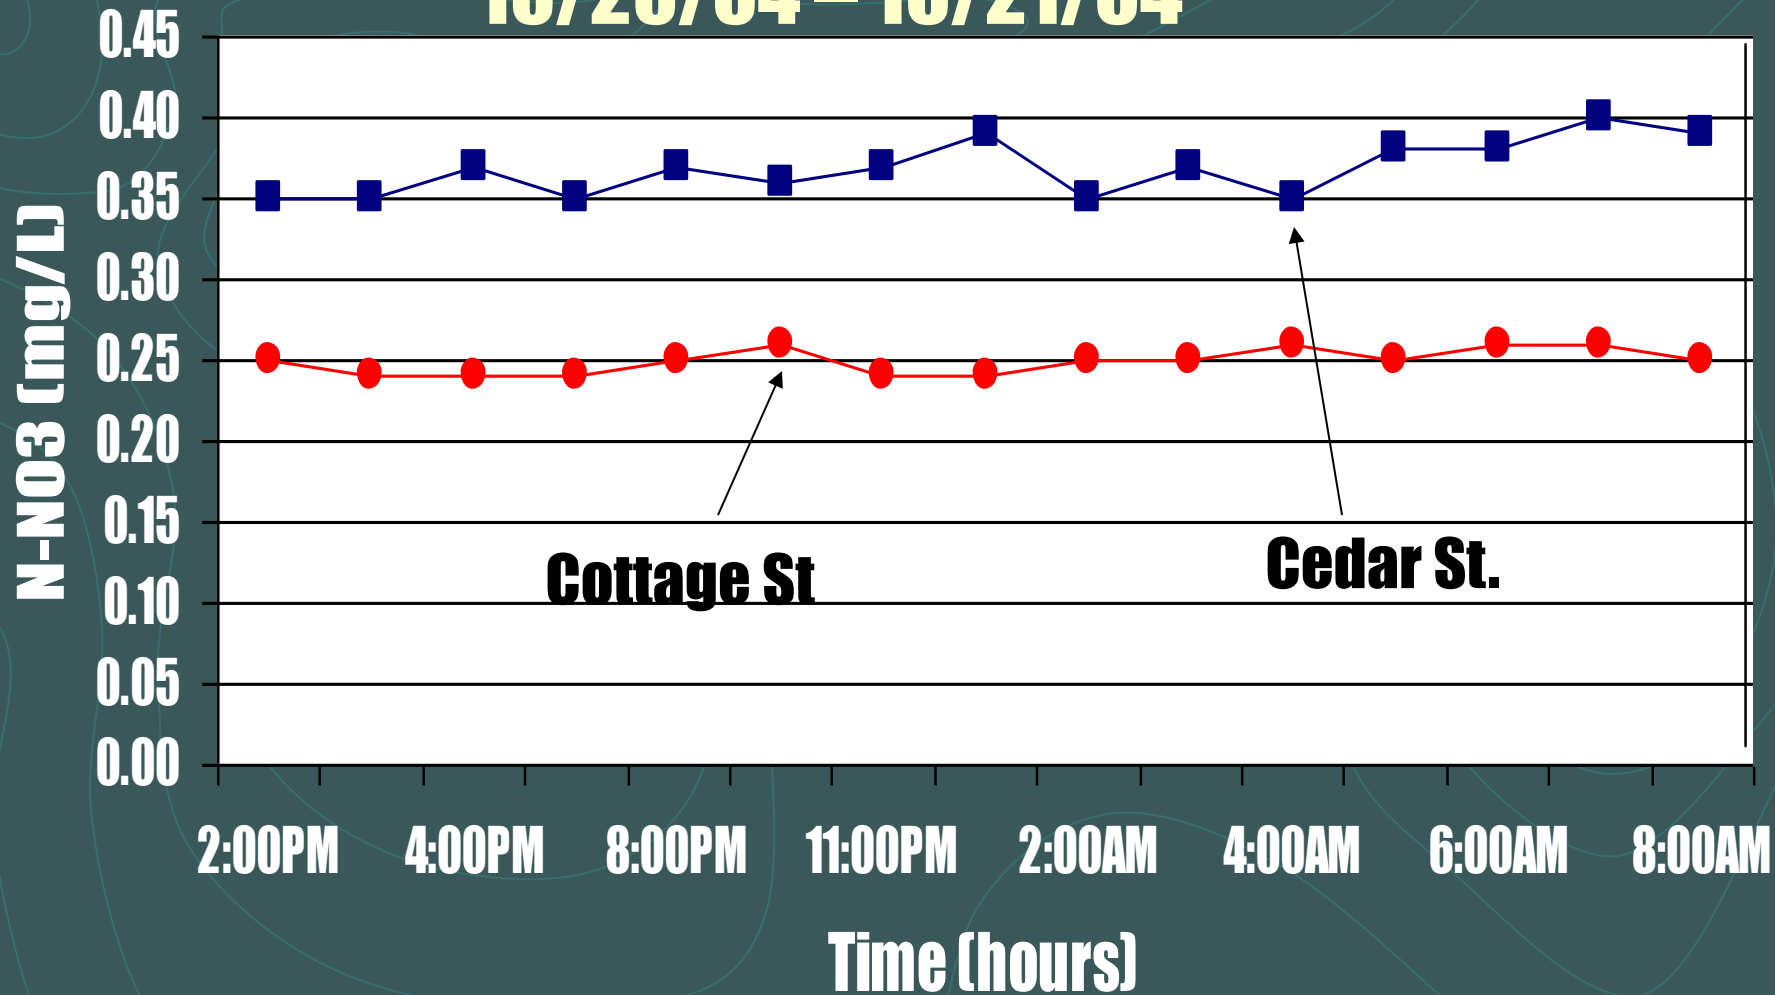
Nitrogen-Nitrate Comparison

Cottage St. and Cedar St.

10/20/04 – 10/21/04

***MA Class B Values require N-NO₃ values to be less than 1 mg/L**
The detection limit is 0.01 mg/L

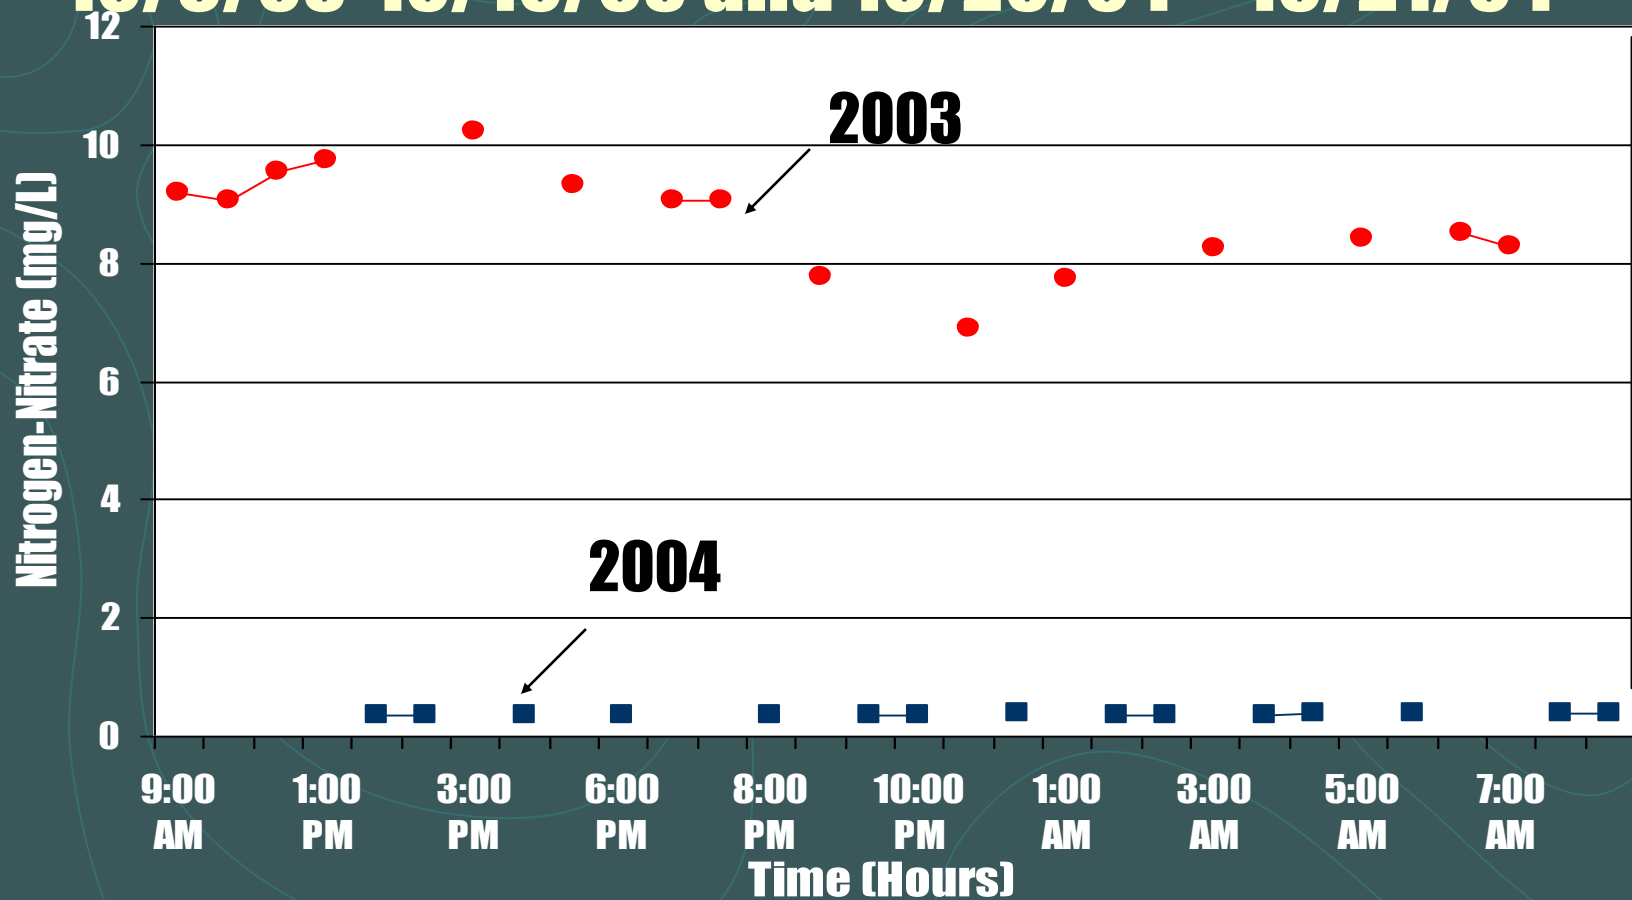
Comparison of Nitrogen-Nitrate Cedar Street

10/9/03-10/10/03 and 10/20/04 – 10/21/04

***MA Class B Values require N-NO₃ values to be less than 1.0 mg/L**
The detection limit is 0.1 mg/L

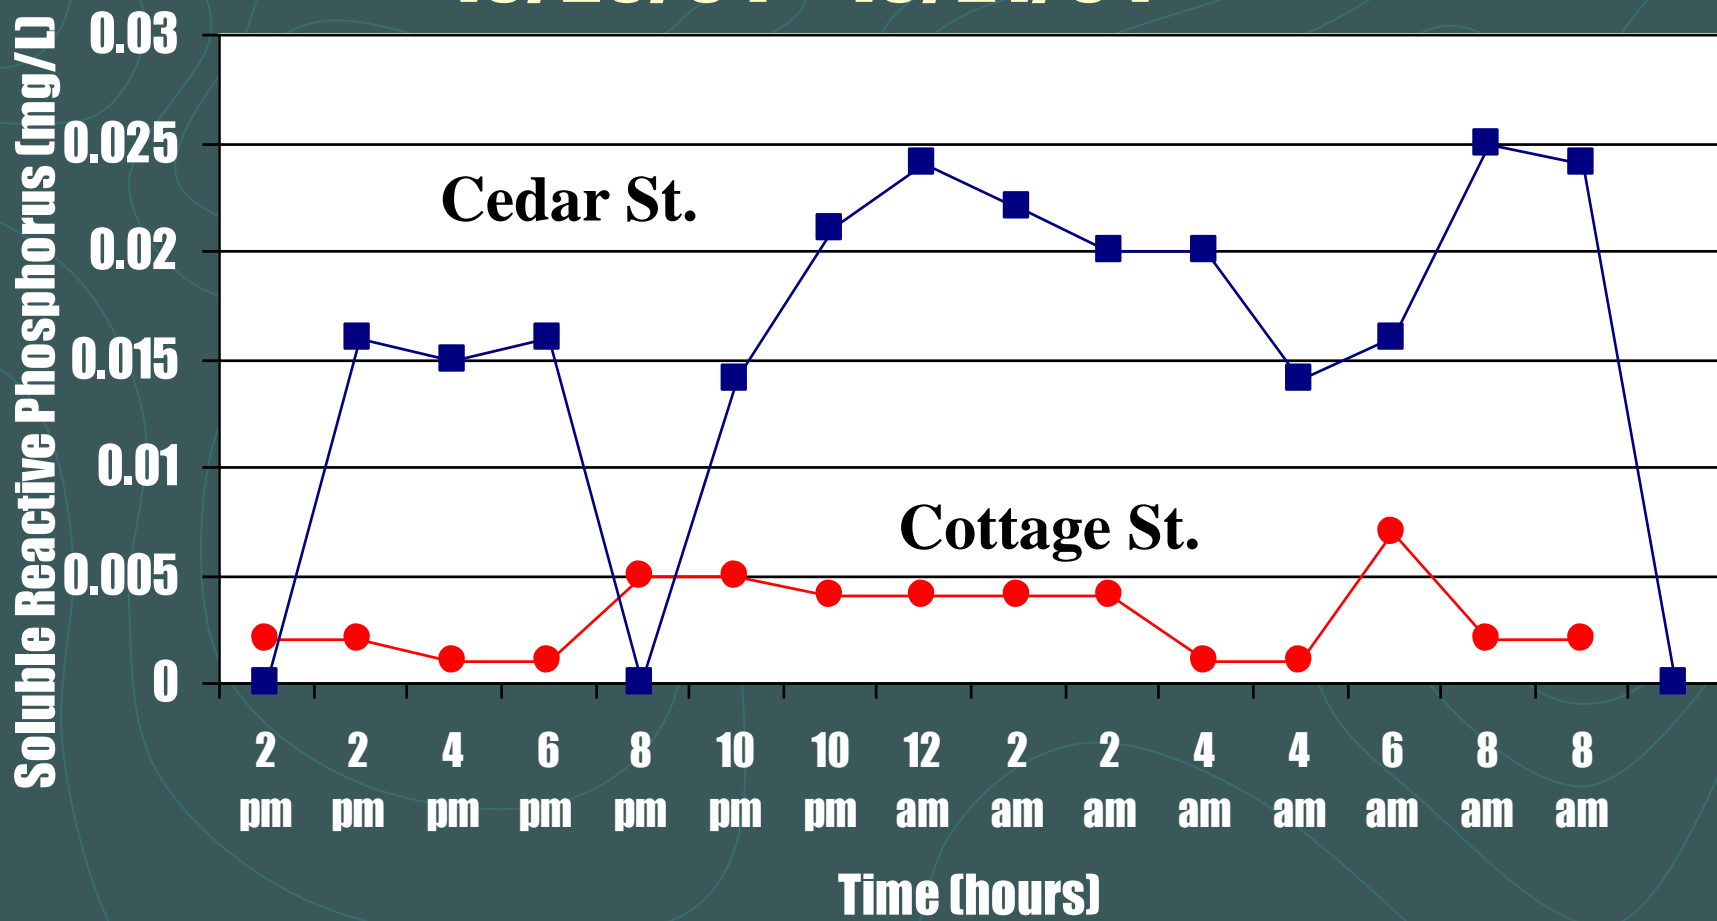
Comparison of Soluble Reactive Phosphorus Cottage St. and Cedar St 10/20/04 – 10/21/04

***MA Class B Standards require SRP levels to be under 0.1 mg/L
The detection limit is 0.008 mg/L**
