The Ten Mile River Study

North Attleboro High School

This study was done to test the Ten Mile River. A series of chemical, physical, and biological tests were performed at two different sites along the river to see if the Ten Mile River fits the Class B Warm Water Standards as set forth by the State of Massachusetts.

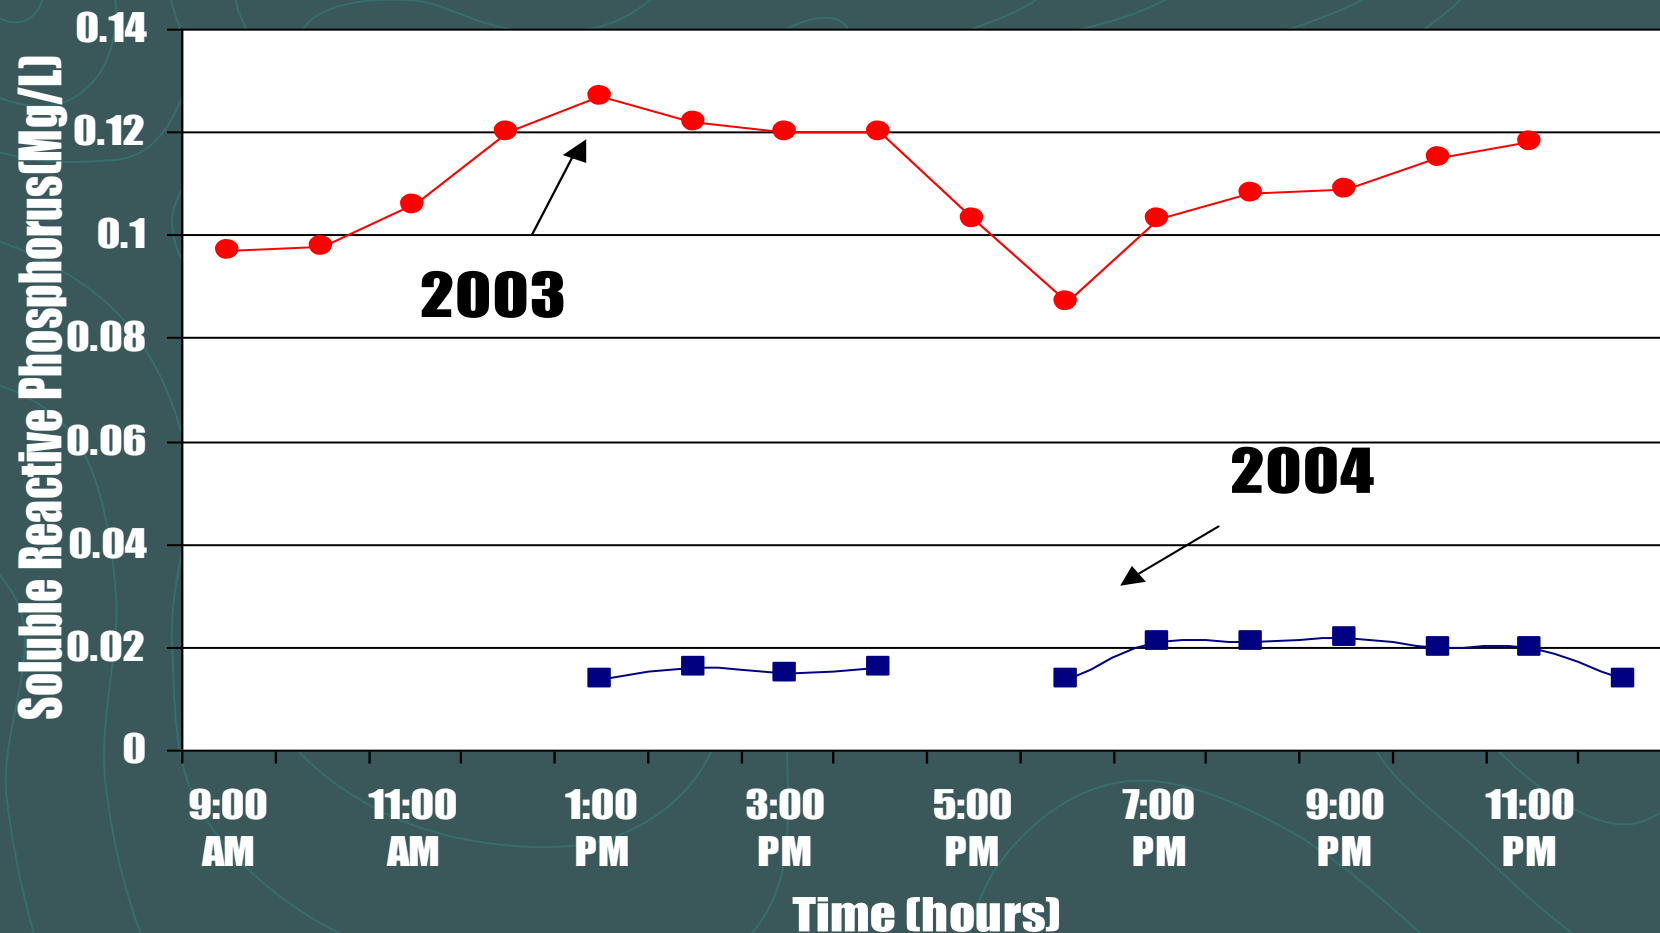
Comparison of Soluble Reactive Phosphorus Cedar St.

10/09/03-10/10/03 and 10/20/04-10/21/04

*MA Class B Standards require SRP levels to be under 0.1 mg/L
The detection limit is 0.008 mg/L

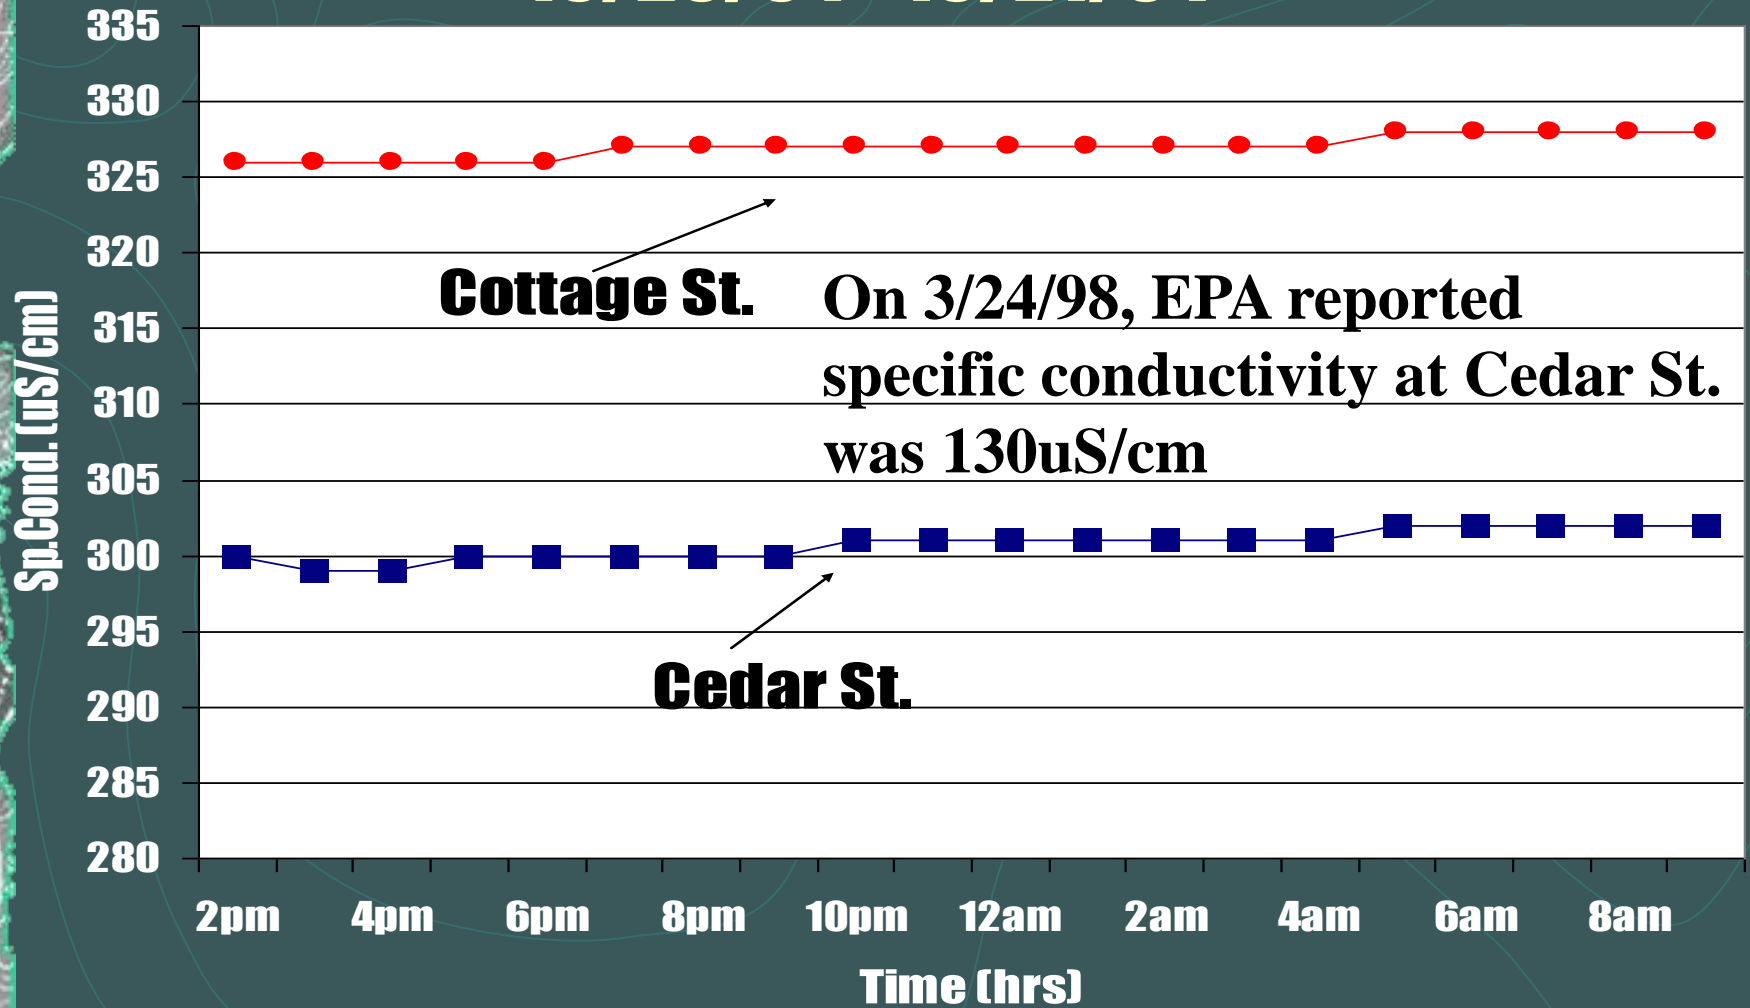
Comparison of Conductivity Cottage St. and Cedar St. 10/20/04 - 10/21/04

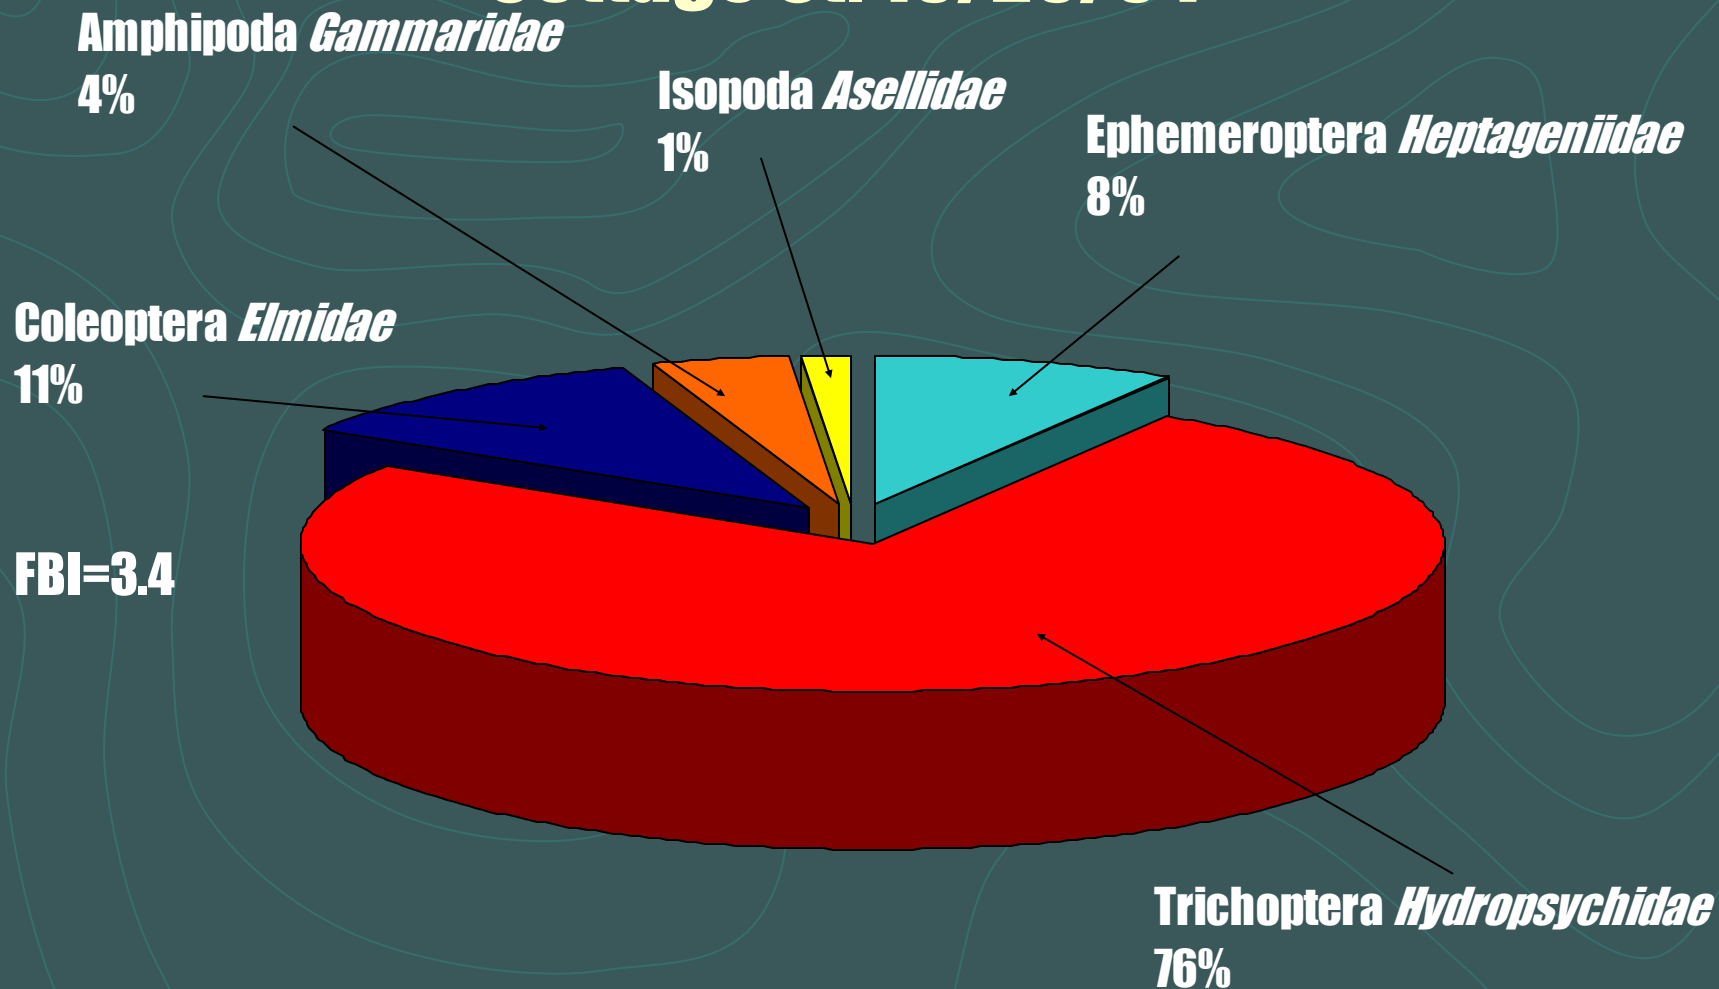
Percentage of Macro-Invertebrate Abundance Cottage St. 10/20/04

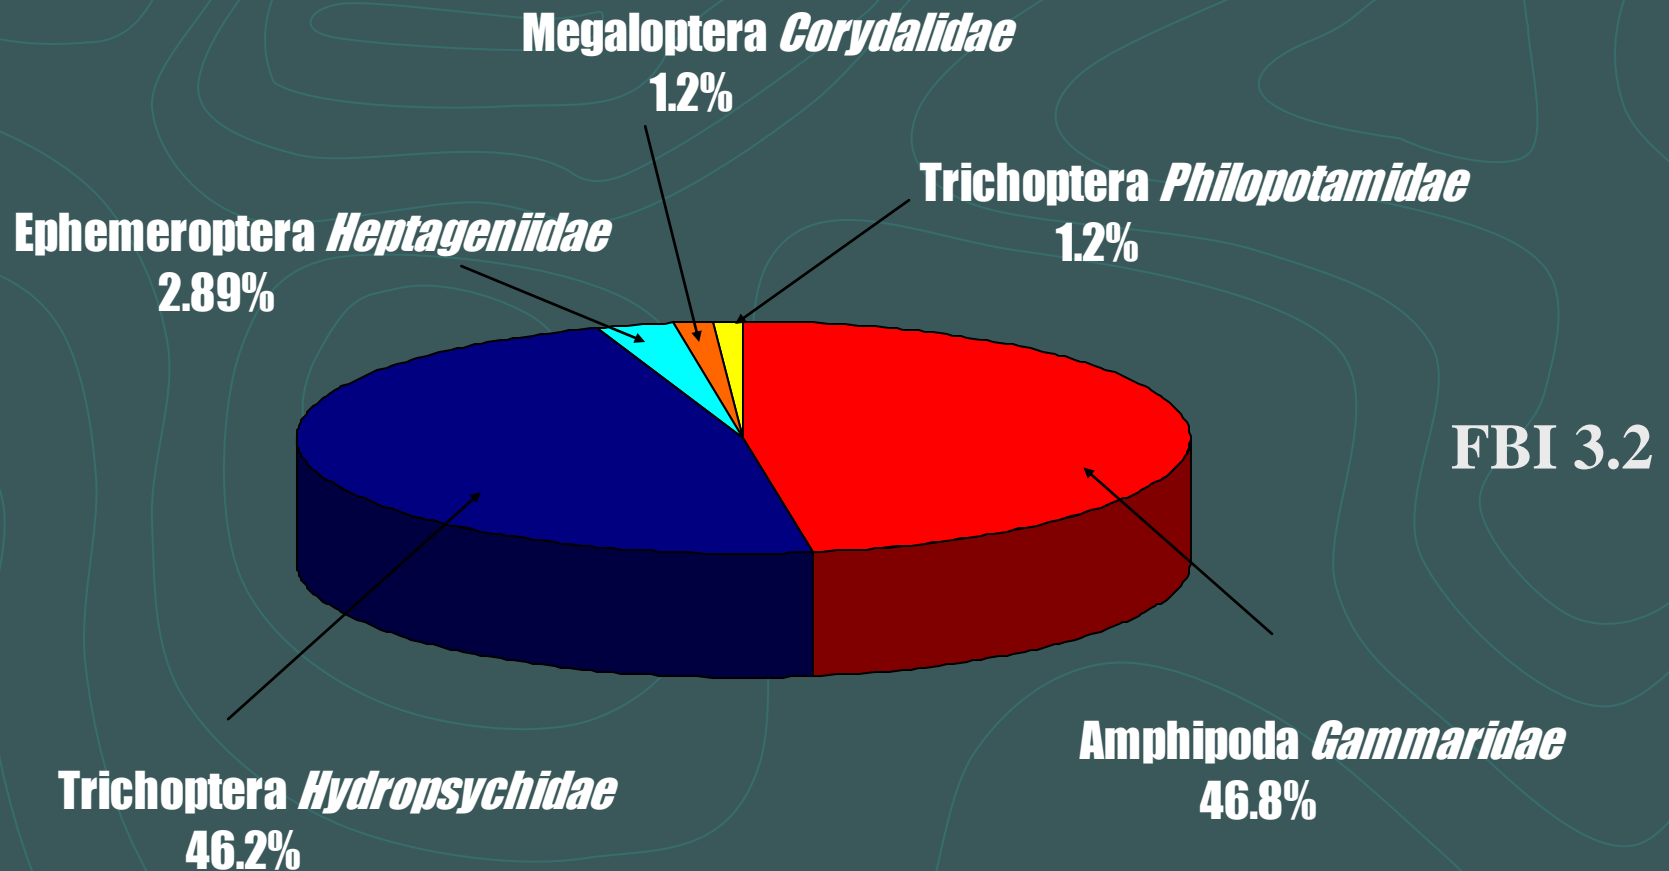
Percentage of Macro-Invertebrate Abundance Cedar St. 10/20/04
