Quashnet River Survey

Mashpee High School, Mashpee, Massachusetts (2006). *Quashnet River Survey*. In Watershed Access Lab Projects. Project 53.

***By D-Wayne Johnson
Kasey Sheenhan
&
Katie Nelson***

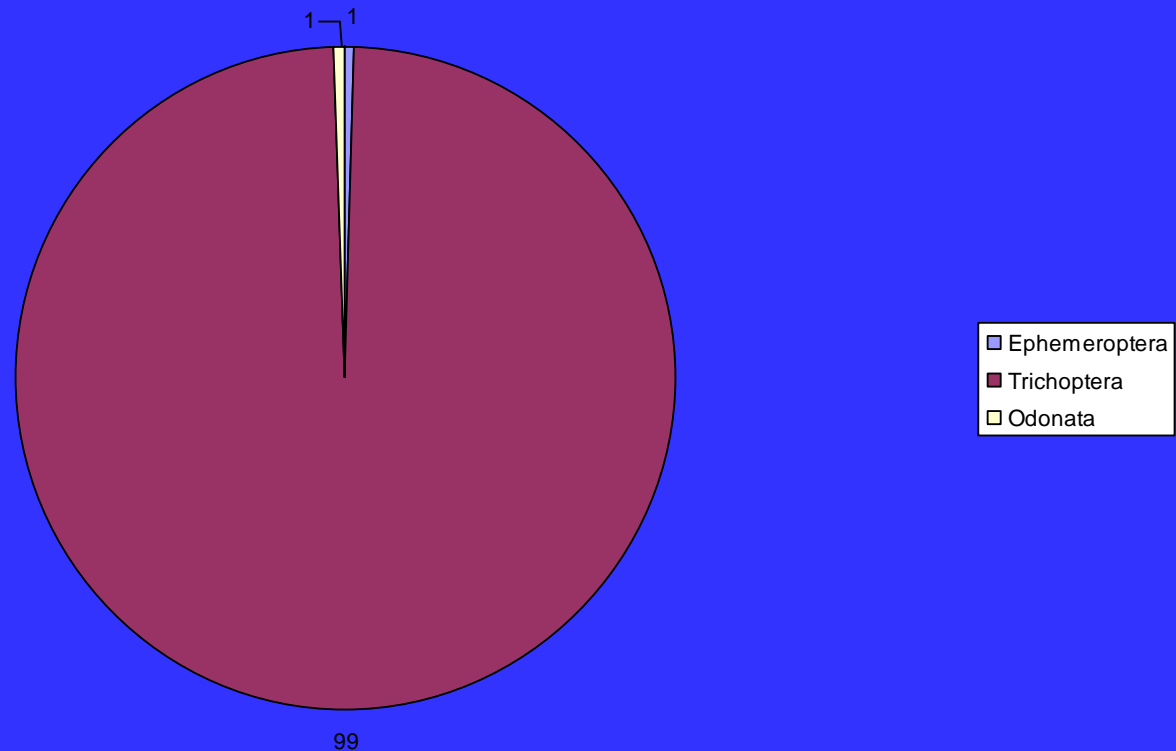
Major Group Composition of Headwater Site

This is a graph of the major group composition of the headwaters site, as you can see Trichoptera make up the majority.

- We found many Trichoptera at the Headwaters Site
- We also found many of these at the Martin Rd site.

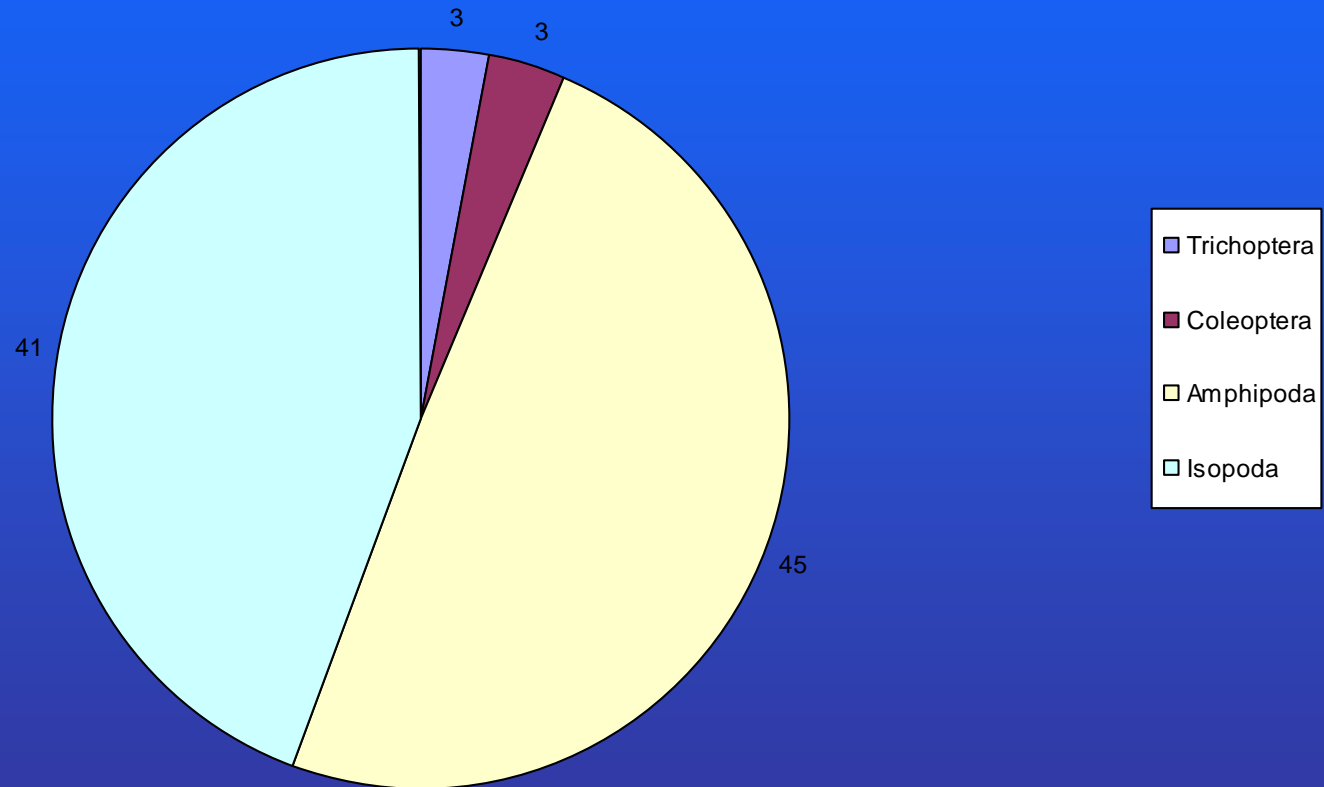
Major Group Composition of Martin Road Site

This is a graph showing the group composition of the river by Martin Road, as you can see Isopoda and Amphipoda make up the majority of the graph

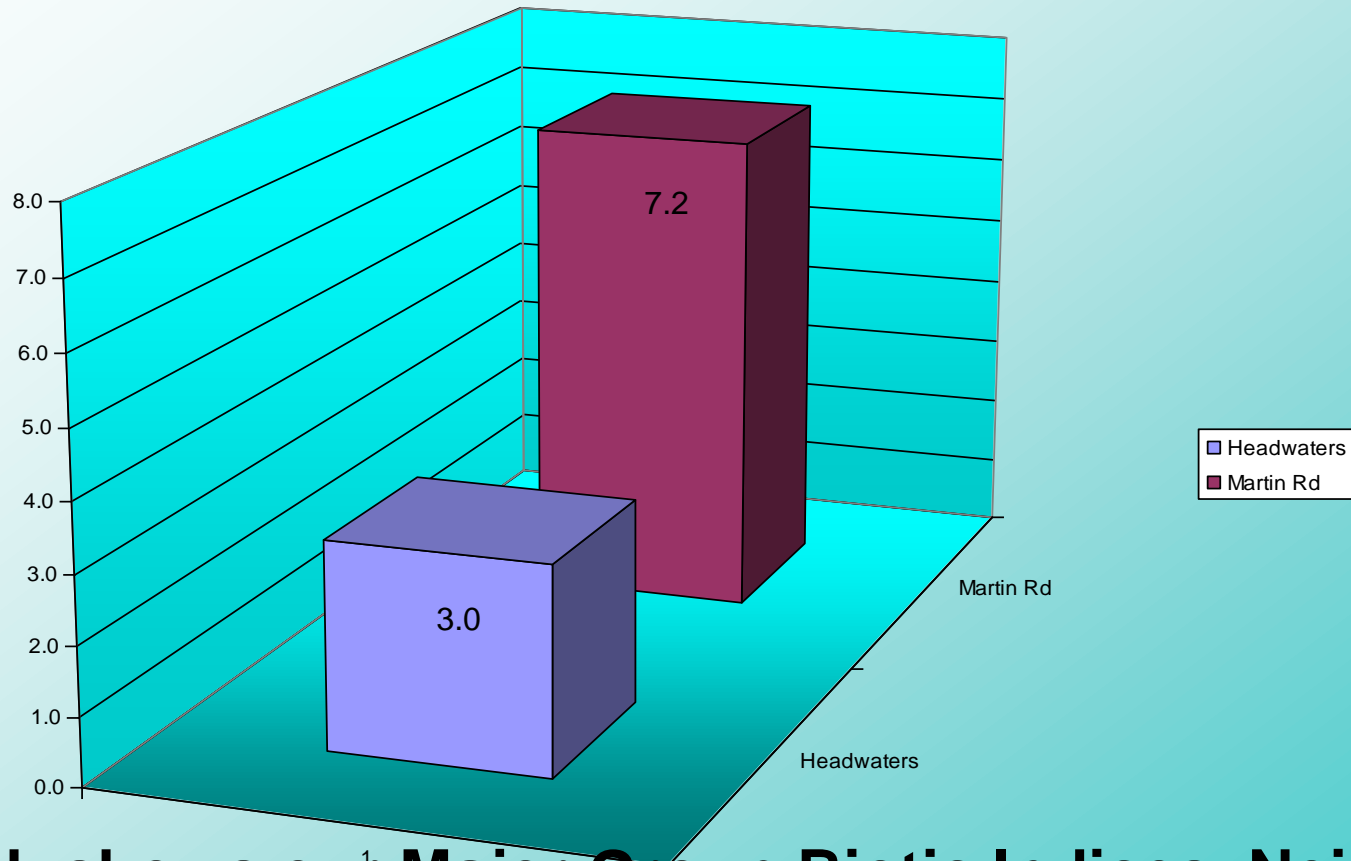
Major Group Biotic Index

This graph shows our Major Group Biotic Indices. Neither site supported a wide variety of groups, and the Martin Rd. site was mostly composed of groups that are considered pollution tolerant, thus the index there is higher.

The numbers are expressions of the water quality based on the organisms that we found; 3.0 is very pure, while 7.2 is considered impaired.

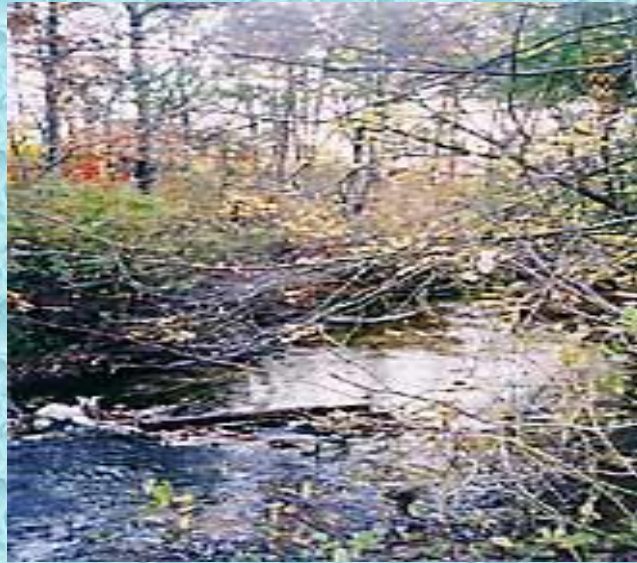
Depth results

- The results show that the river near Martin Rd. was about 2.5 feet deep.

- While at the Headwaters site data suggest the average depth is about $\frac{9}{10}$ of a foot.

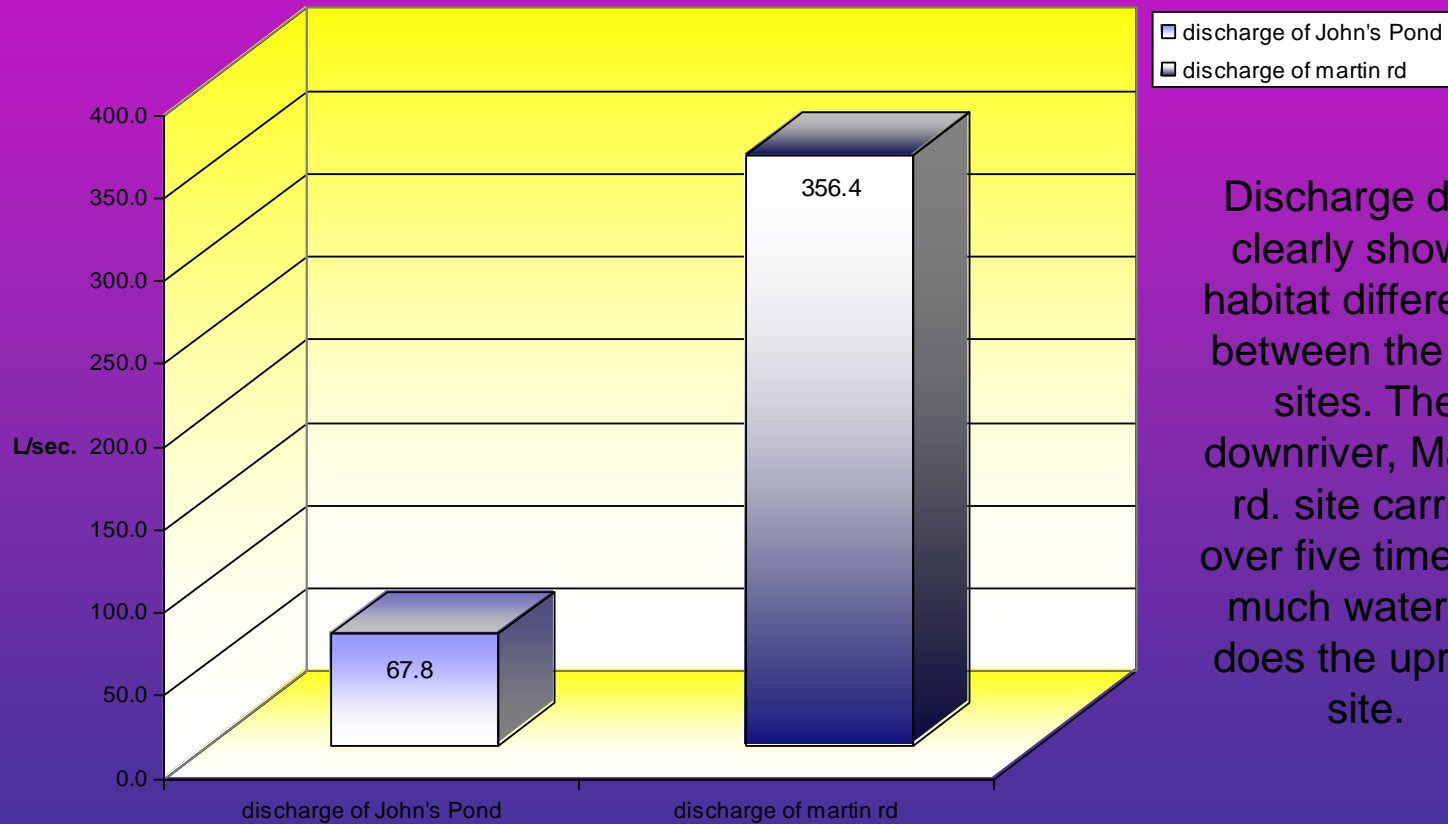
Comparitive Discharge

Discharge data clearly show a habitat difference between the two sites. The downriver, Martin rd. site carries over five times as much water as does the upriver site.

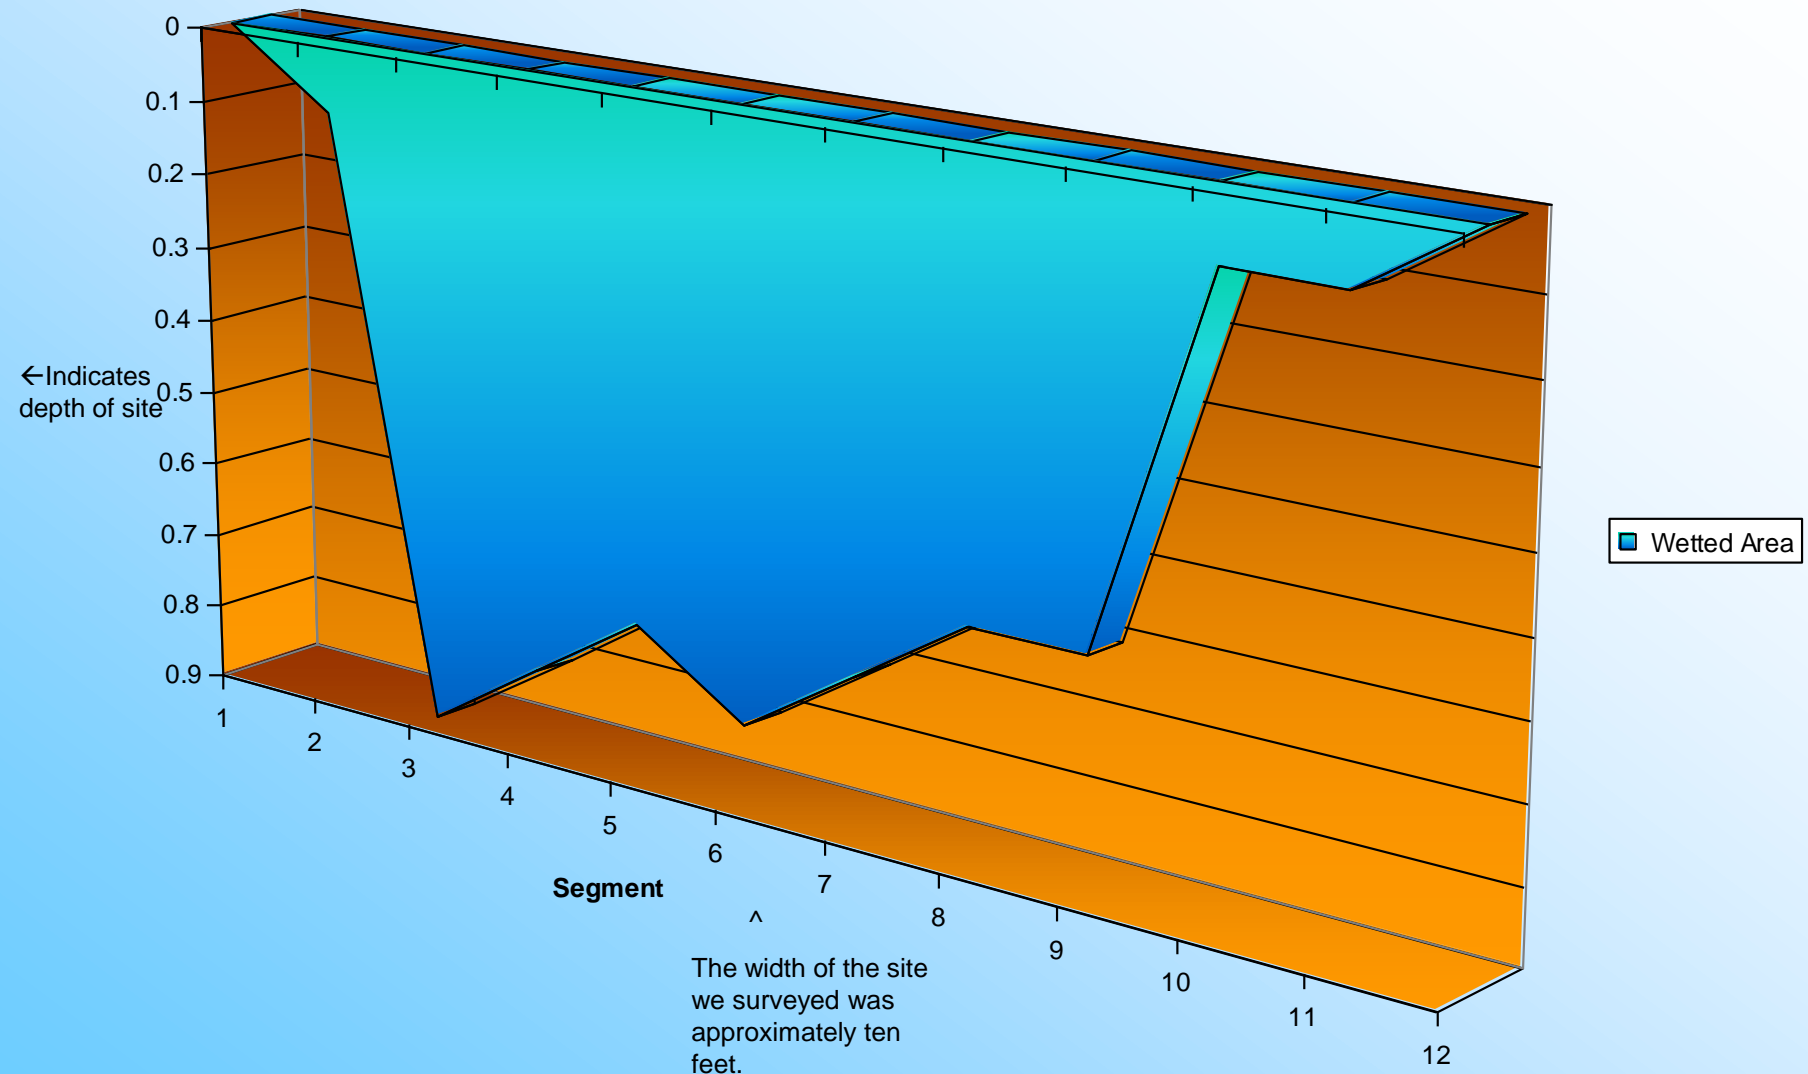
Stream Profile: Headwaters

This is a graph representing the width and depth data collected at the headwaters site.

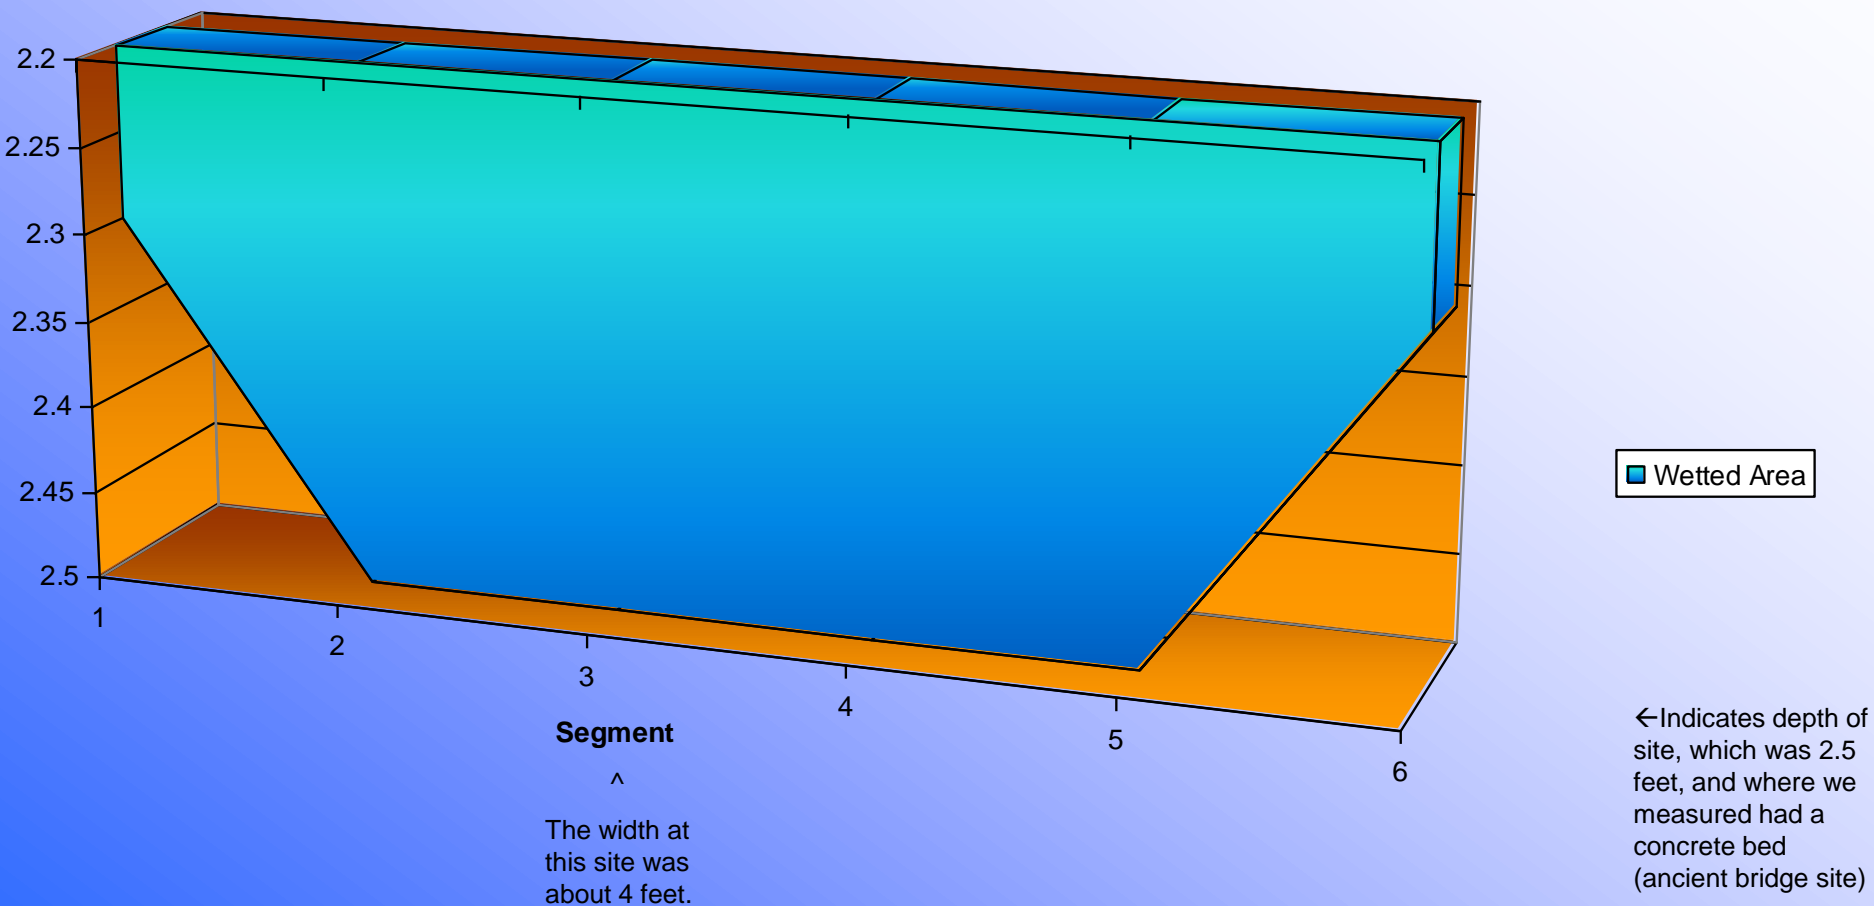
Stream Profile: Martin Rd

This is a graph representing the width and depth data that was collected at Martin Road.
