### Water Quality Project: Mashpee River Study

# Water Quality Project

By:  
Brianna Huard,  
Rachel Owen,  
Lizzie Sardinha, and  
Jasmine McCall.

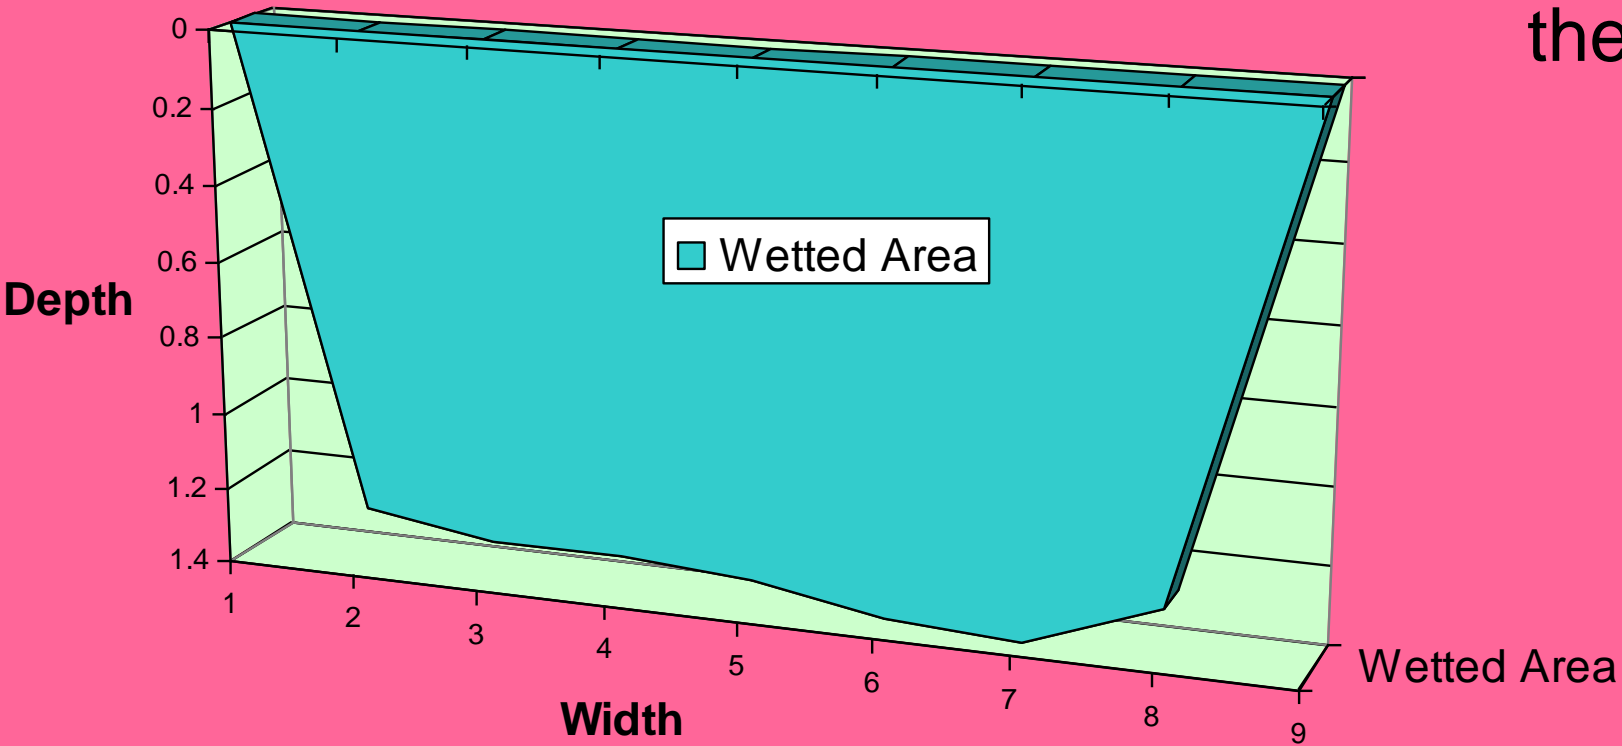
## Profile of Herring Run

This is the  
width and  
depth of  
the Herring  
Run

The  
average  
depth is  
1.3 feet.

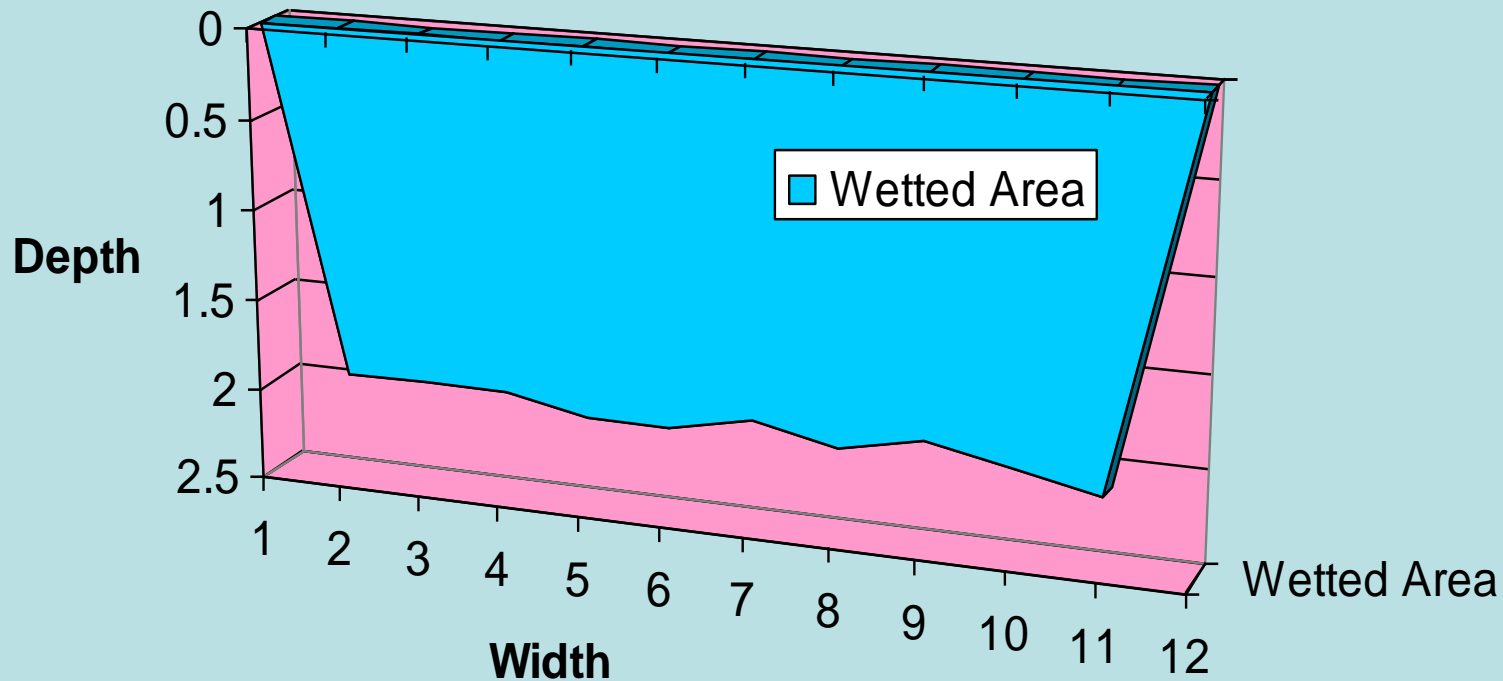
## Profile at S. Rt.28

This is the width  
and depth of our  
site: South of Rt. 28

The  
average  
depth is  
1.96 feet

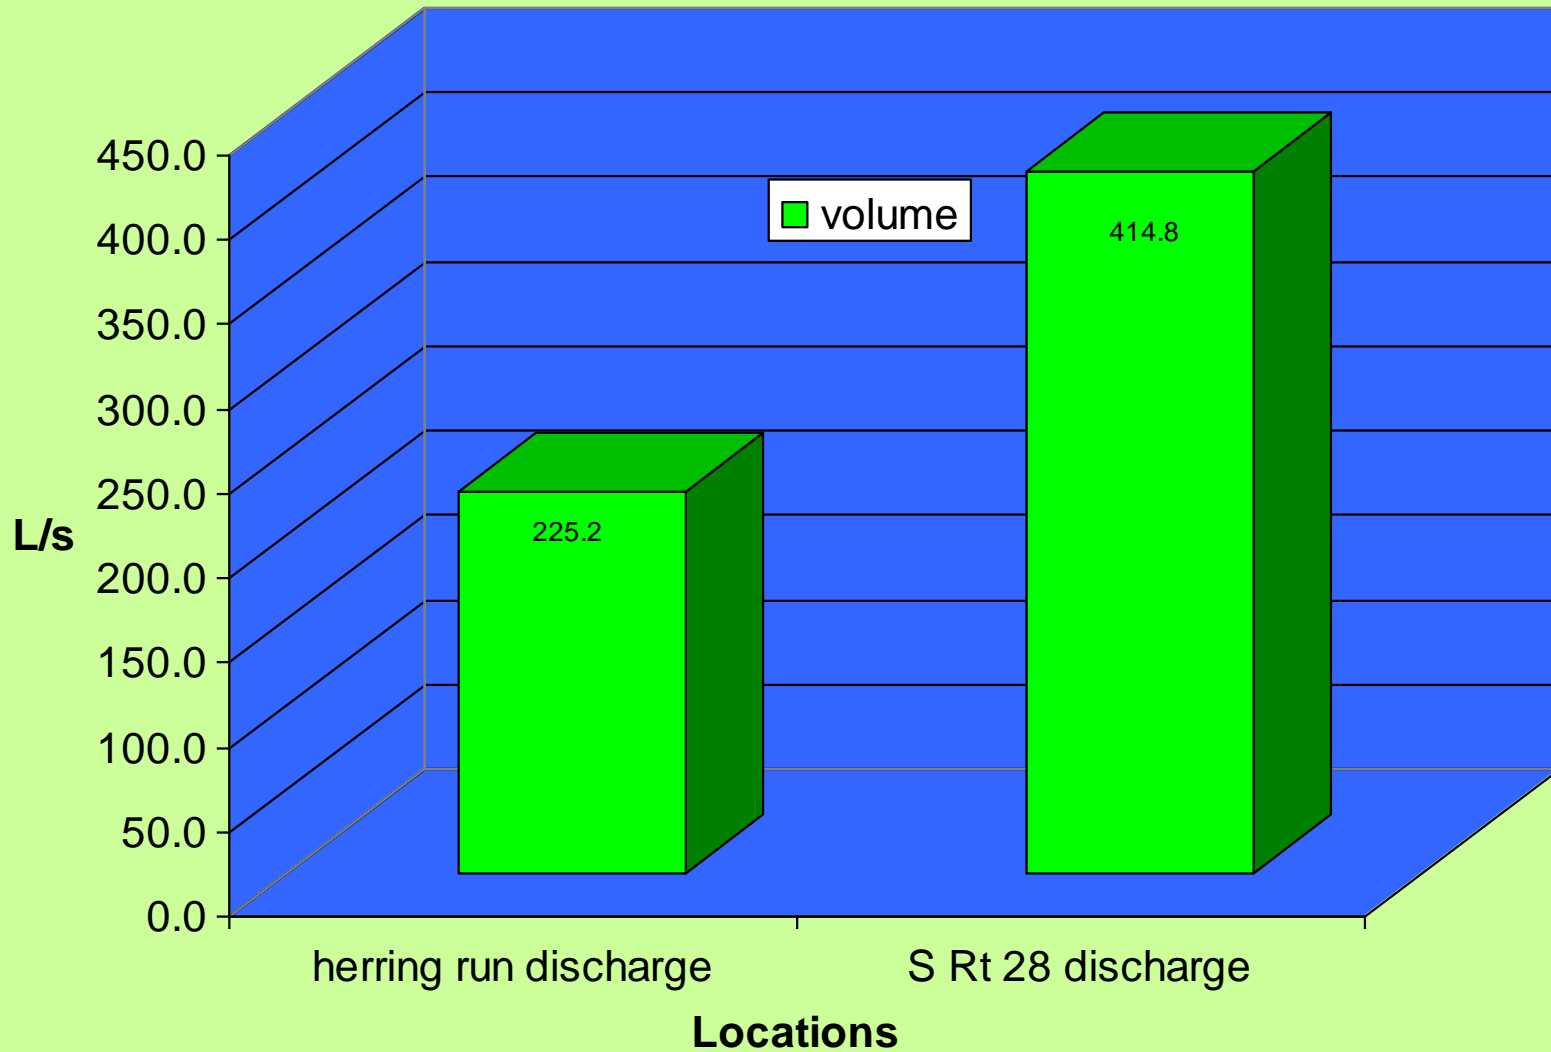
## Total Discharge

There is more discharge at Rt. 28., it's lower in the river system. It carries almost twice the volume of the upper site.

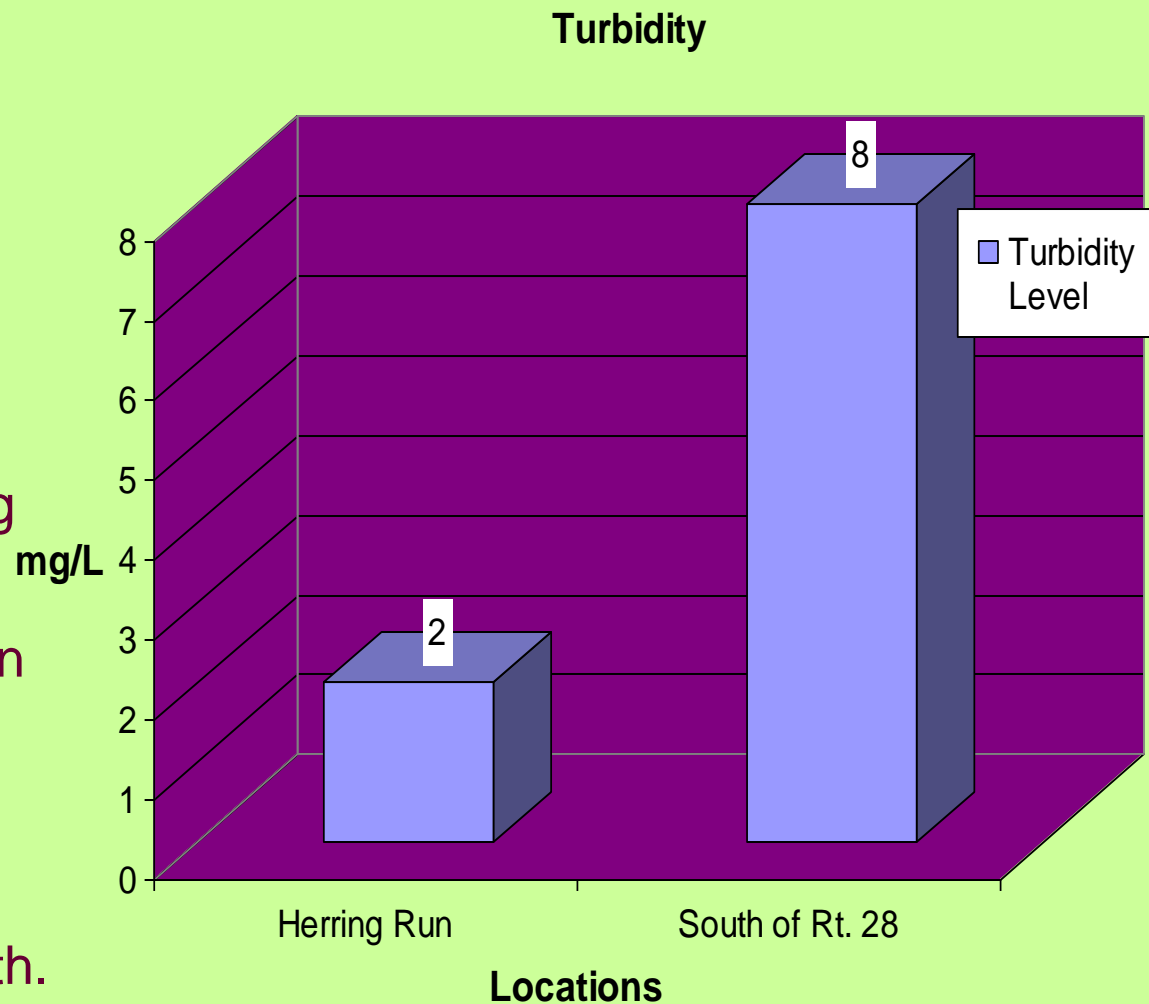
The Herring Run was clearer, possibly because there was less floating algae. The reduced algae could have been associated with lower nitrate levels which is a nutrient that stimulates plant growth.

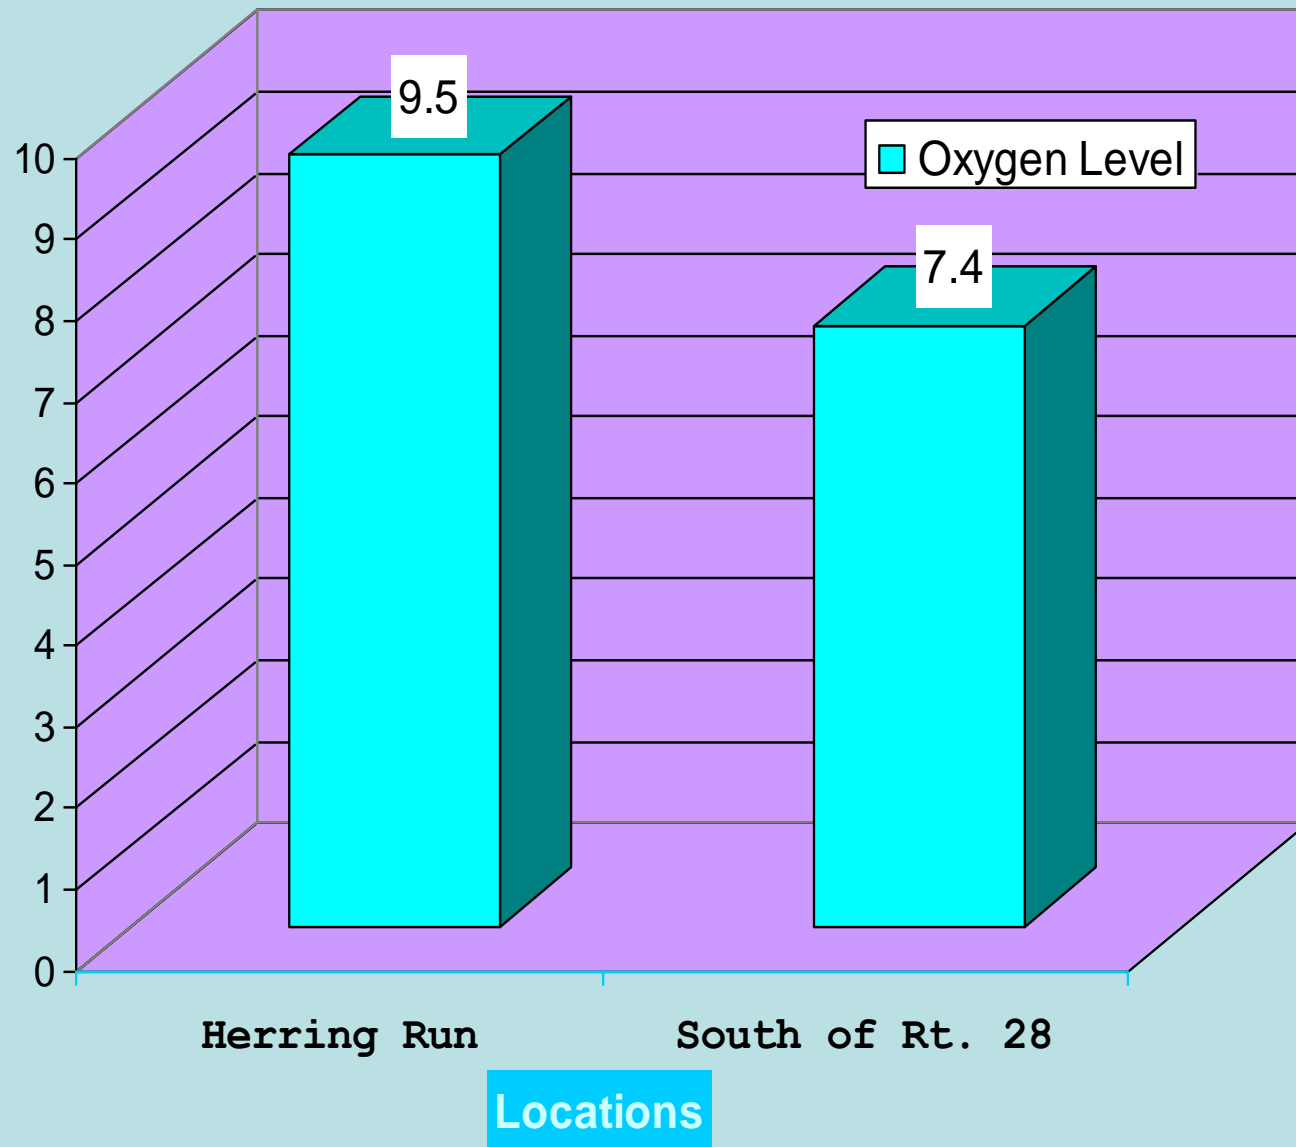
## Disolved Oxygen Levels

Possibly it was higher at the Herring Run because of the fish ladder. Water was tumbling down the concrete ladder. Another possibility is that rooted plants were producing more oxygen in the water at the open Herring Run site.

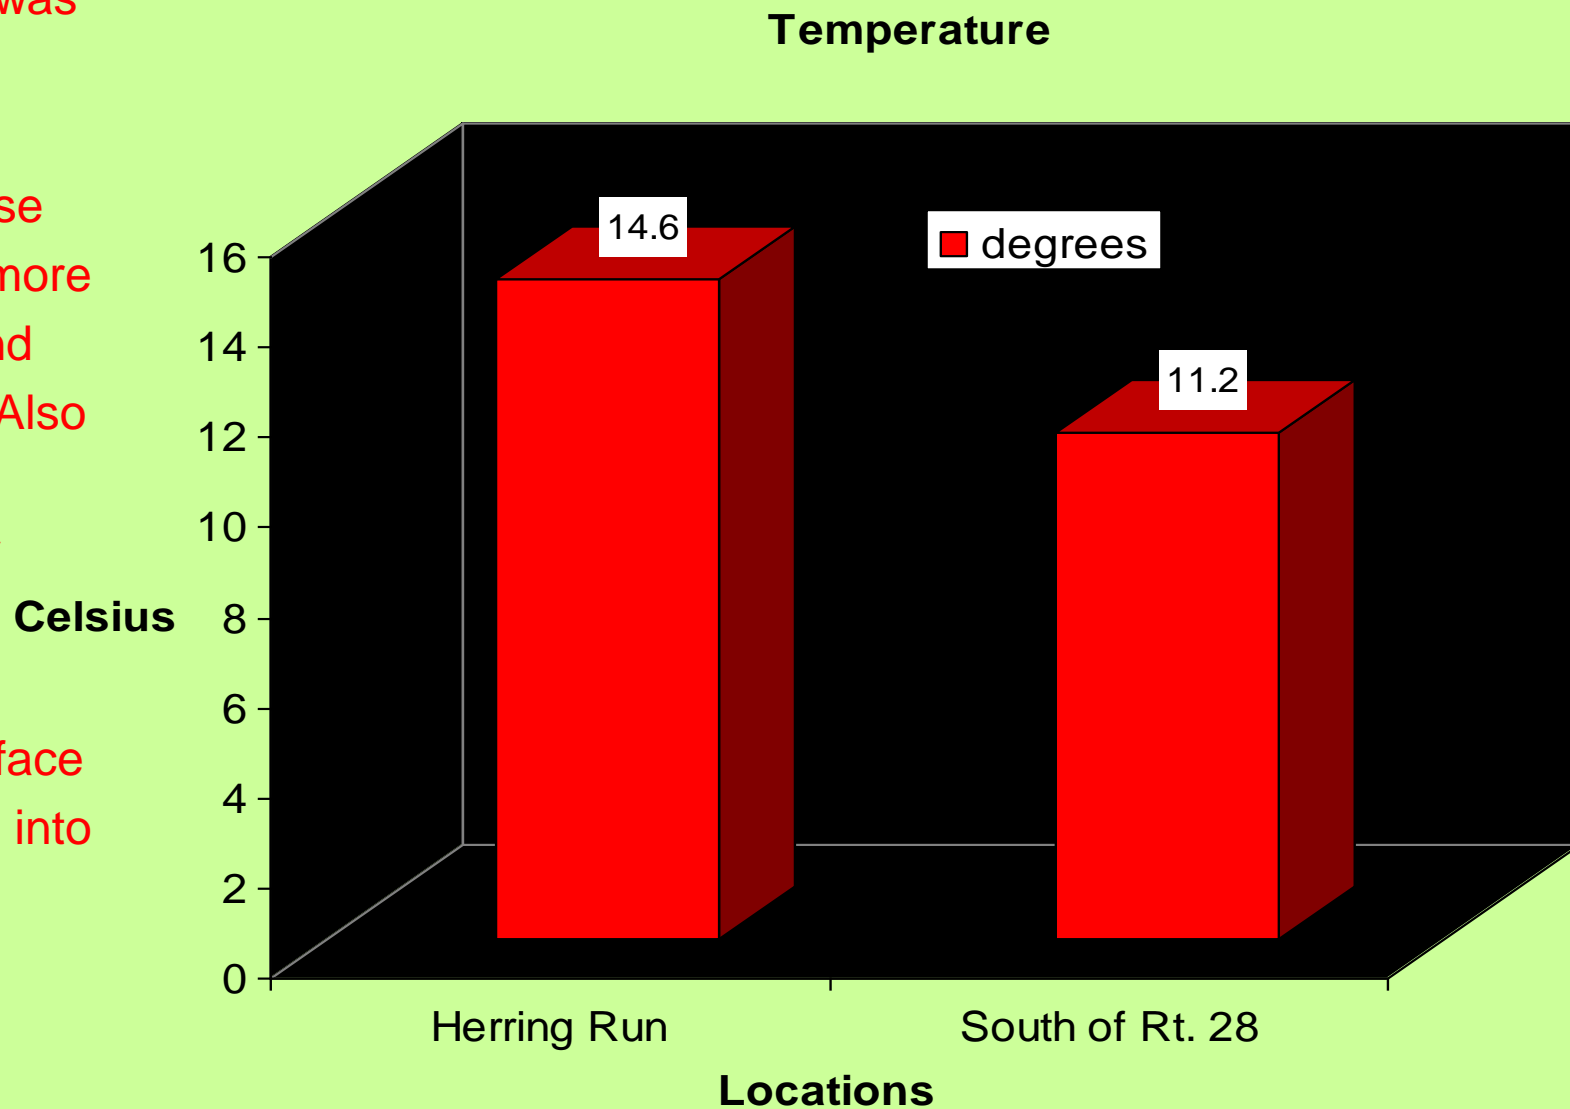
Possibly It was Warmer at the Herring Run because there was more sunlight, and less trees. Also the Herring Run is very close to a large lake whose surface water flows into the river.

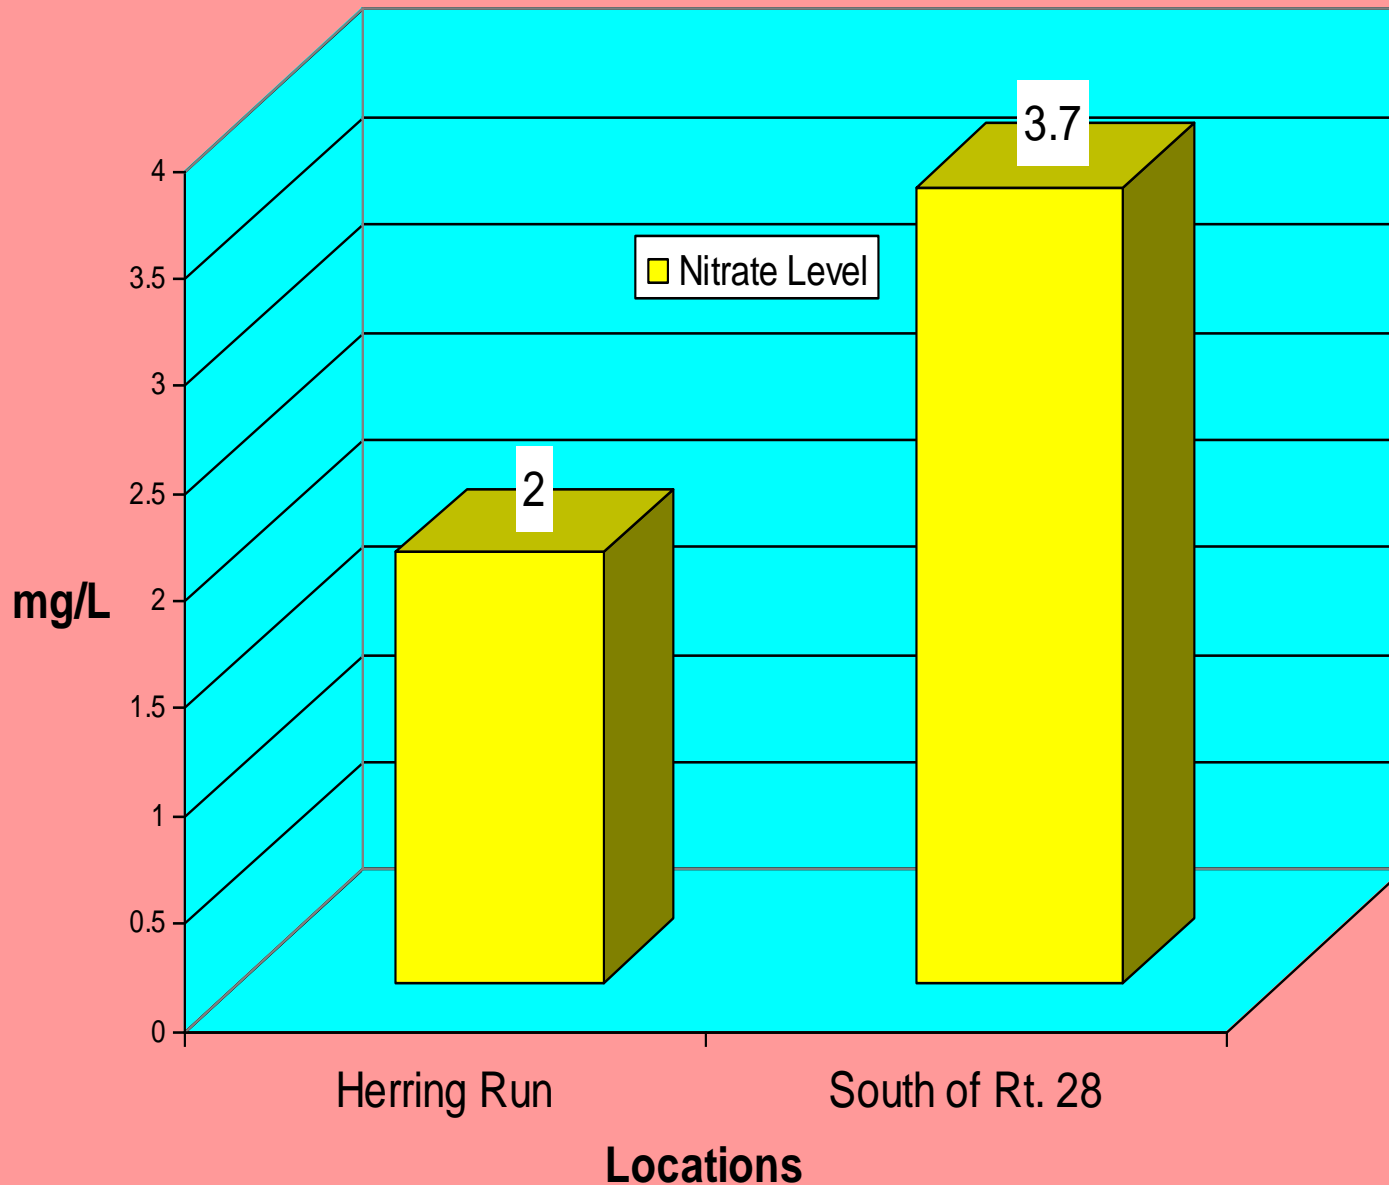
## Nitrates

Nitrates may be higher further down the river due to contributions from runoff and/or septic systems. Another possibility is that rooted plants were producing more oxygen in the water at the open Herring Run site.

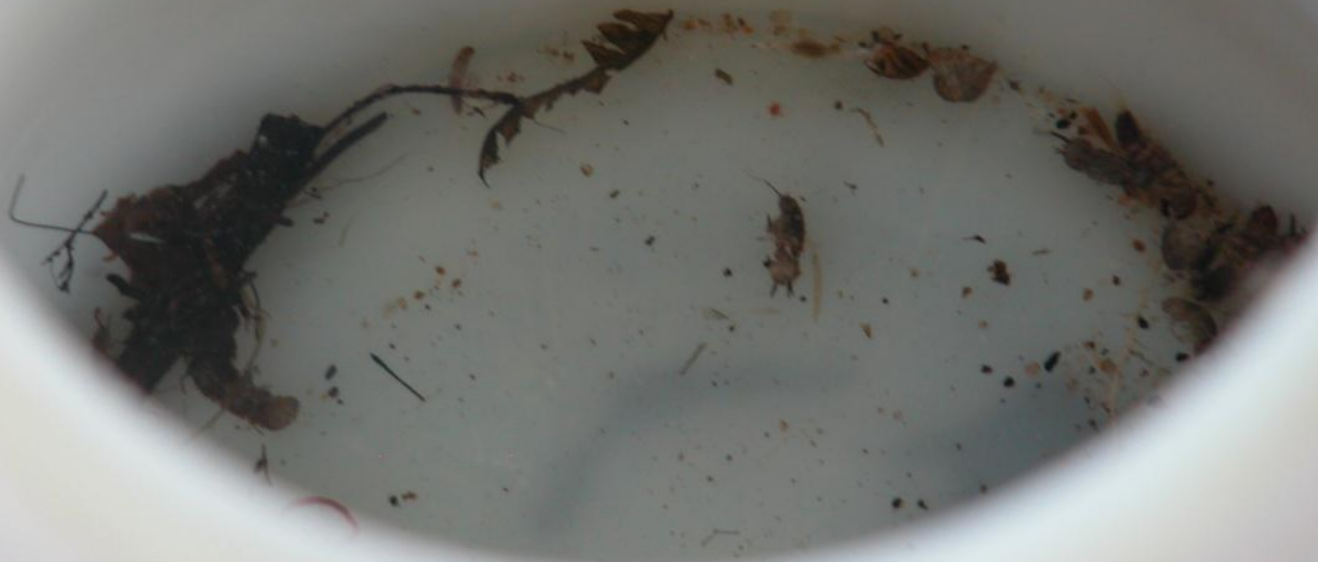
We examined the macroinvertebrates that we collected, in class. We put them into the groups that they belonged to. The bugs not only tell us what lives in the water, but also something about the water quality.

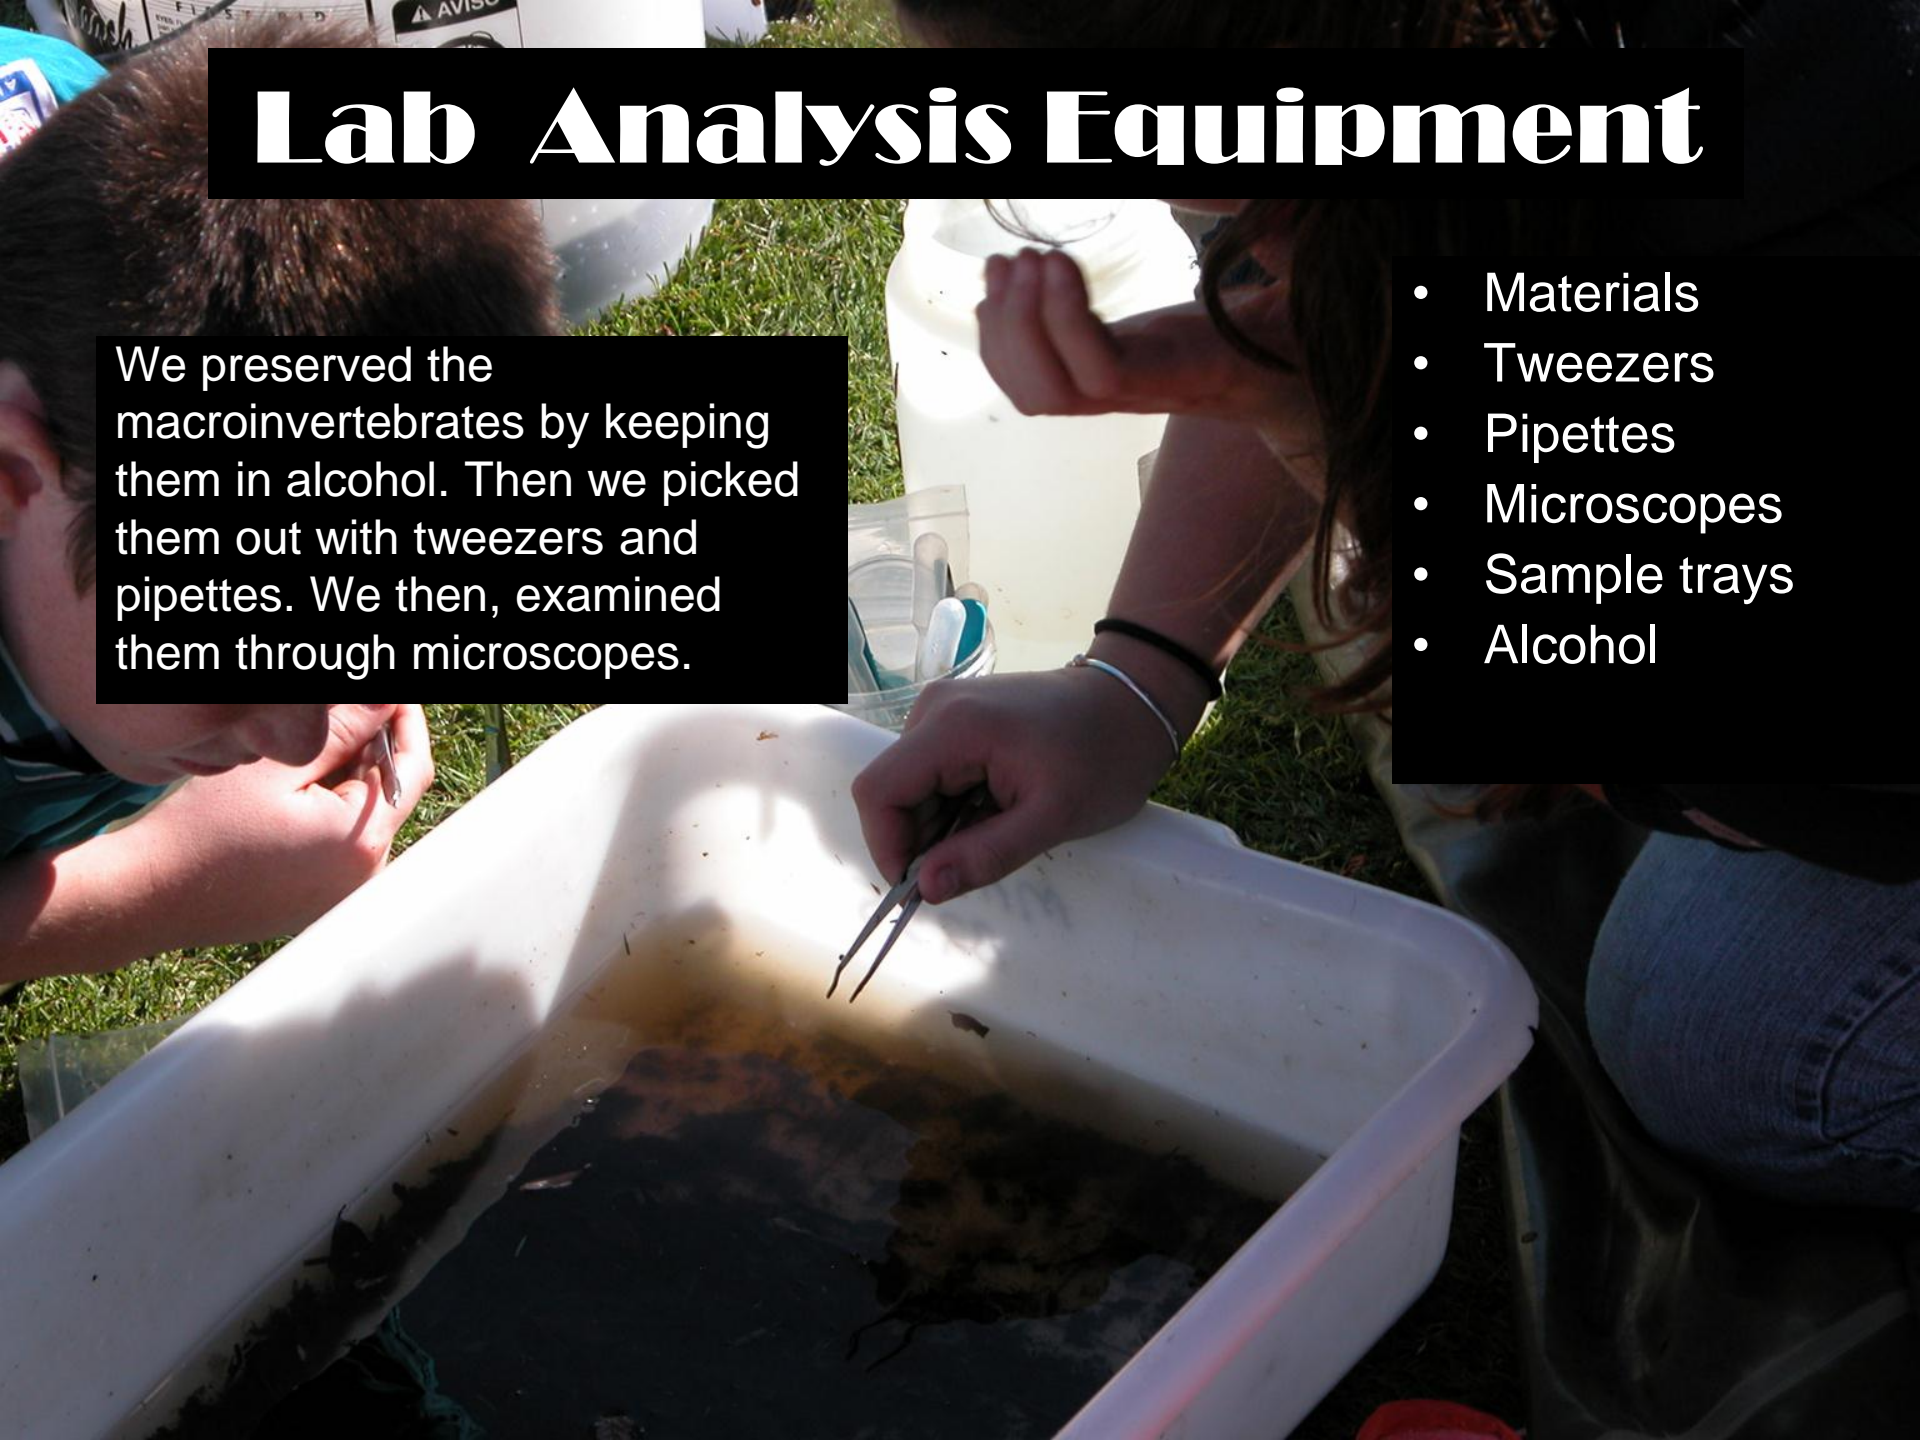
# Lab Analysis Equipment

We preserved the macroinvertebrates by keeping them in alcohol. Then we picked them out with tweezers and pipettes. We then, examined them through microscopes.

- Materials
- Tweezers
- Pipettes
- Microscopes
- Sample trays
- Alcohol

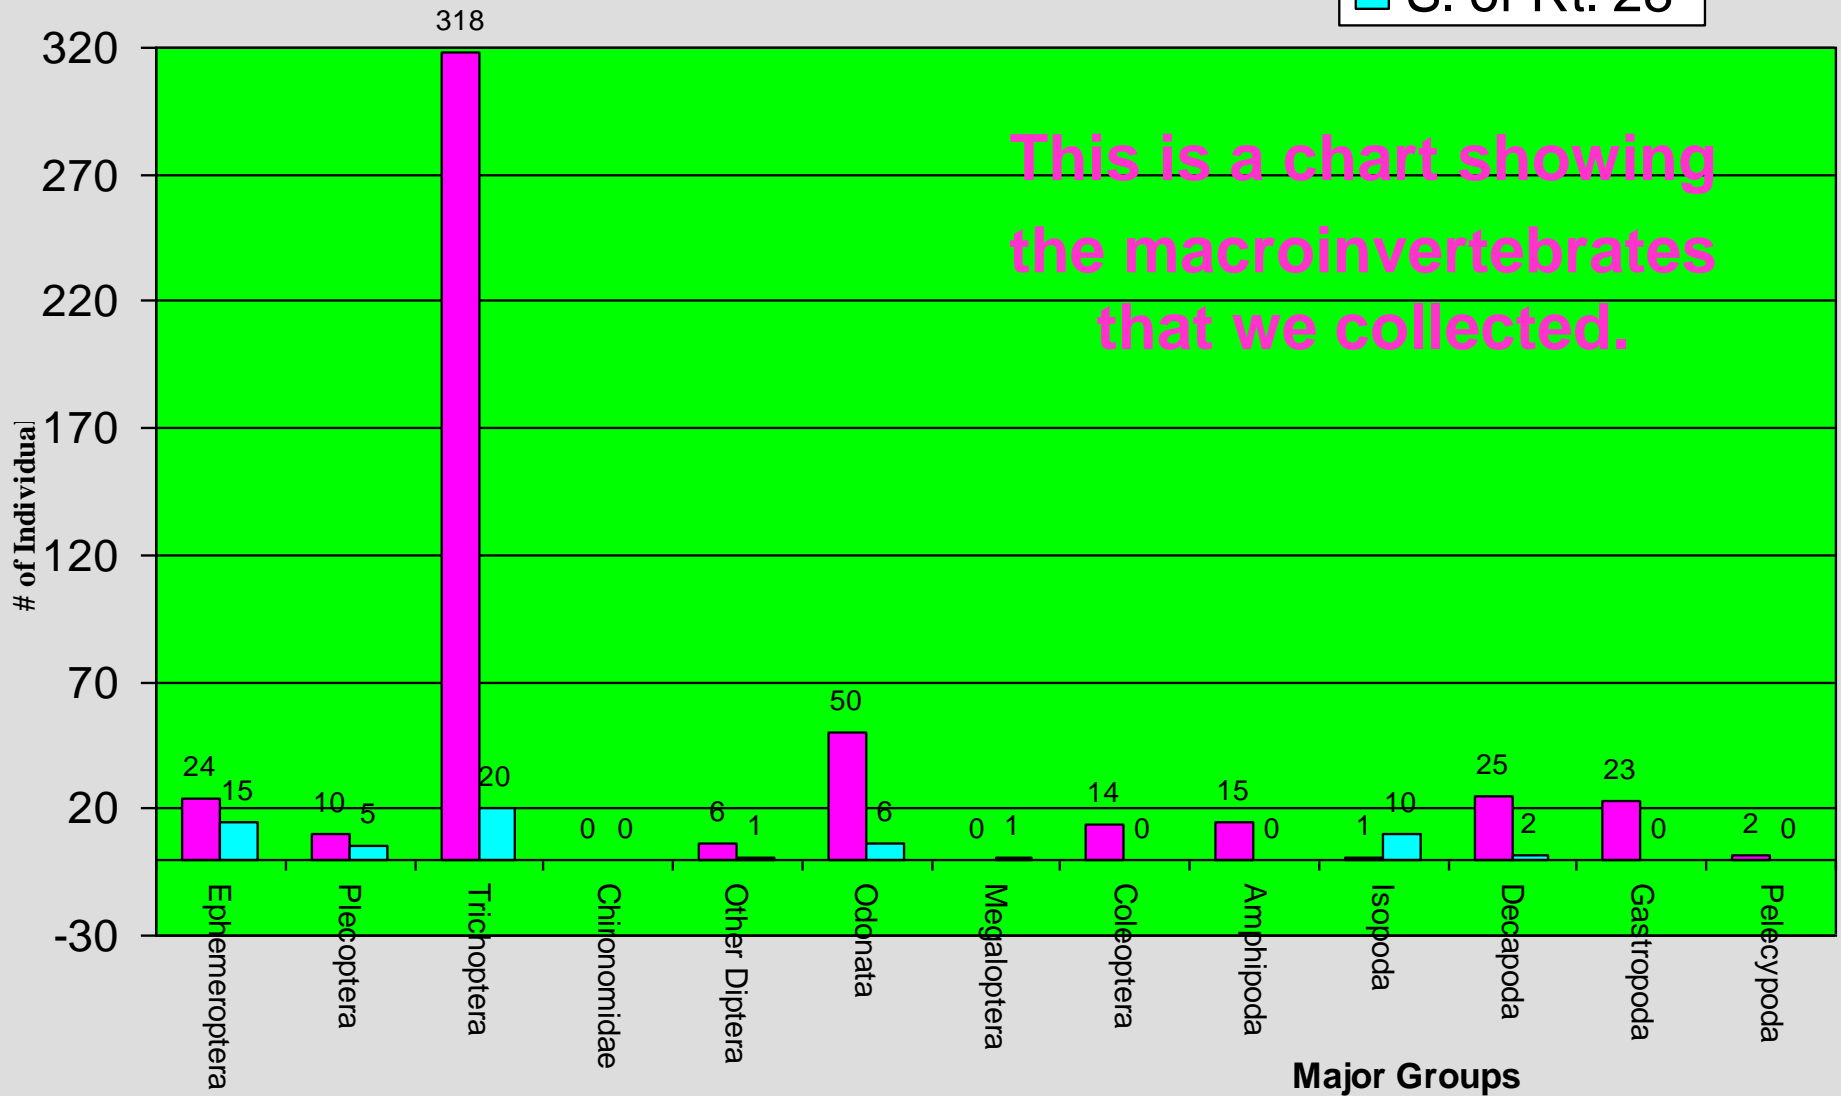
# Organism Density

■ Herring Run  
■ S. of Rt. 28

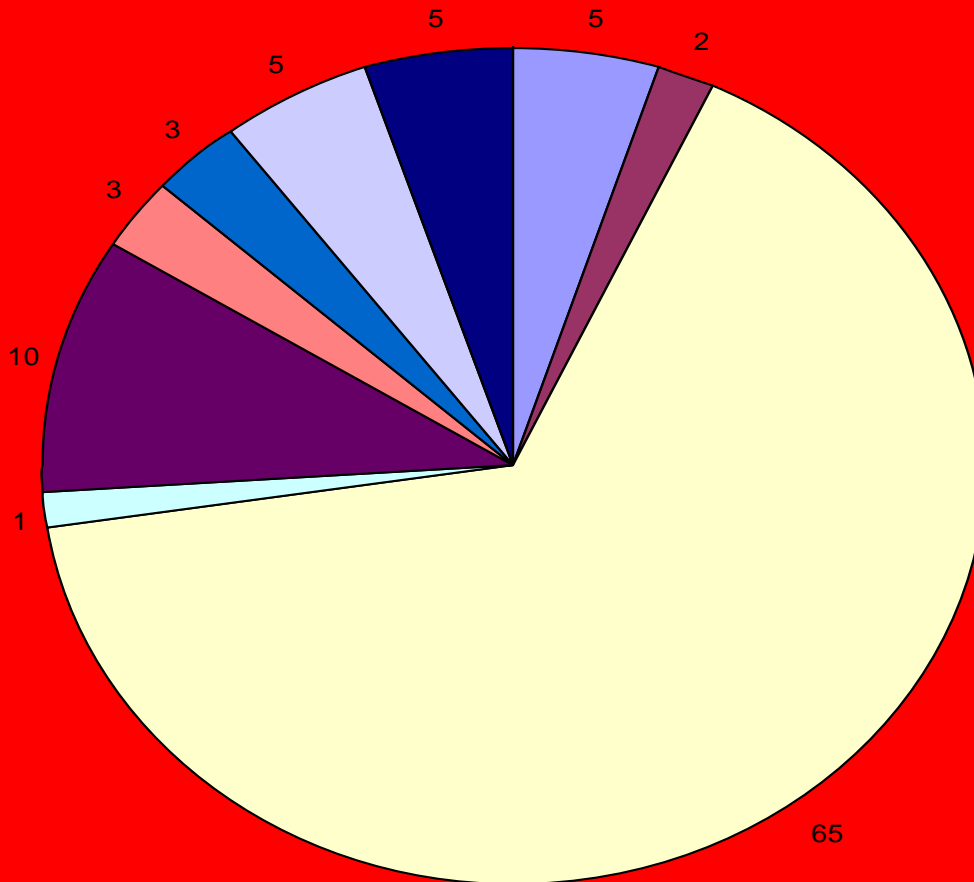
# Percent Composition at Herring Run

The Trichoptera made up the majority of our collection here, but we also found quite a few Odonata as well as other interesting organisms.

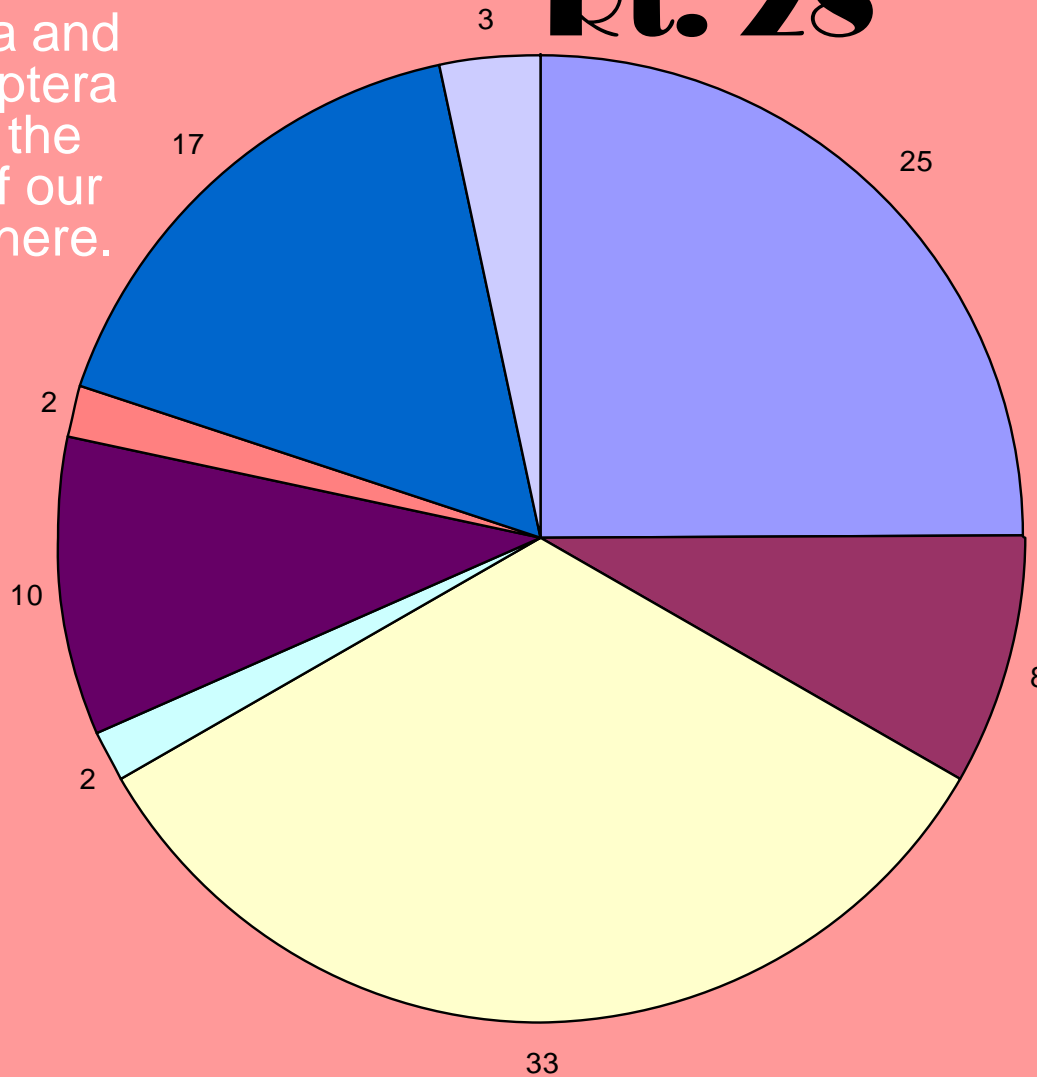
# Percent Composition of Rt. 28

Trichoptera and  
Ephemeroptera  
made up the  
majority of our  
collection here.

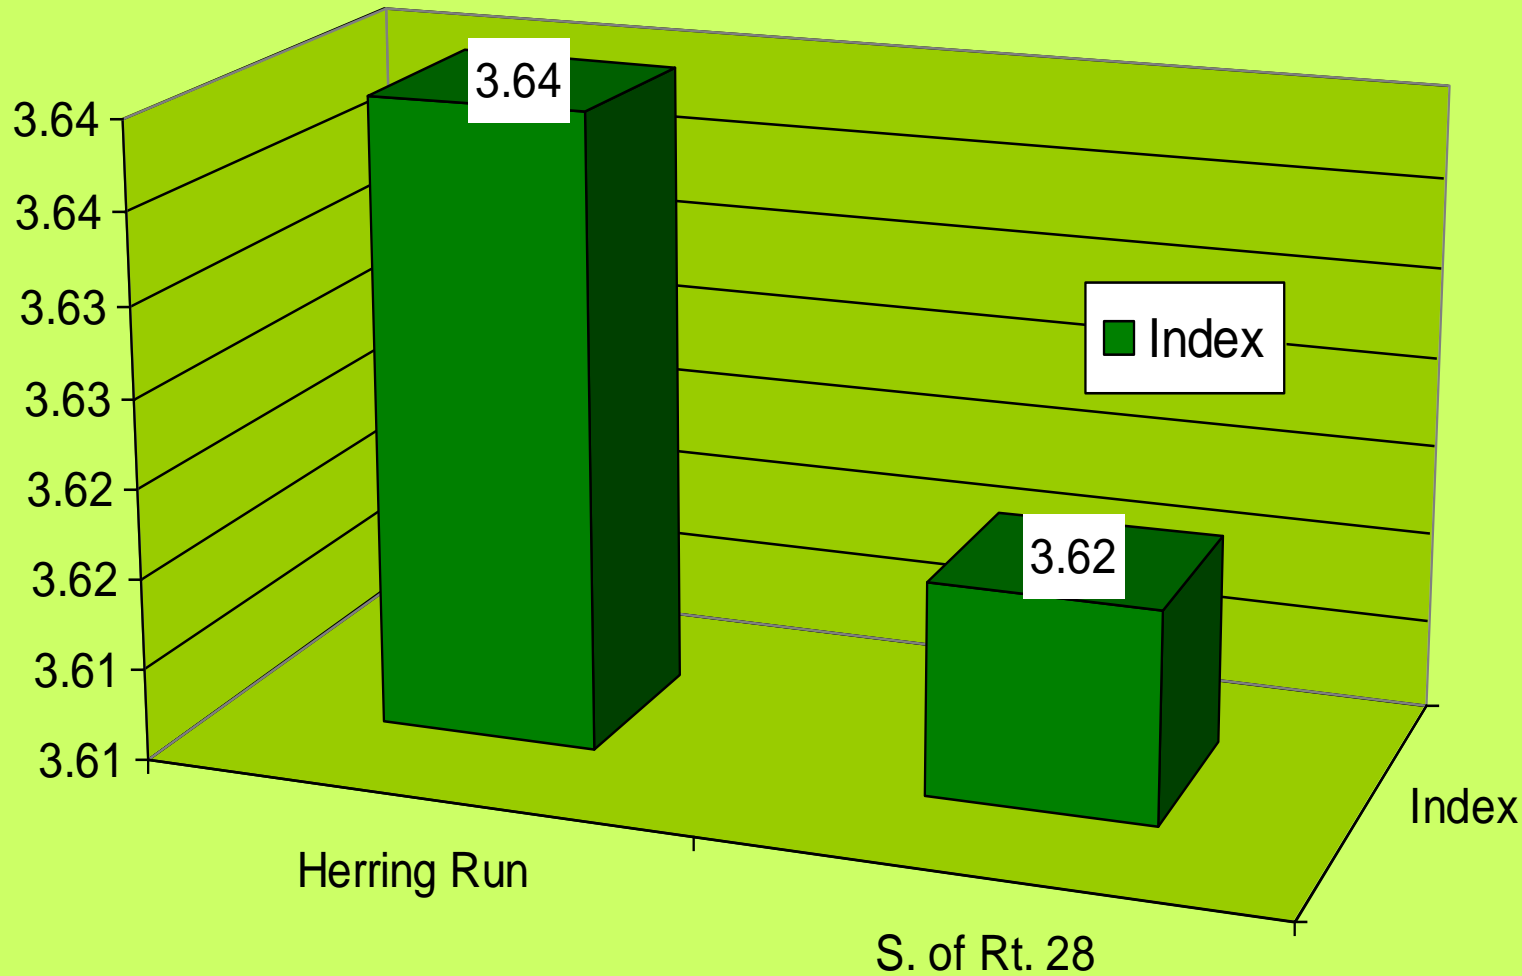
## Major Group Biological Index

The two were very close. The upper site did have more pollution tolerant species. This may account for the differences
