### Palmer River Water Discharge and Nutrient Study

# *Painter River Water Discharge & Nutrient Study*

Conducted by Dighton-Rehoboth  
Regional High School  
Environmental Science Class

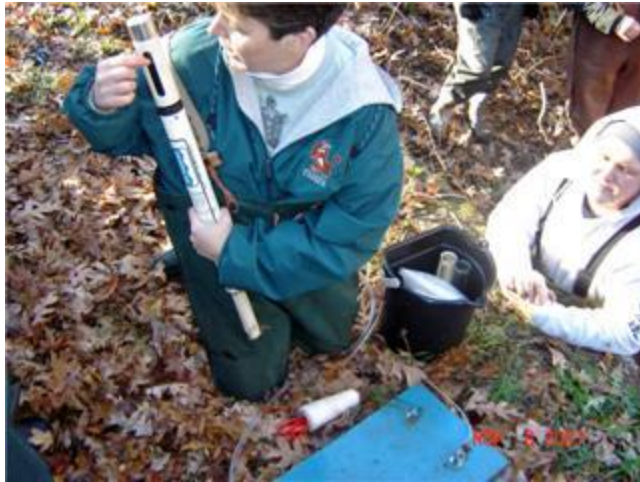
Dissolved Oxygen, Temperature & pH Sensor

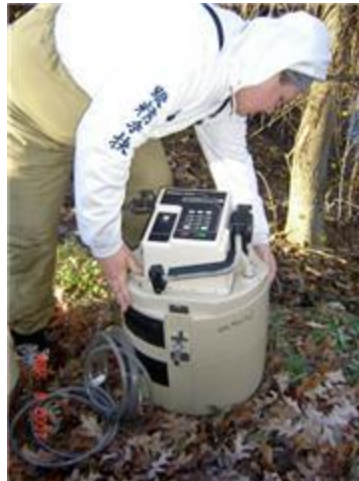
Sigma Probe Sampler –  
Phosphates & Nitrates

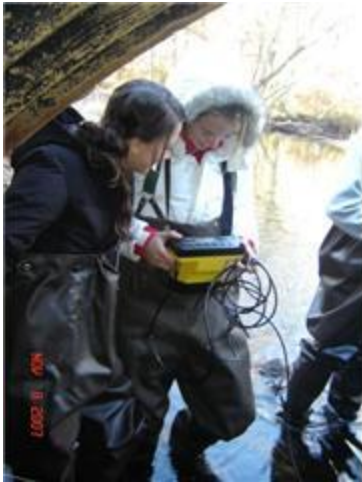
Velocity Sensor  
& Depth Rod

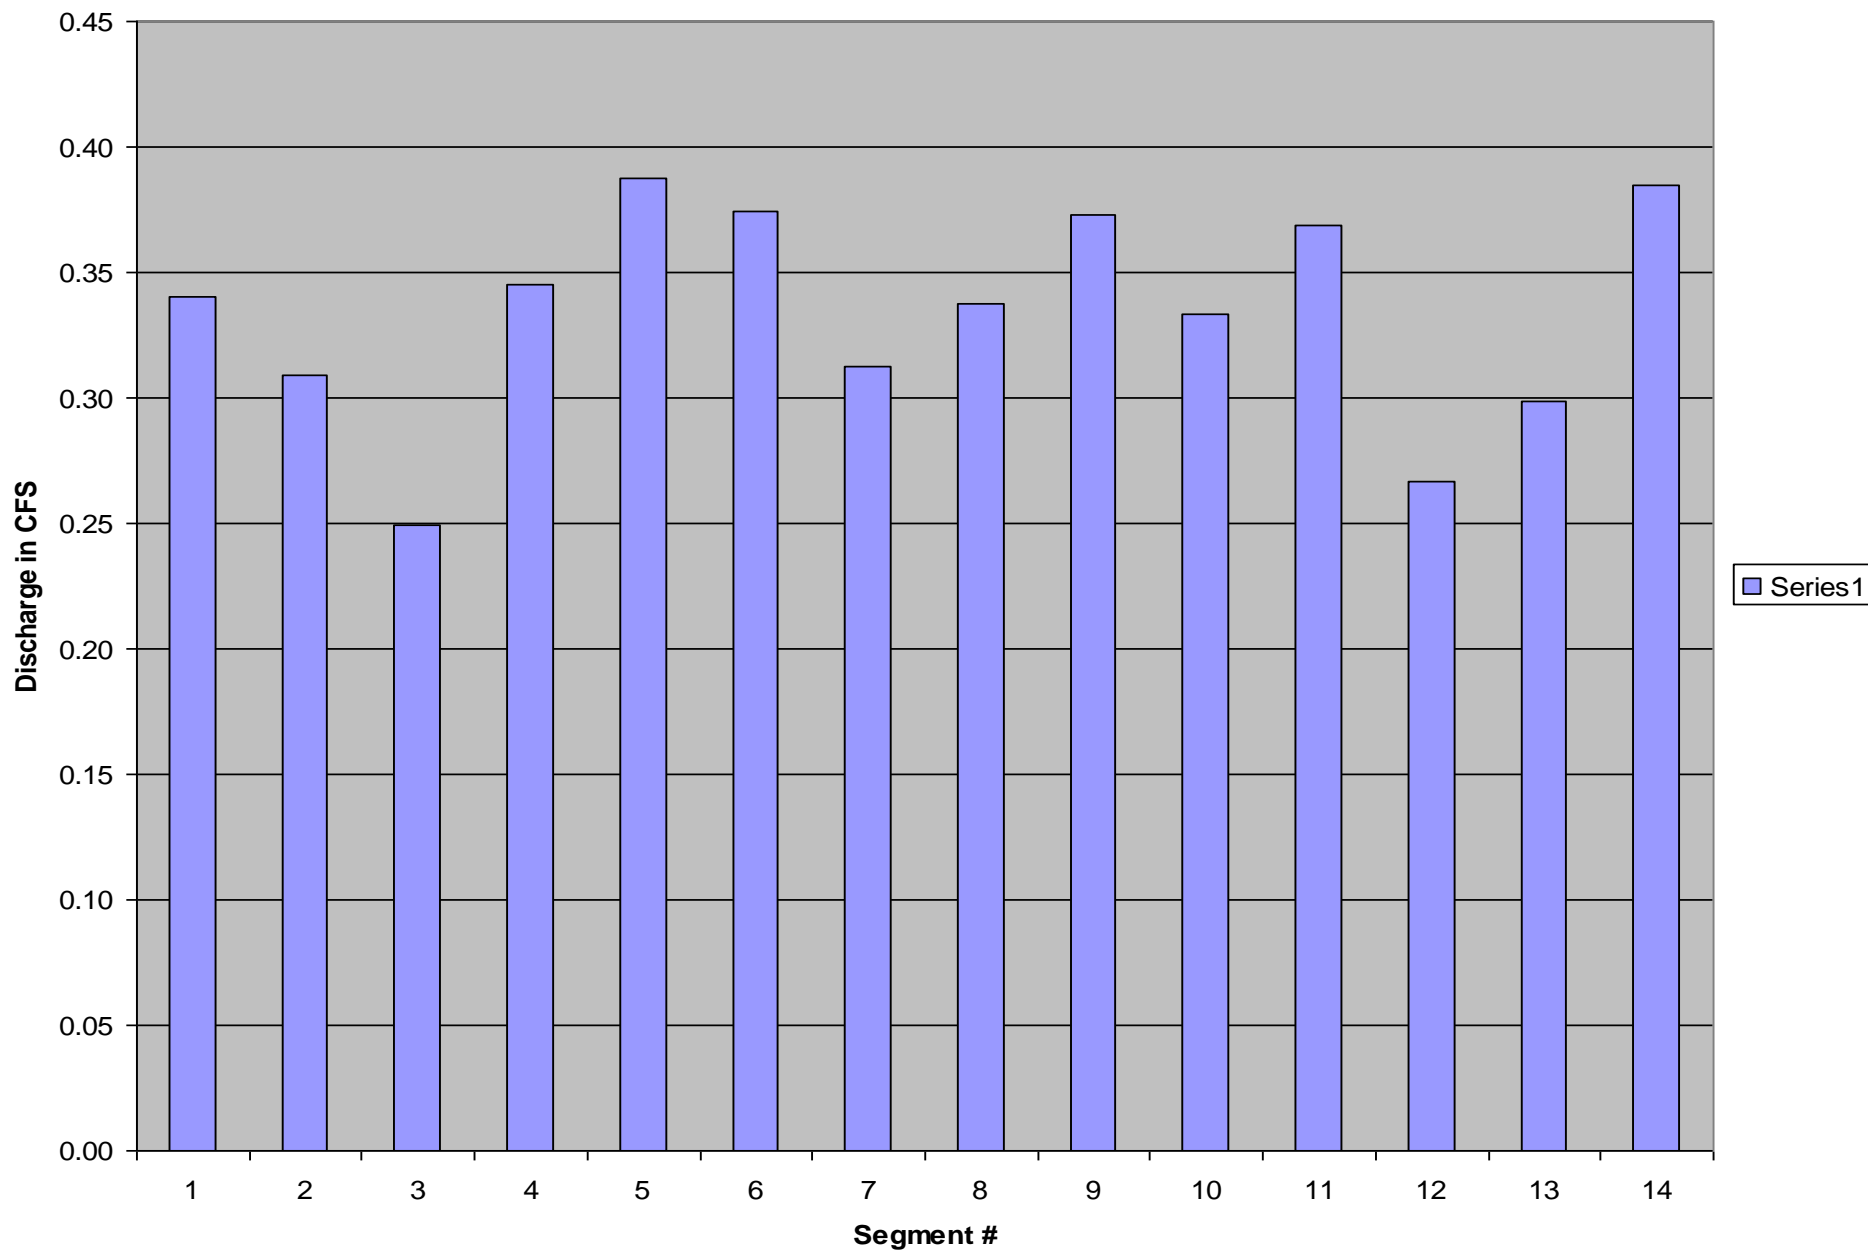
Discharge by segment-Wilmarth

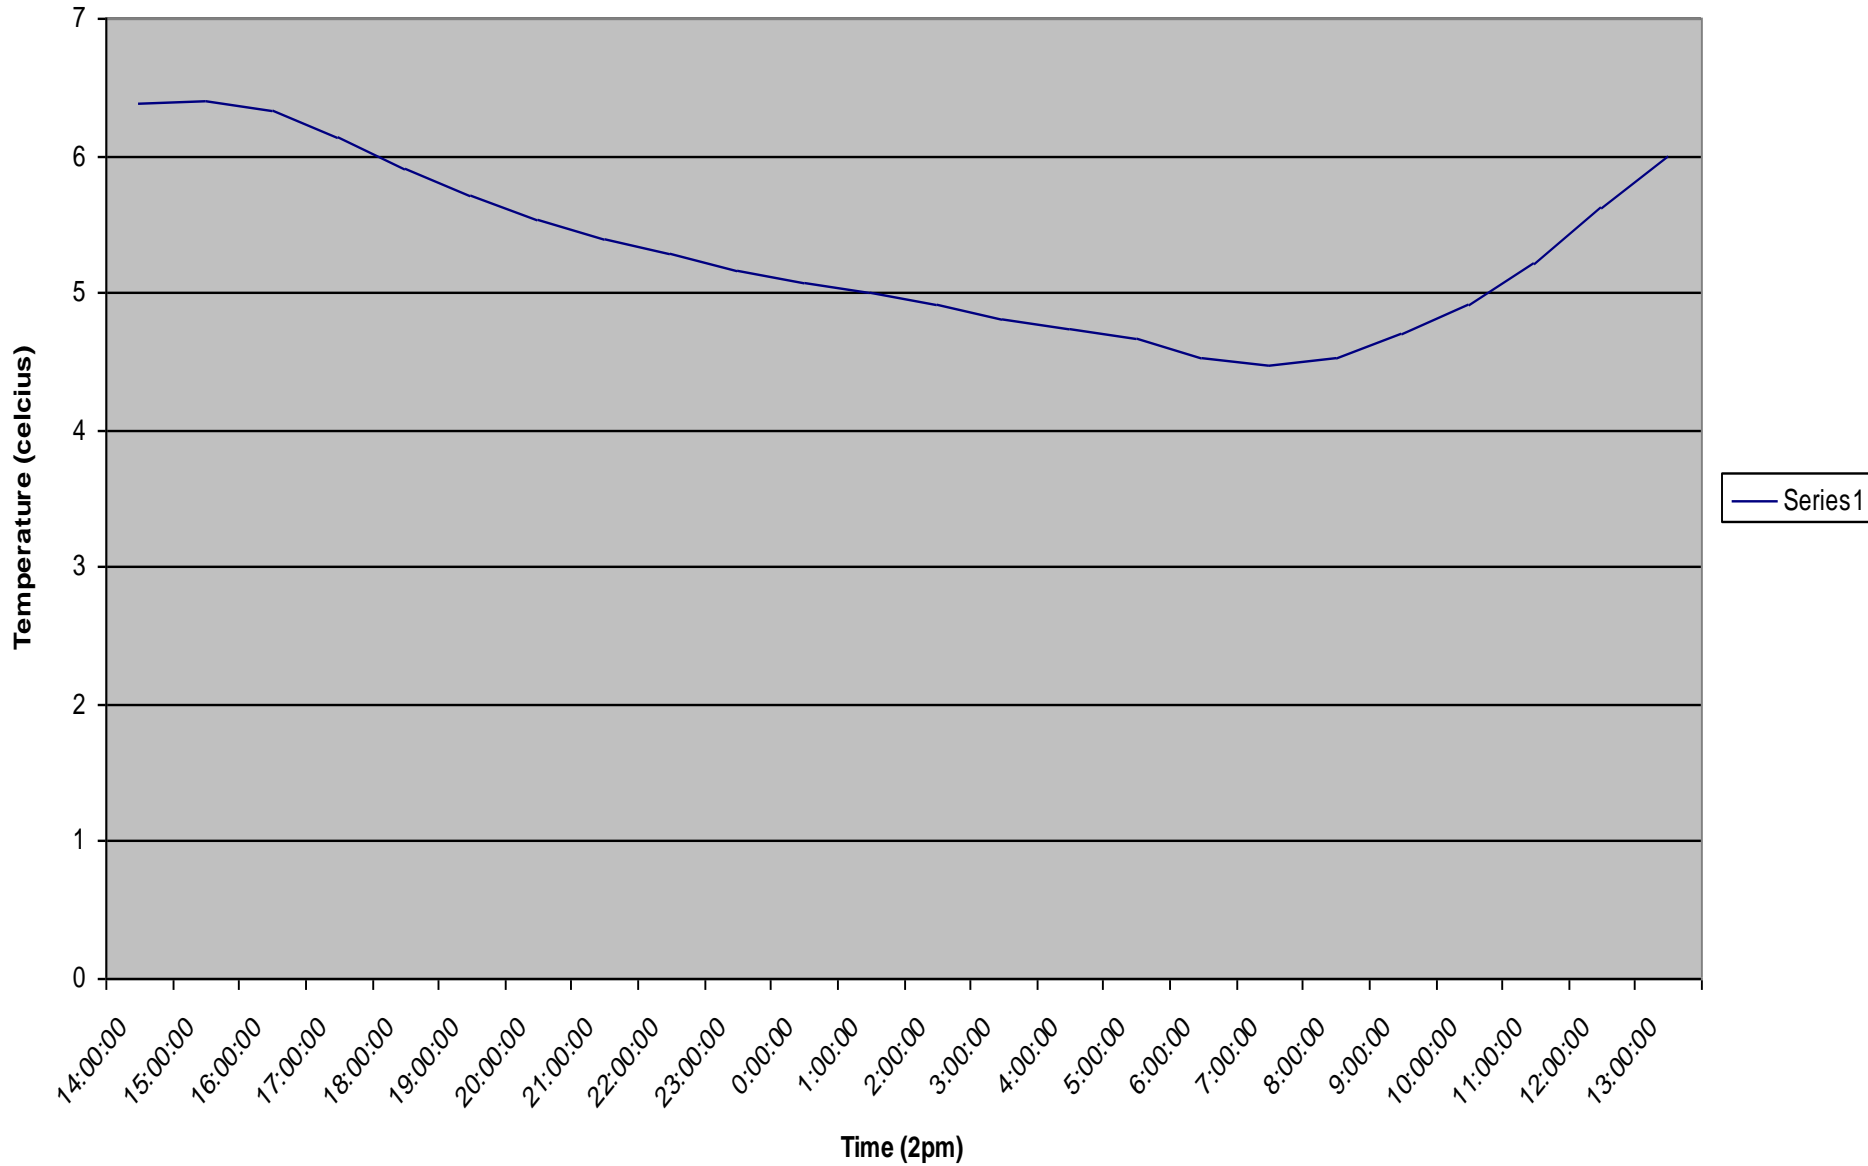
Wilmarth: Temperature vs. Time

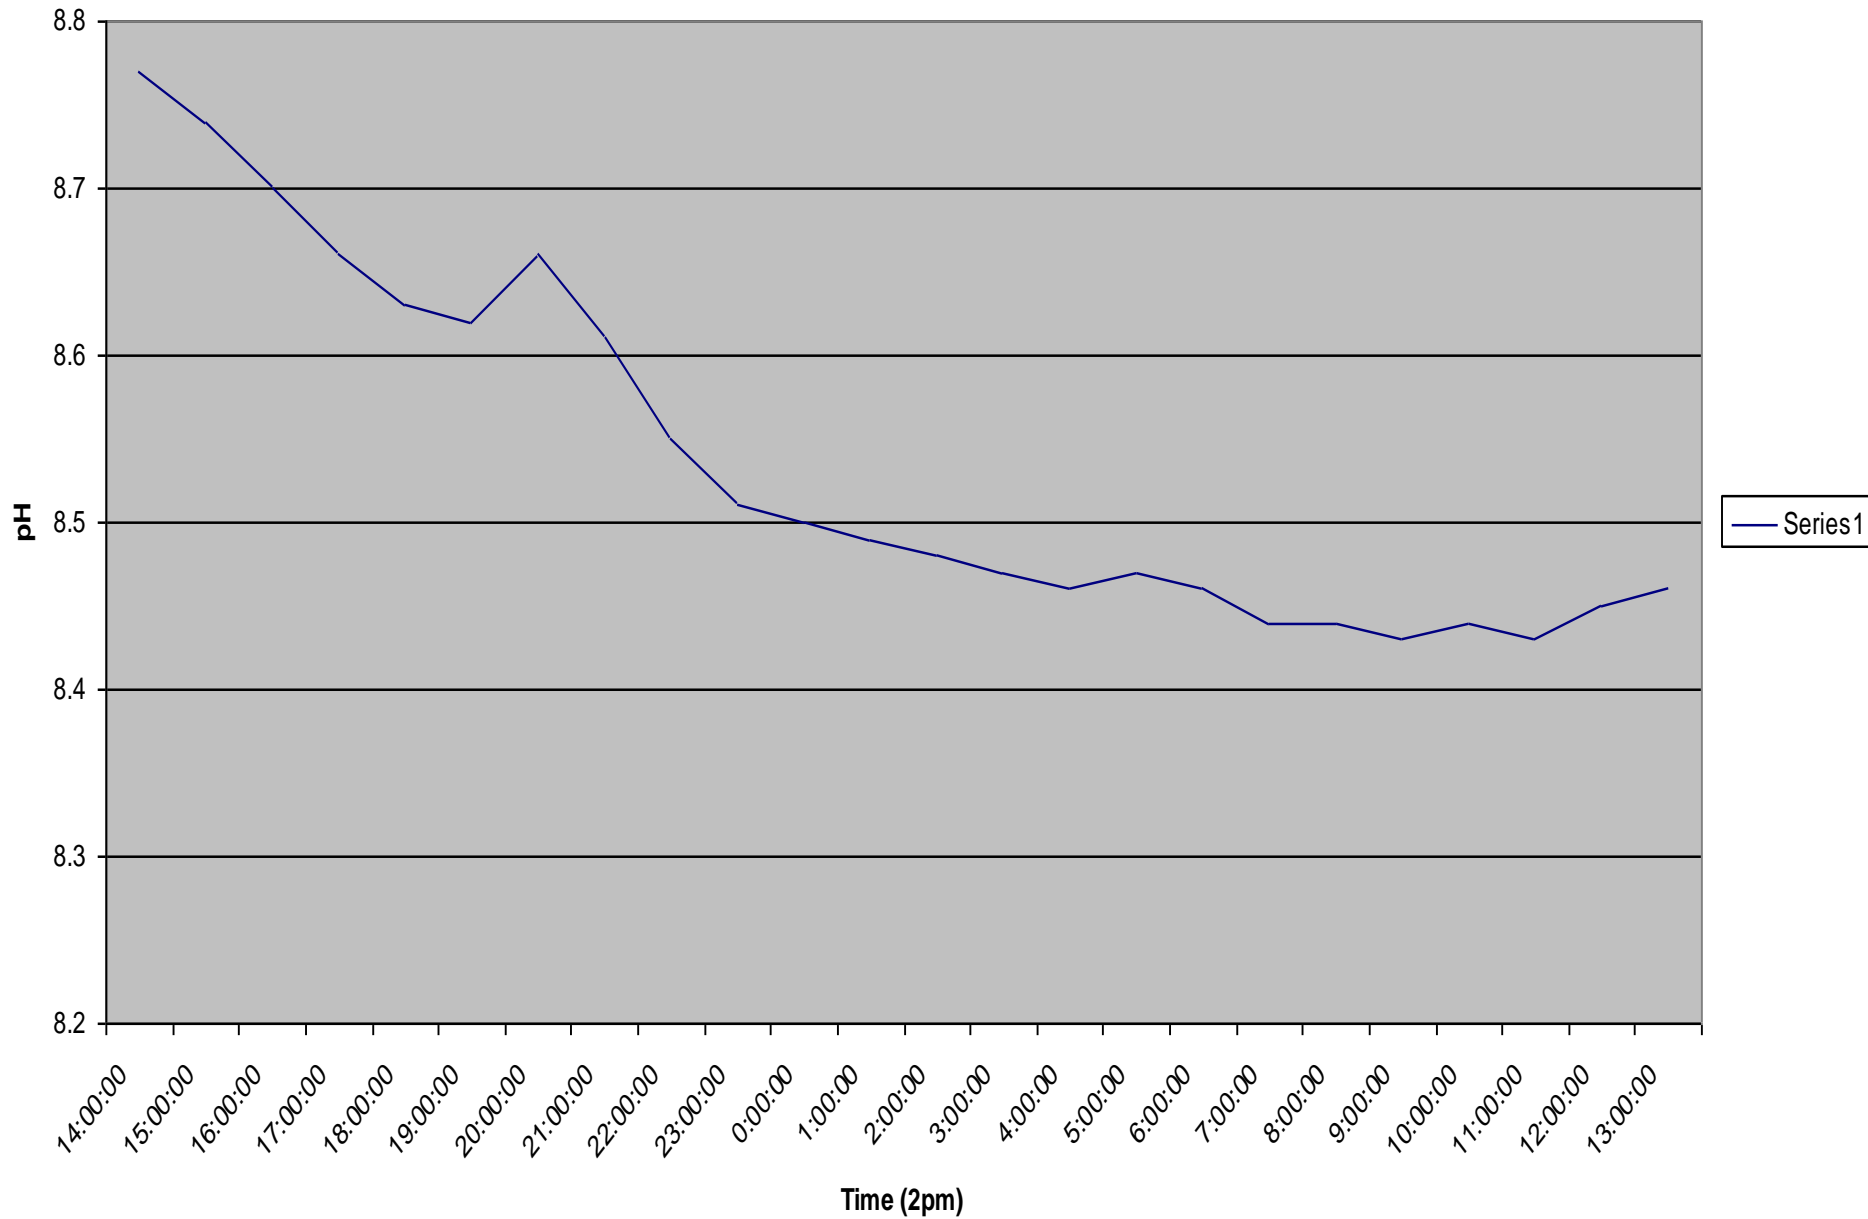
Wilmarth: pH vs. Time

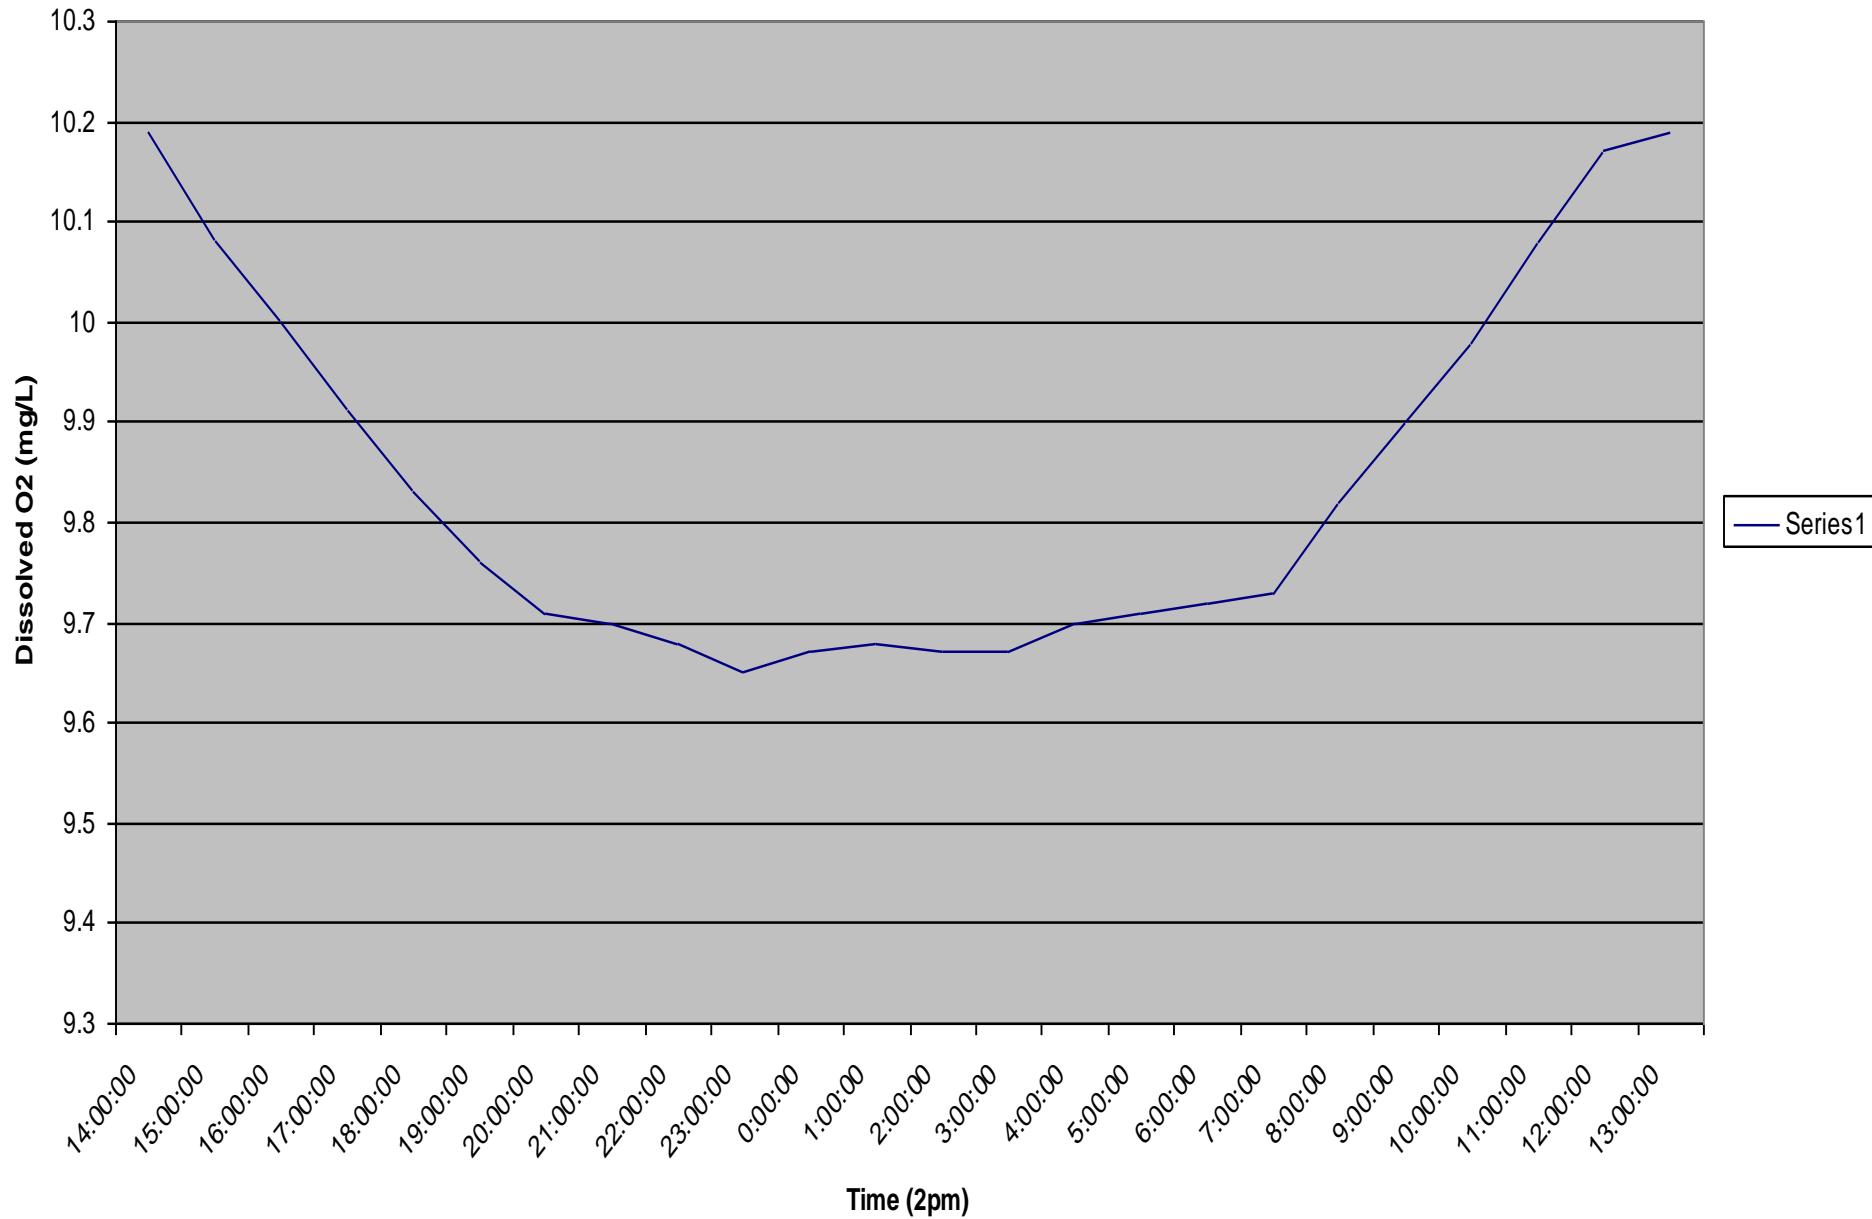
Wilmarth: Dissolved Oxygen vs. Time

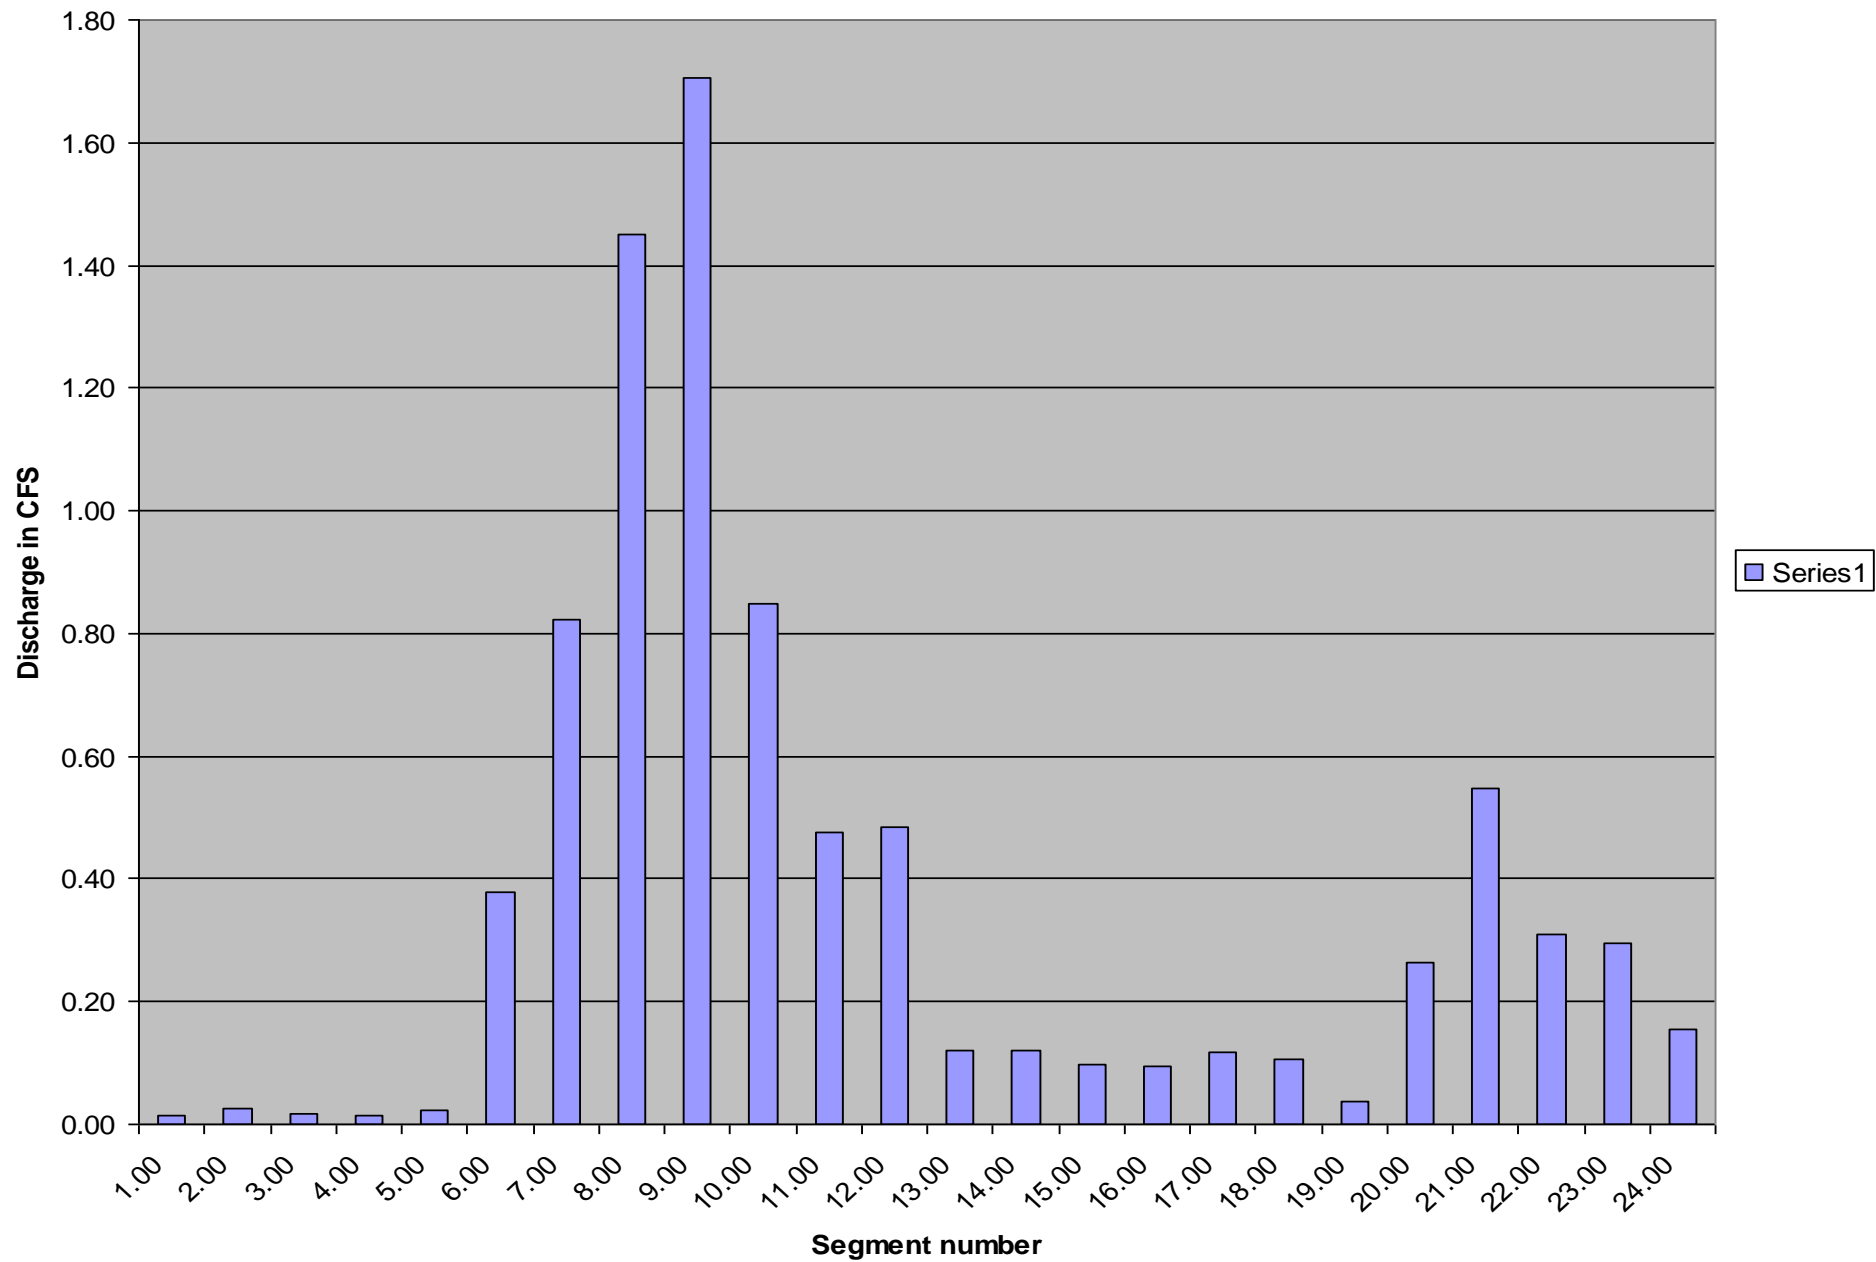
Discharge by segment-Reed st.

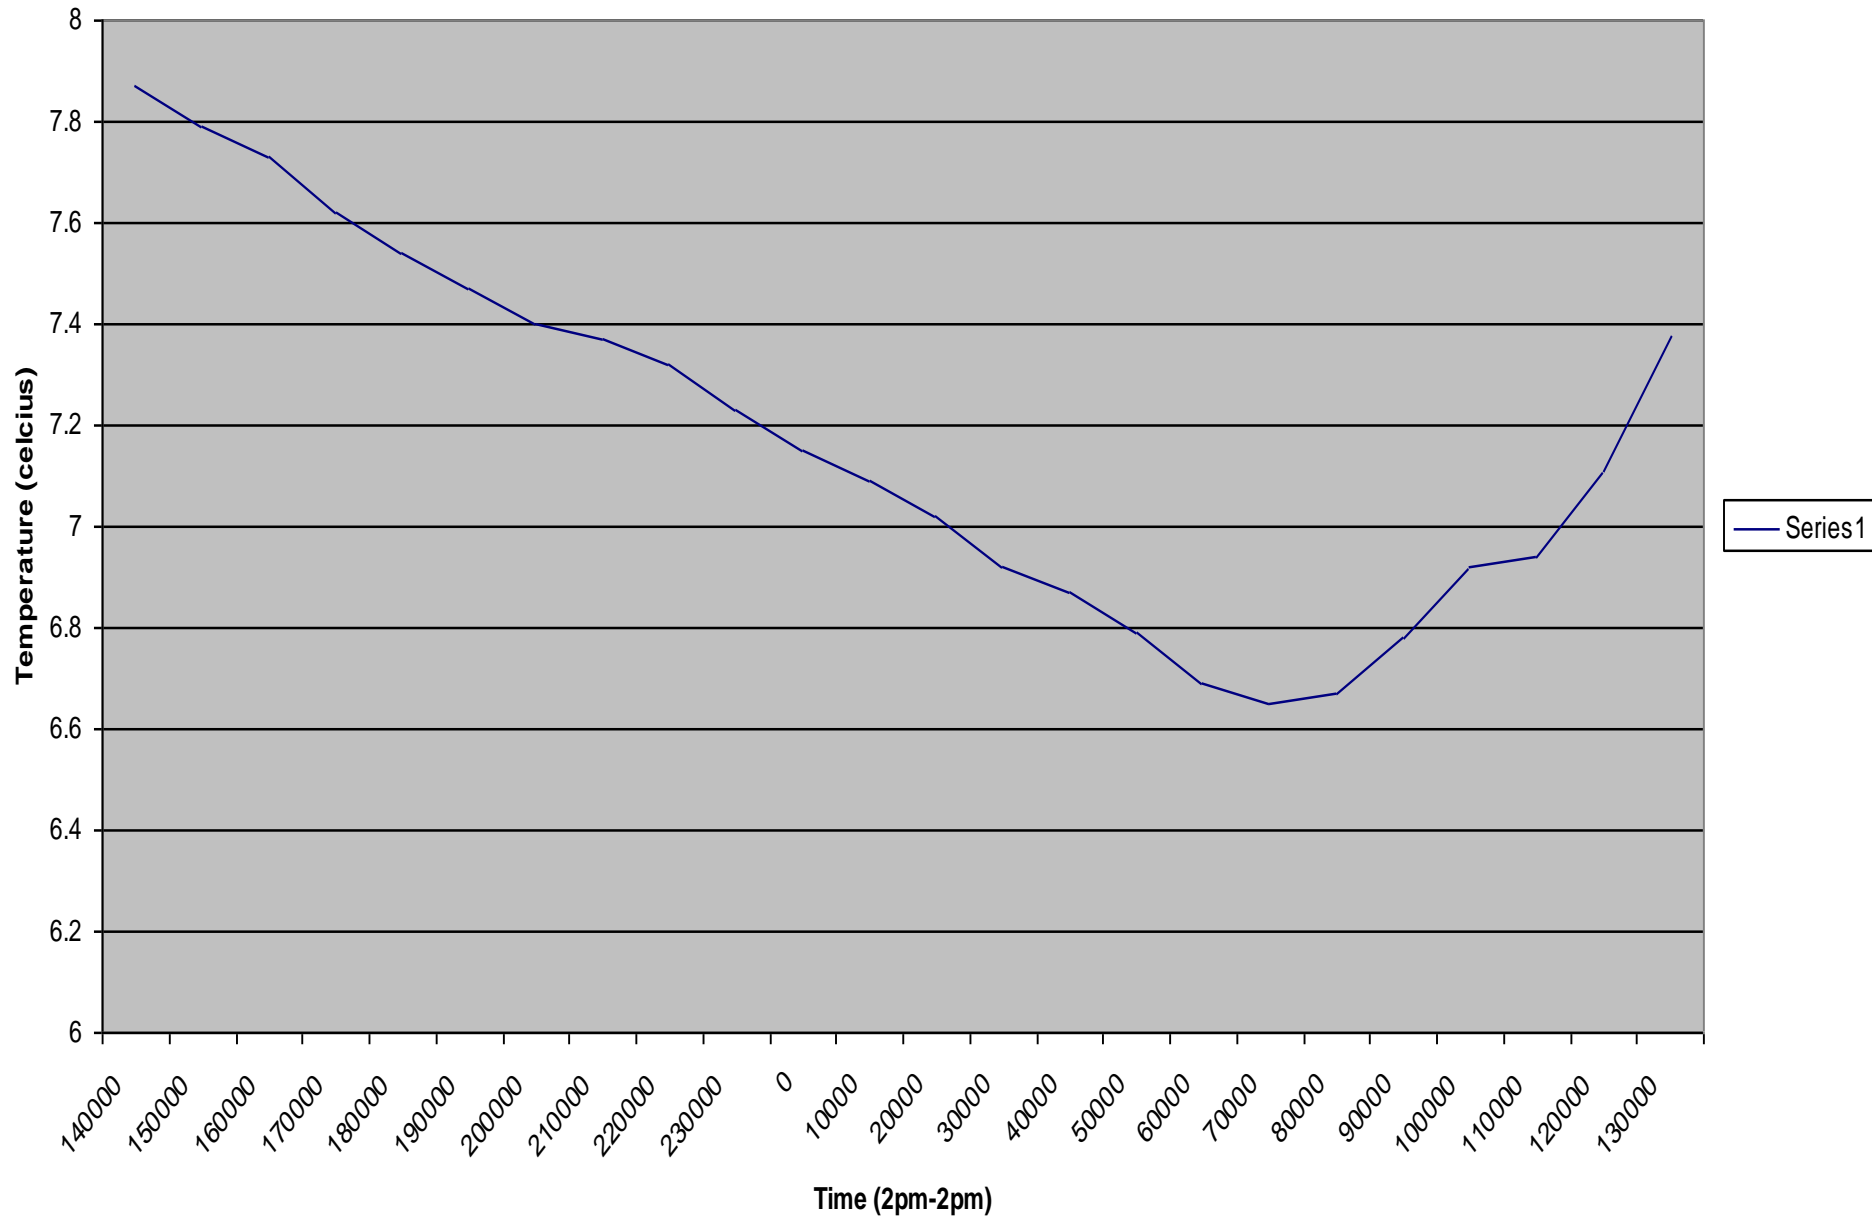
Reed Street Temperature vs. Time

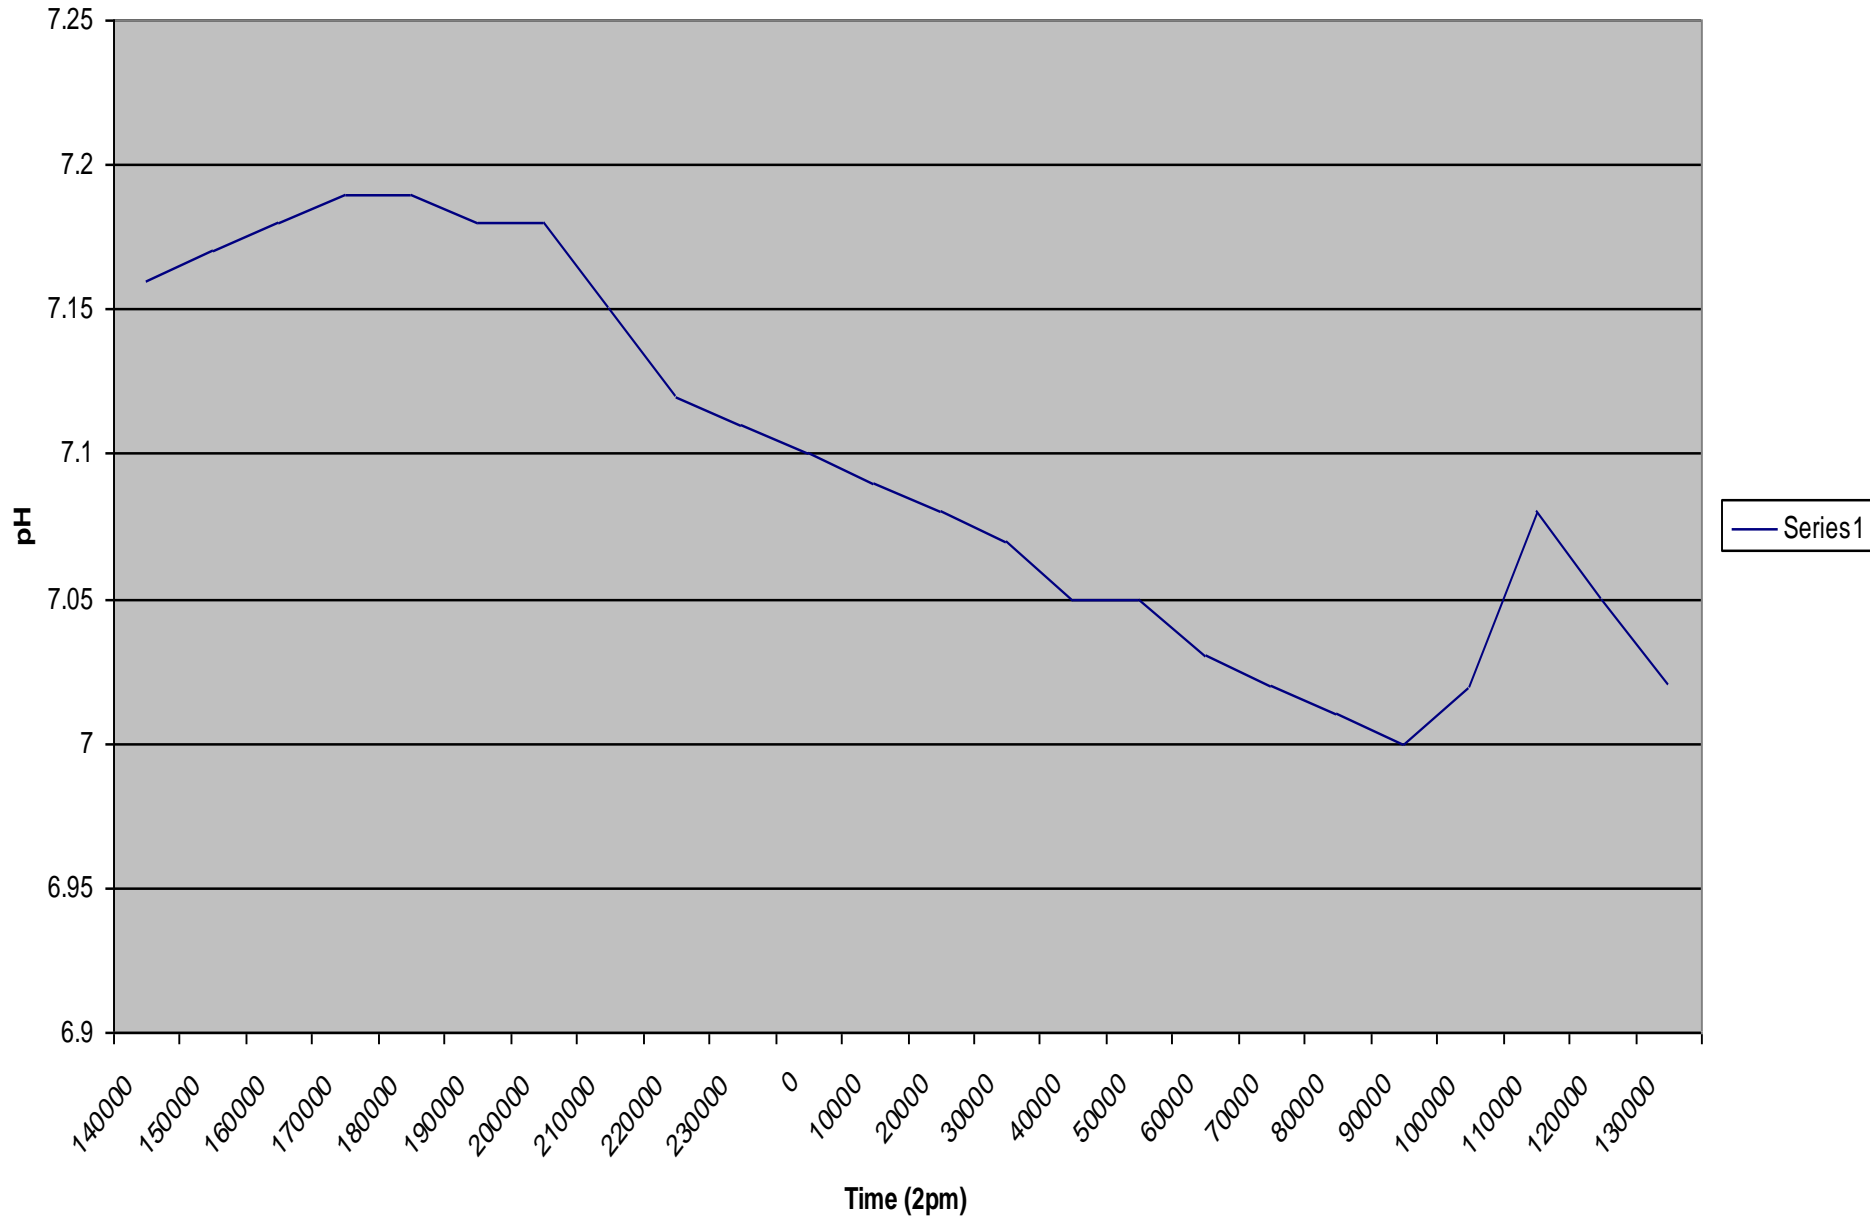
Reed Street: pH vs. Time

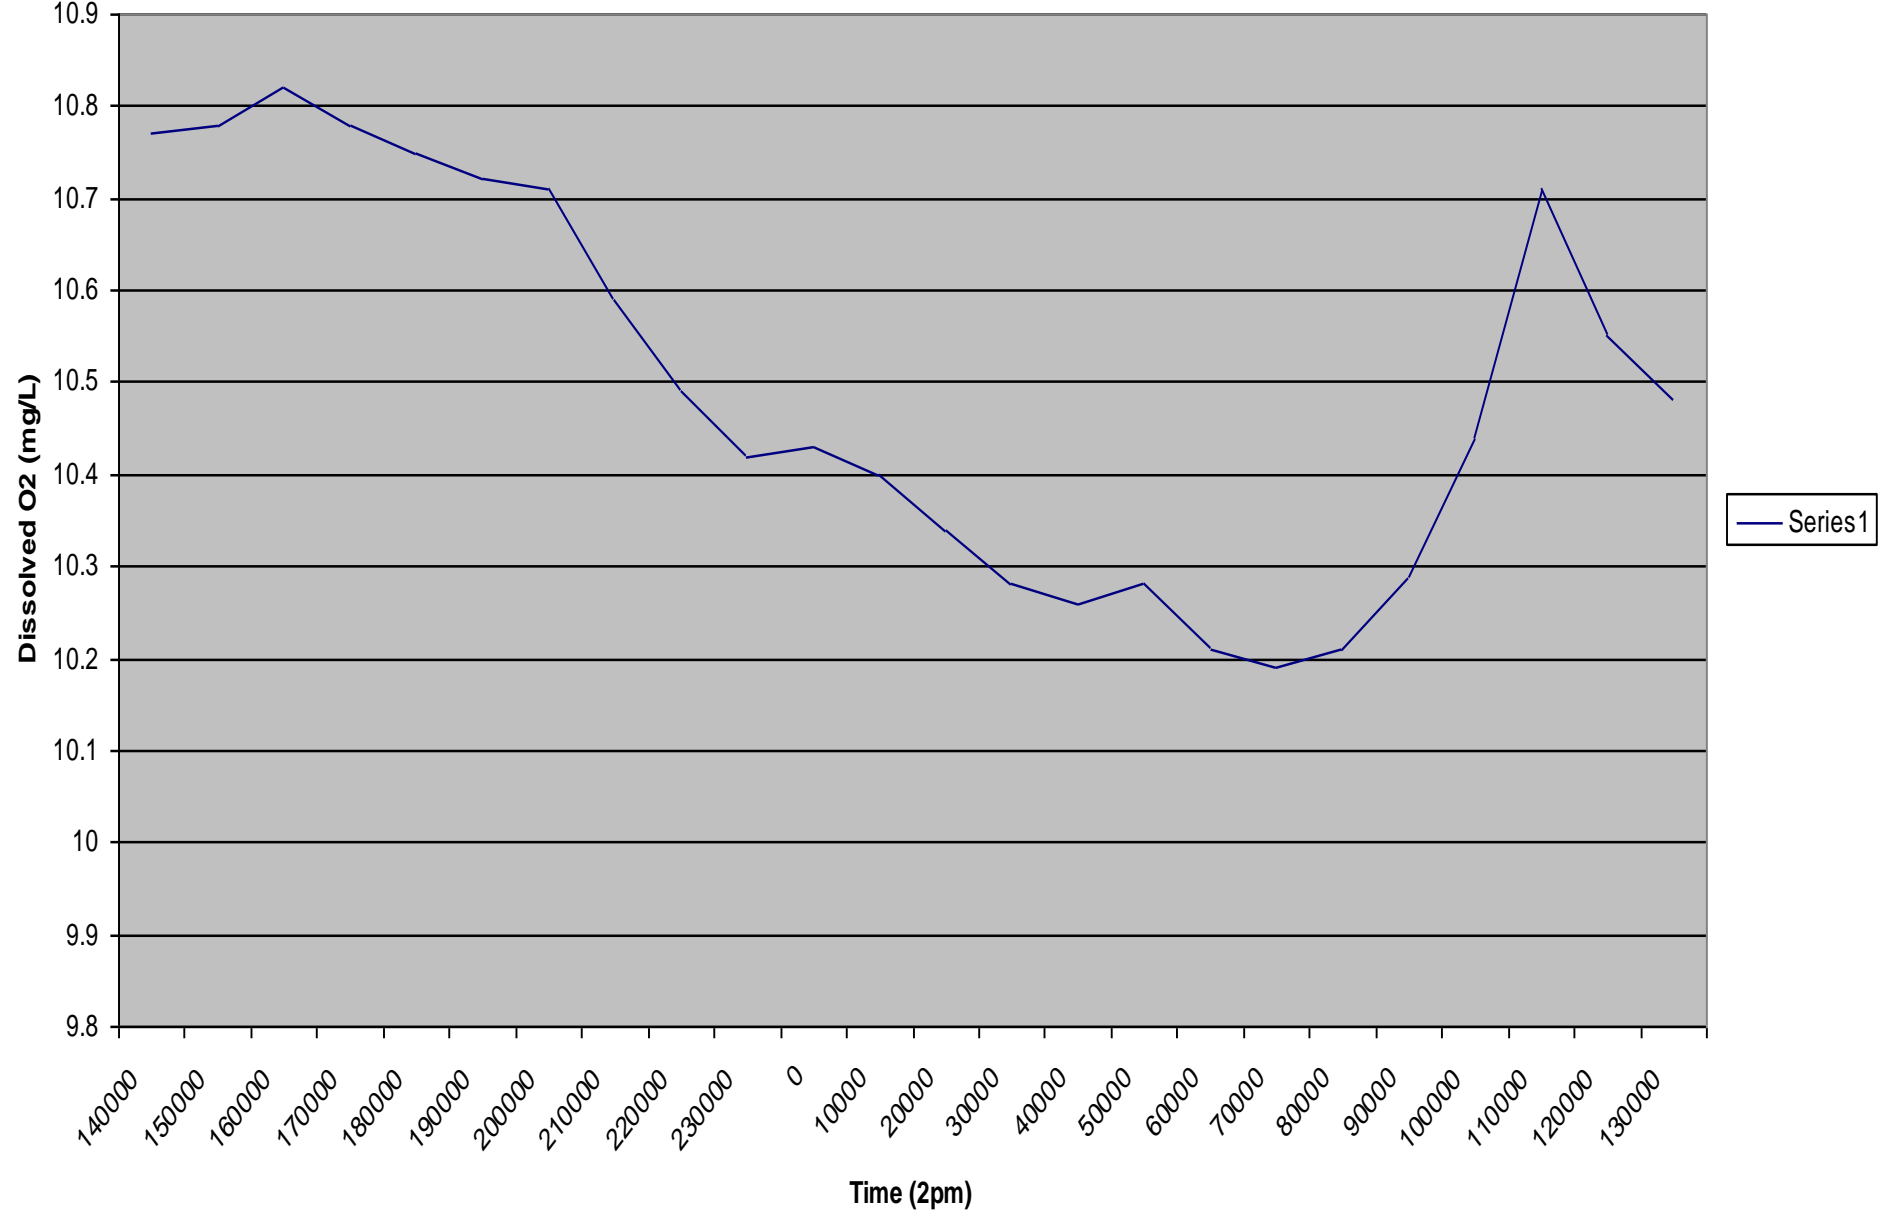
Reed Street: Dissolved O2 vs. Time

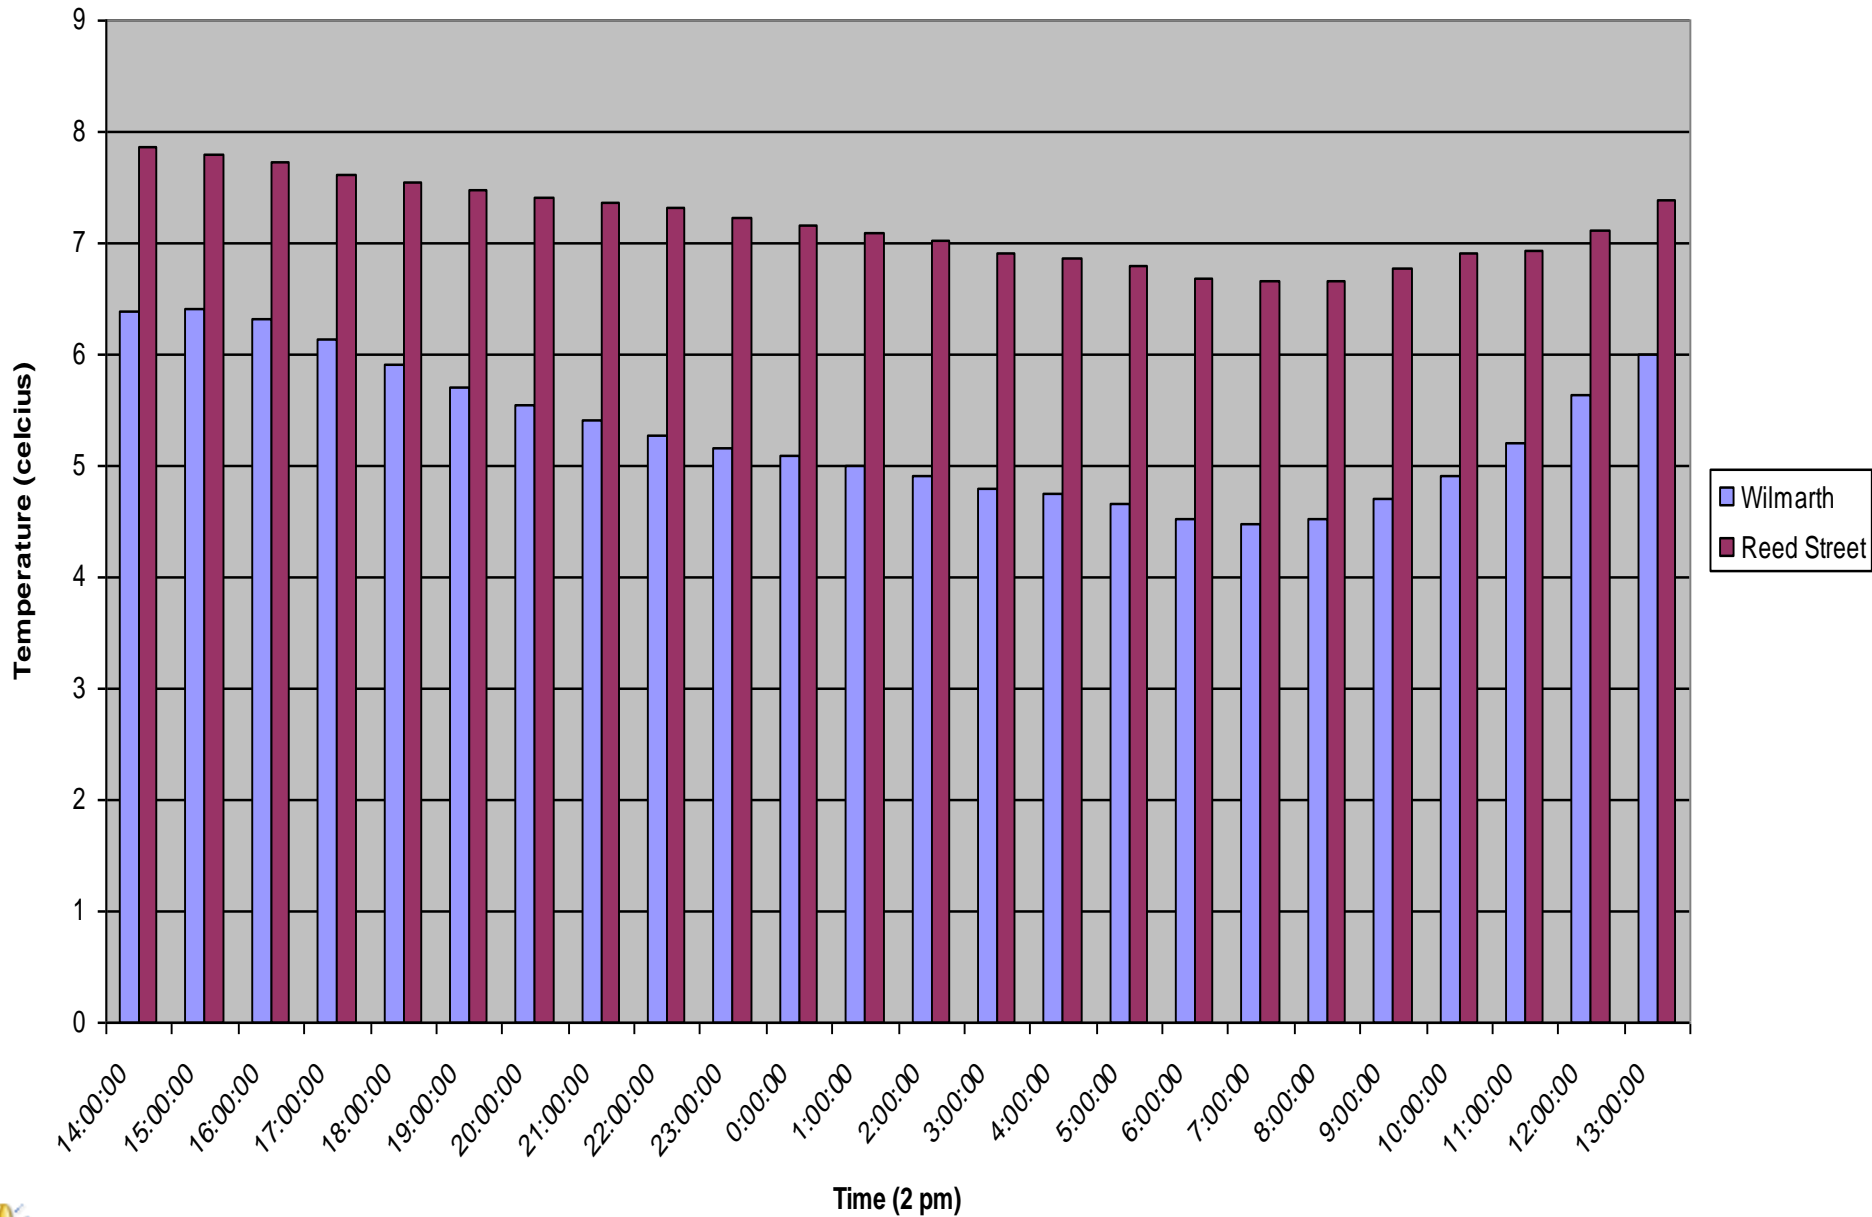
Temperature vs. Time - both sites

- Observation: Reed Street maintained a higher Temperature than Wilmarth and exhibited fewer variations
- Hypothesis: This may be because of the higher discharge. The high *Specific Heat Capacity* of water combined with the shear *Volume* helped Reed street retain the heat & exhibit less day/night variation
