### Palmer River Water Discharge and Nutrient Study

# *Painter River Water Discharge & Nutrient Study*

Conducted by Dighton-Rehoboth  
Regional High School  
Environmental Science Class

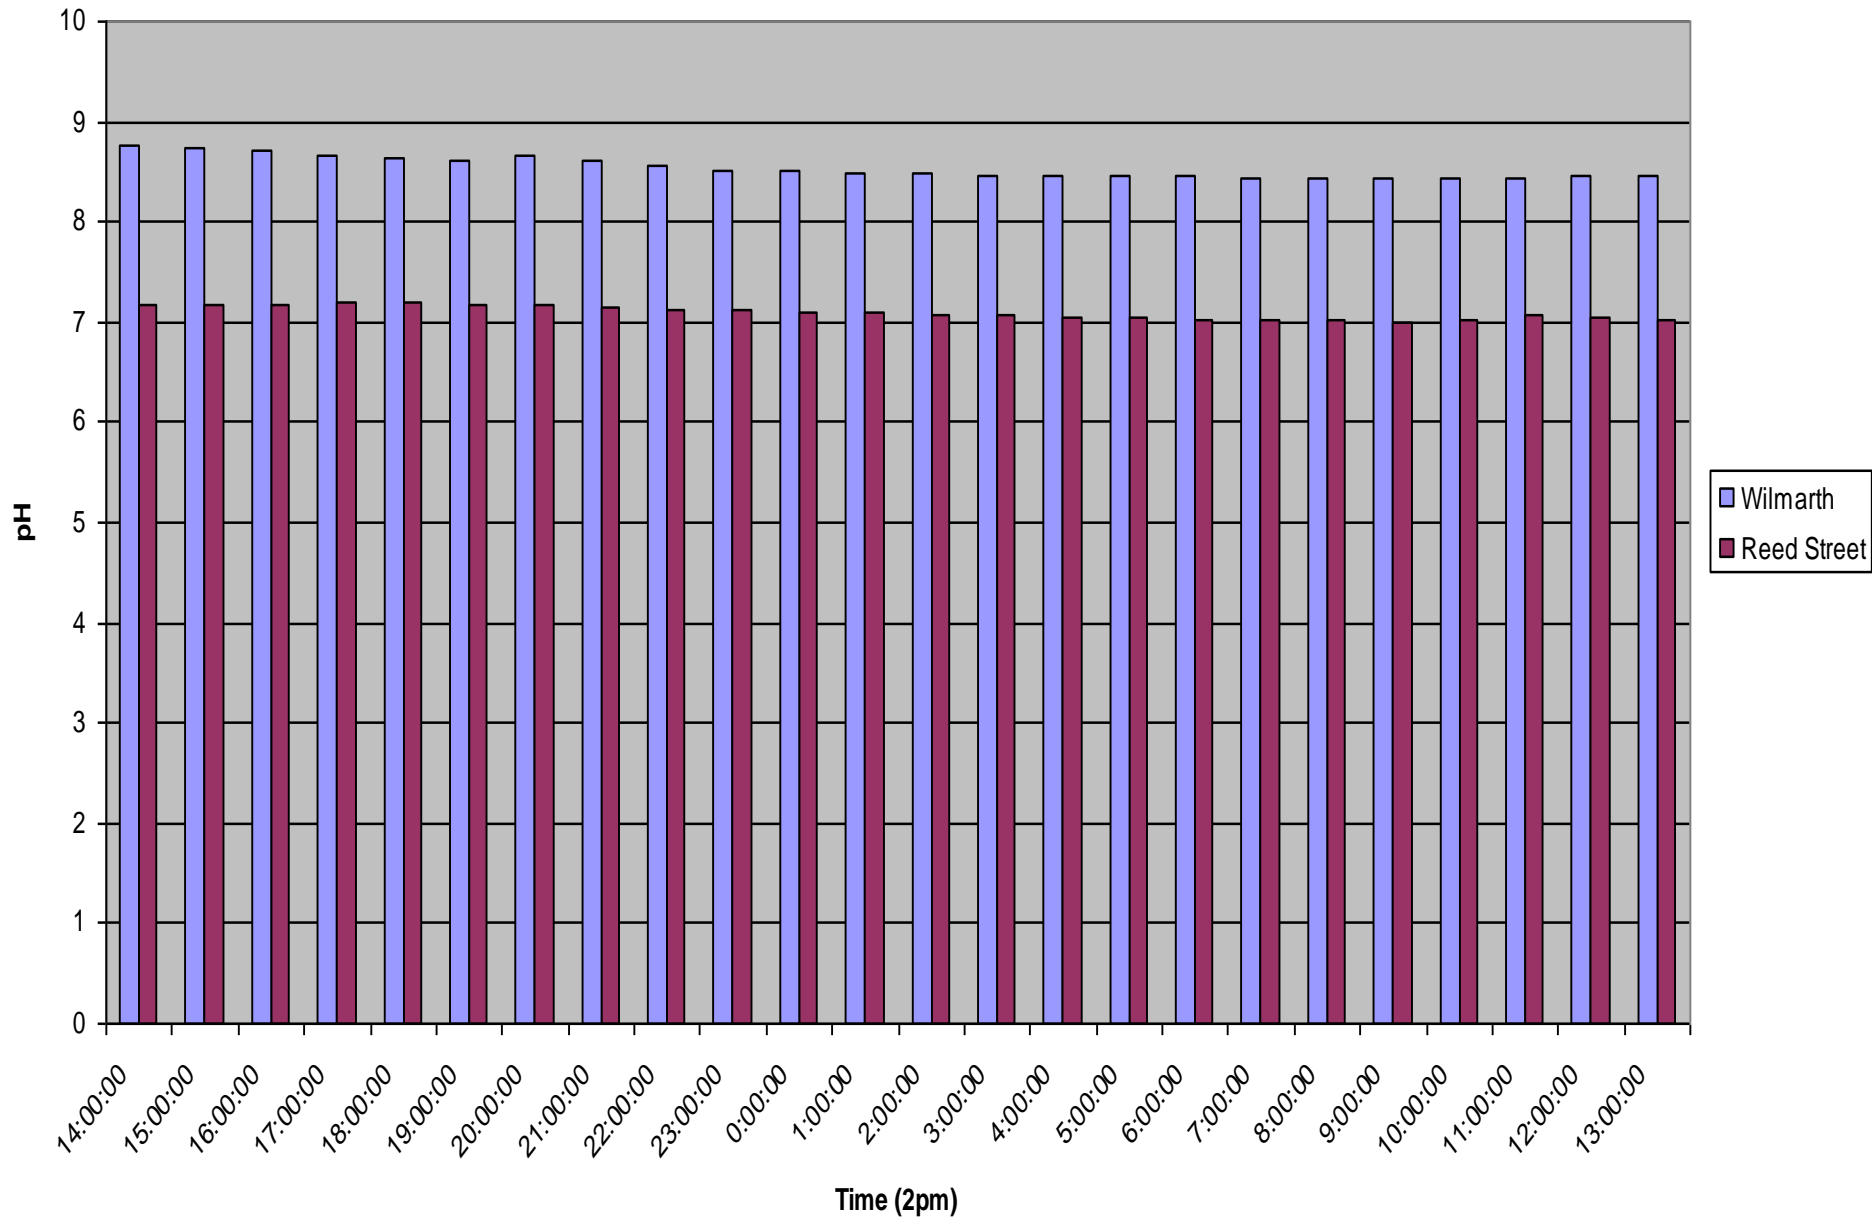
pH vs. Time - both sites

- Observations:
  - 1. There was no significant overnight lowering of pH in either site.
  - 2. Wilmarth Bridge Road site exhibited more basic pH's than Reed Street

1. Turbulent (rather than laminar) flow helped keep gas concentrations from being highly variable. This, in turn, kept CO<sub>2</sub> levels from contributing to acidity overnight (Carbonic acid)
2. There may be an underlying geological reason: perhaps the area surrounding this site contains Basic rock and/or weathered Bicarbonate (HCO<sub>3</sub><sup>-</sup>) ions; which can slow the effects of acidification by neutralizing contributors like acid rain and contaminated runoff.

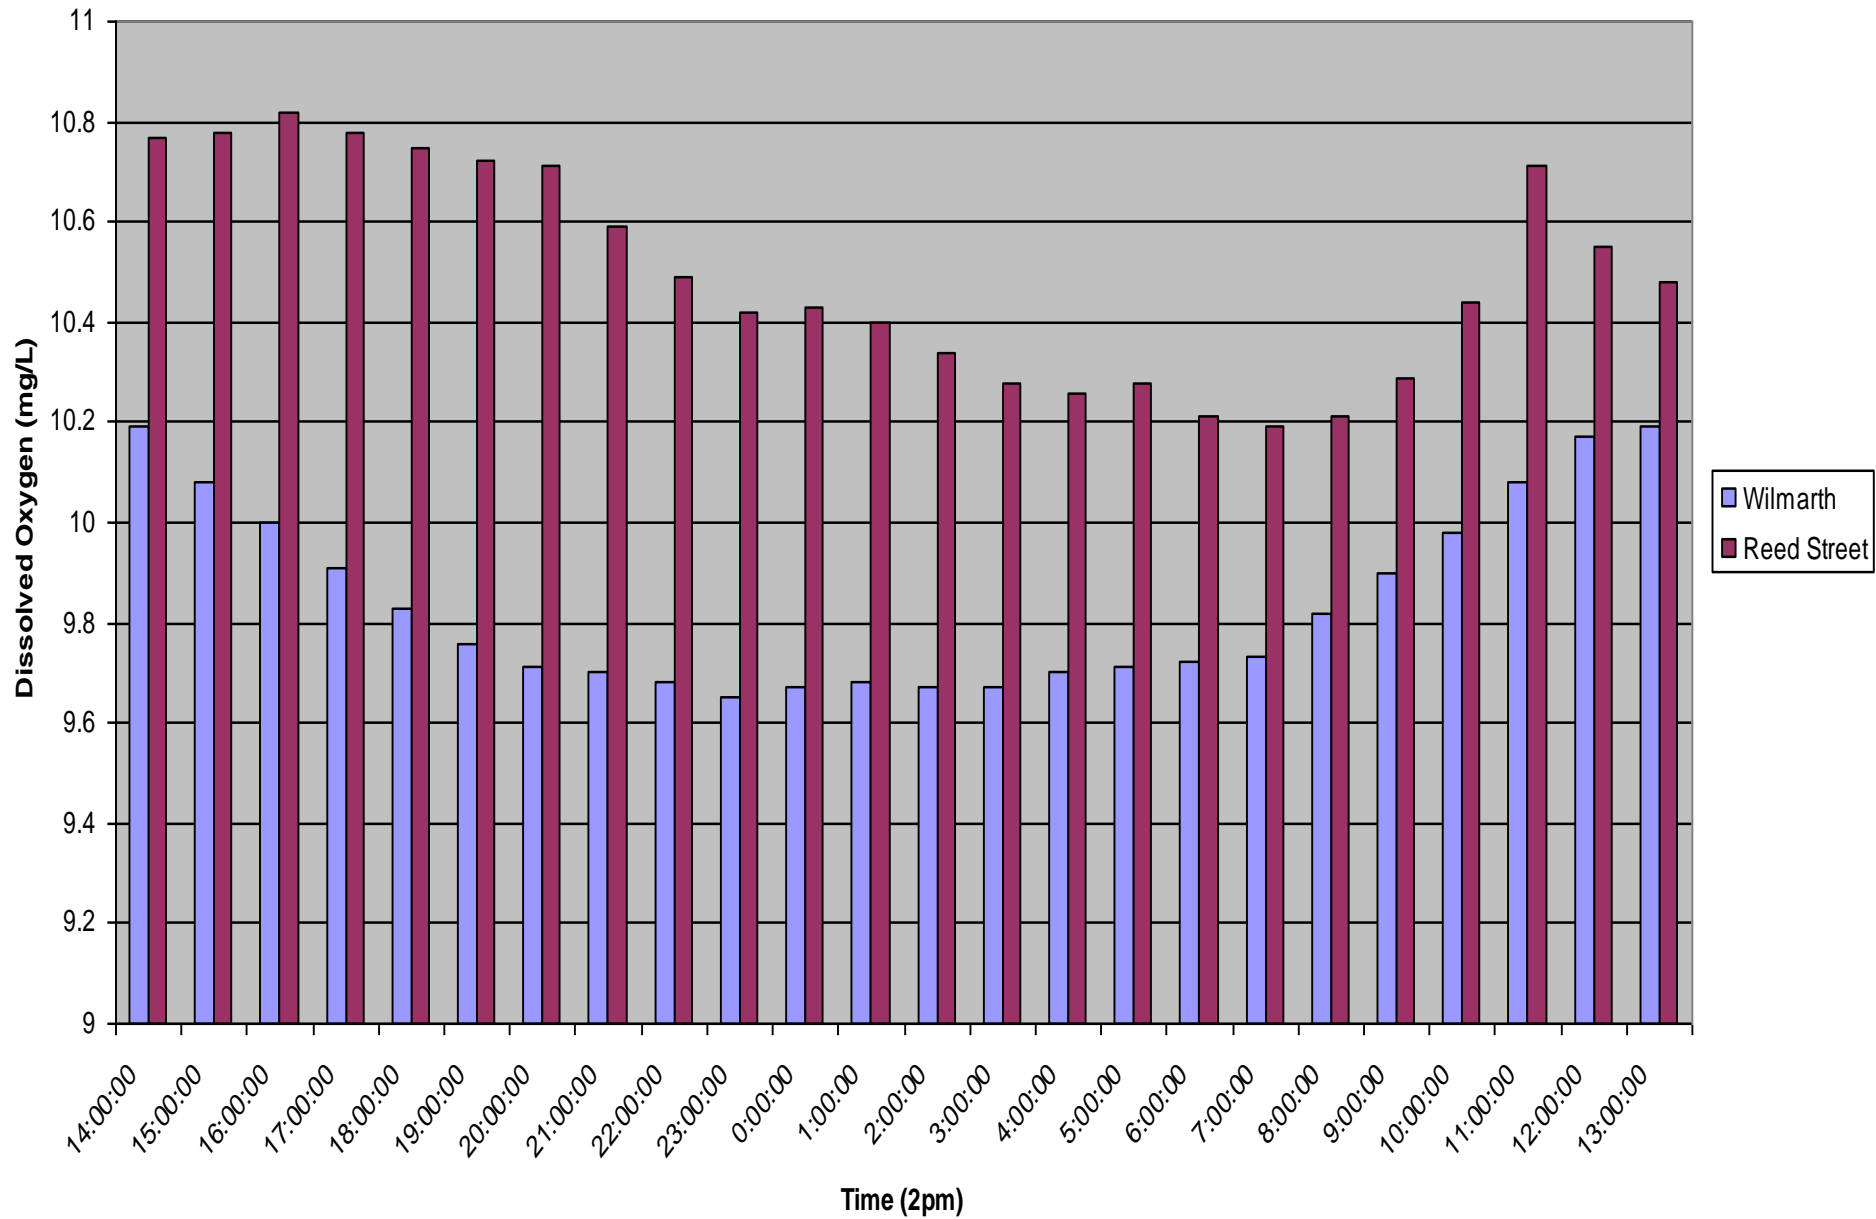
Dissolved Oxygen vs. Time - both sites

1. Both sites dO<sub>2</sub> levels drop off in the evening hours.
2. Wilmarth Bridge Road's drop-off seems to occur earlier.

1. Halted photosynthetic activity (sunset) coupled with continued respiration shifts a balance of gasses to an output of CO<sub>2</sub> (respiration) with **no O<sub>2</sub> input** (due to *halted photosynthesis*)
2. Perhaps the higher percent of *canopy cover* at this site provided significant shade to halt photosynthesis earlier in the evening than at Reed Street.

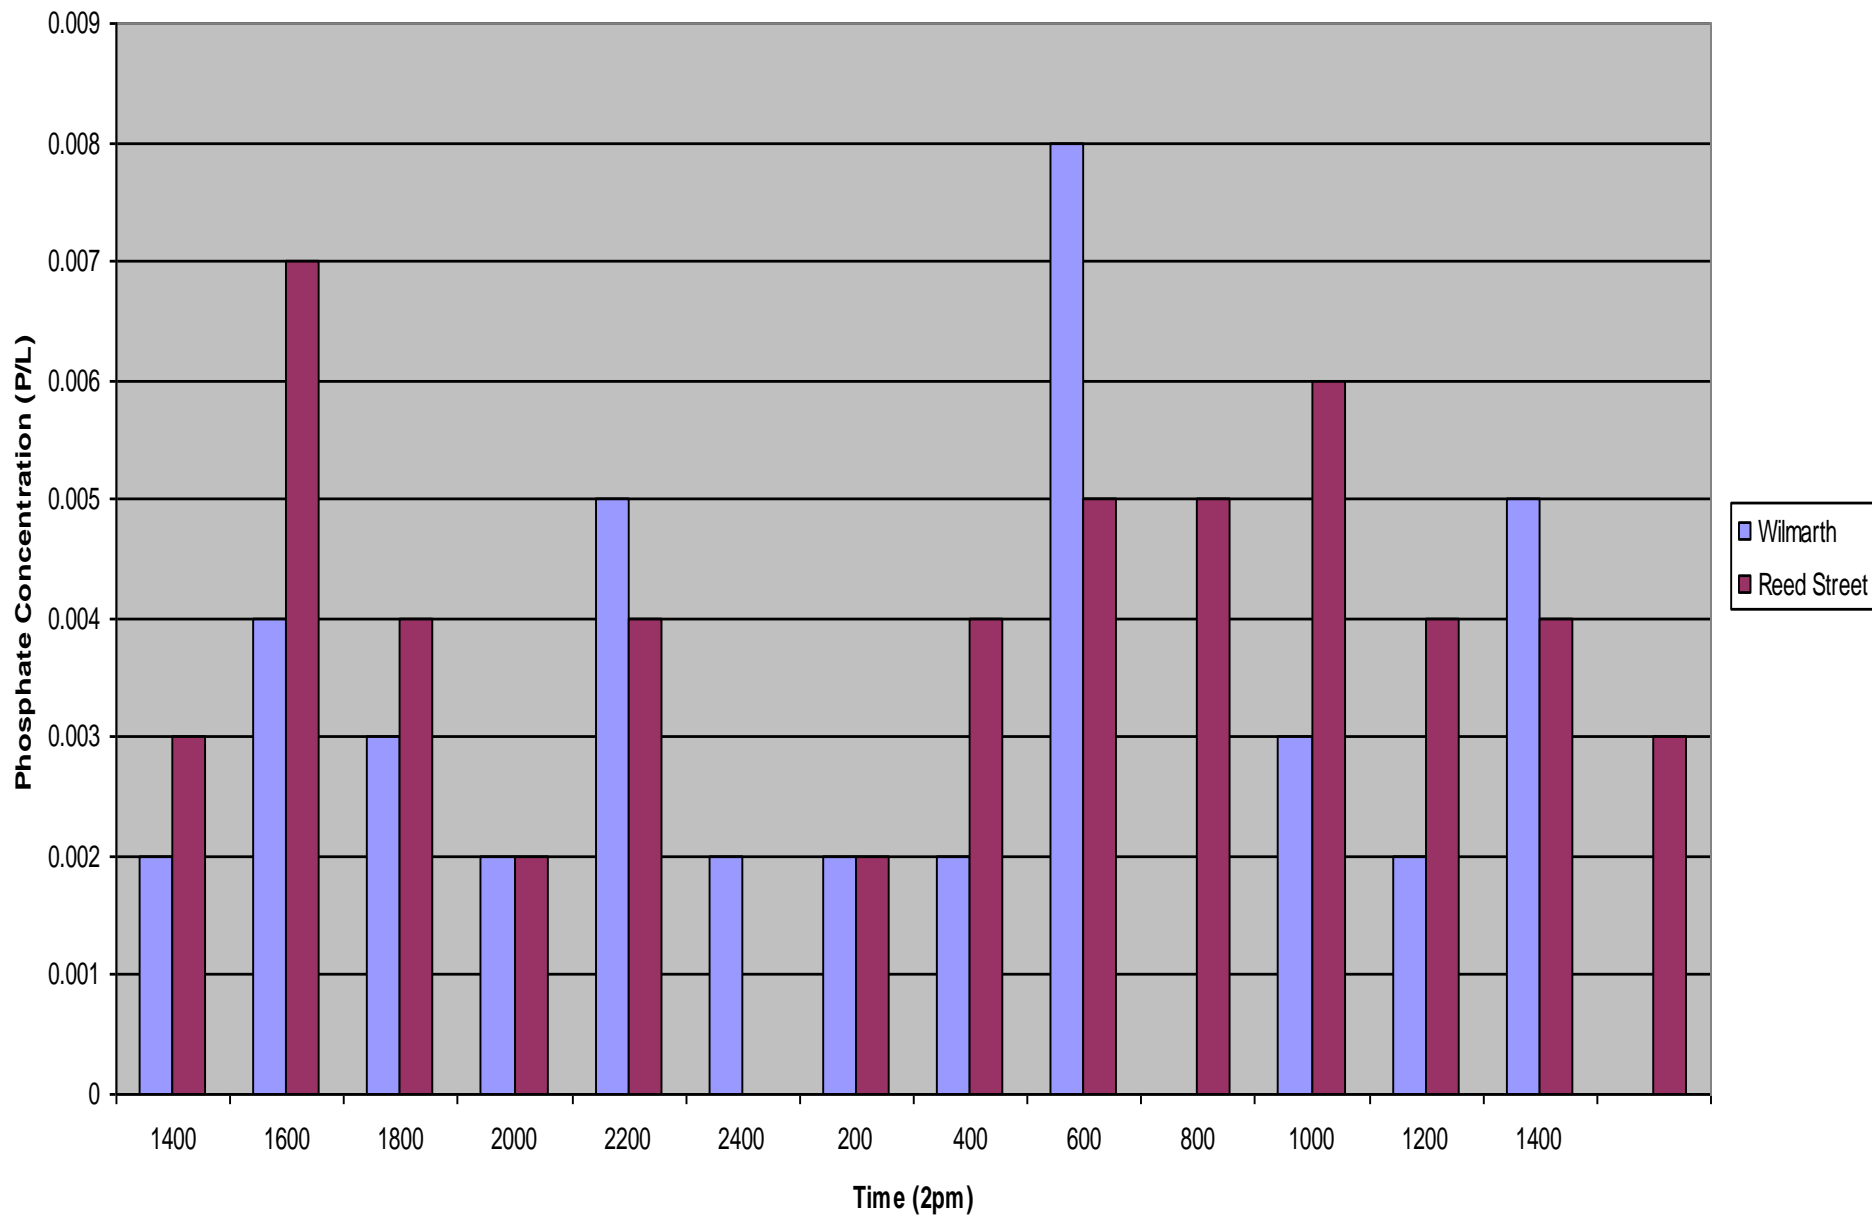
Phosphate levels vs. Time - Both Sites

- 1. No data was available for Wilmarth Bridge road at 8AM or at Reed St. at midnight.
  - The analysis registered an airspike for these samples
- 2. All values were **AT** or **BELOW** detection limits
  - This would suggest that phosphates are at a low enough level to be a limiting factor for both sites

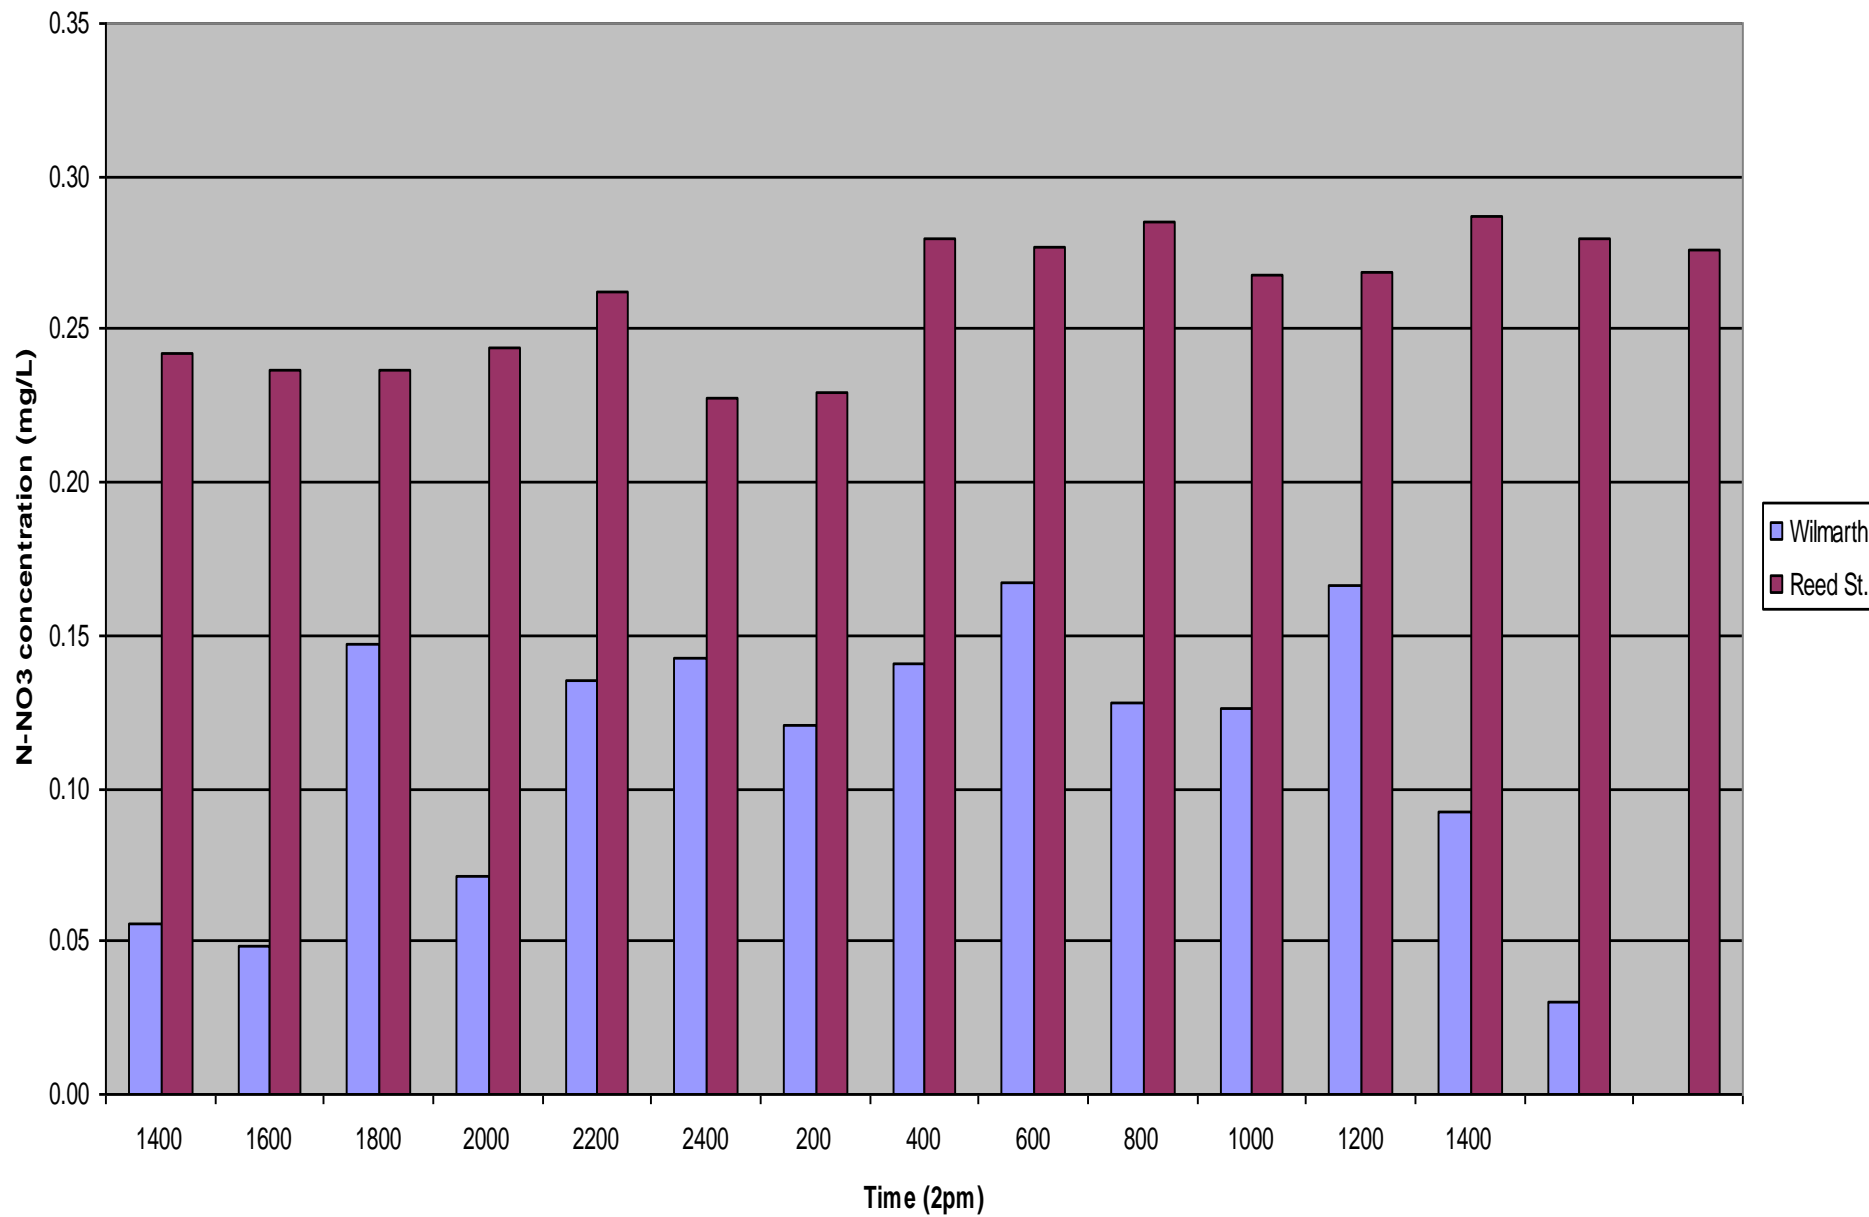
N-NO3 concentration vs. Time - both sites

- 1. All levels were above detection limits of the analyzing device
  - This suggests that NO<sub>3</sub> is NOT a limiting factor for either site
- 2. Concentrations were higher at Reed Street.
  - With higher discharge, we would expect lower concentrations. So this tells us that between these 2 sites, there must have been a significant addition of NO<sub>3</sub> to the Palmer River
  - Between the 2 sites are farmland, wooded marshes, a golf course, and low-density residential areas

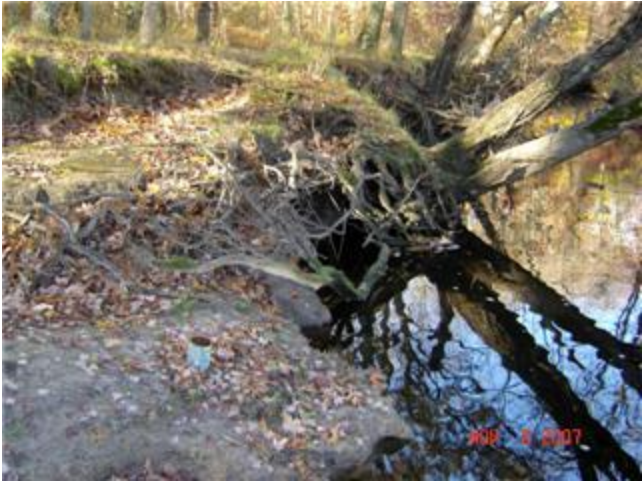
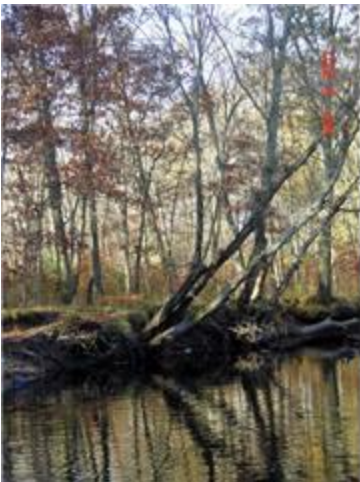
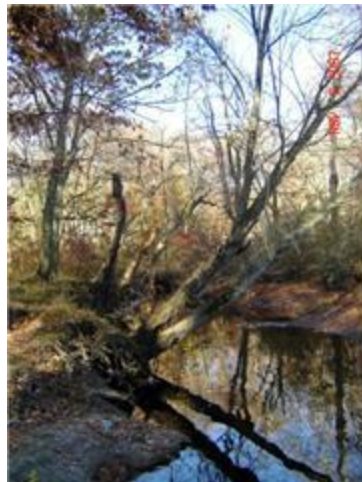
Observation: Bent shape to Riparian Trees at both sites

Hypothesis: Trees have corrected their growth toward the sun (phototropism) in response to erosion taking the soil around their roots away

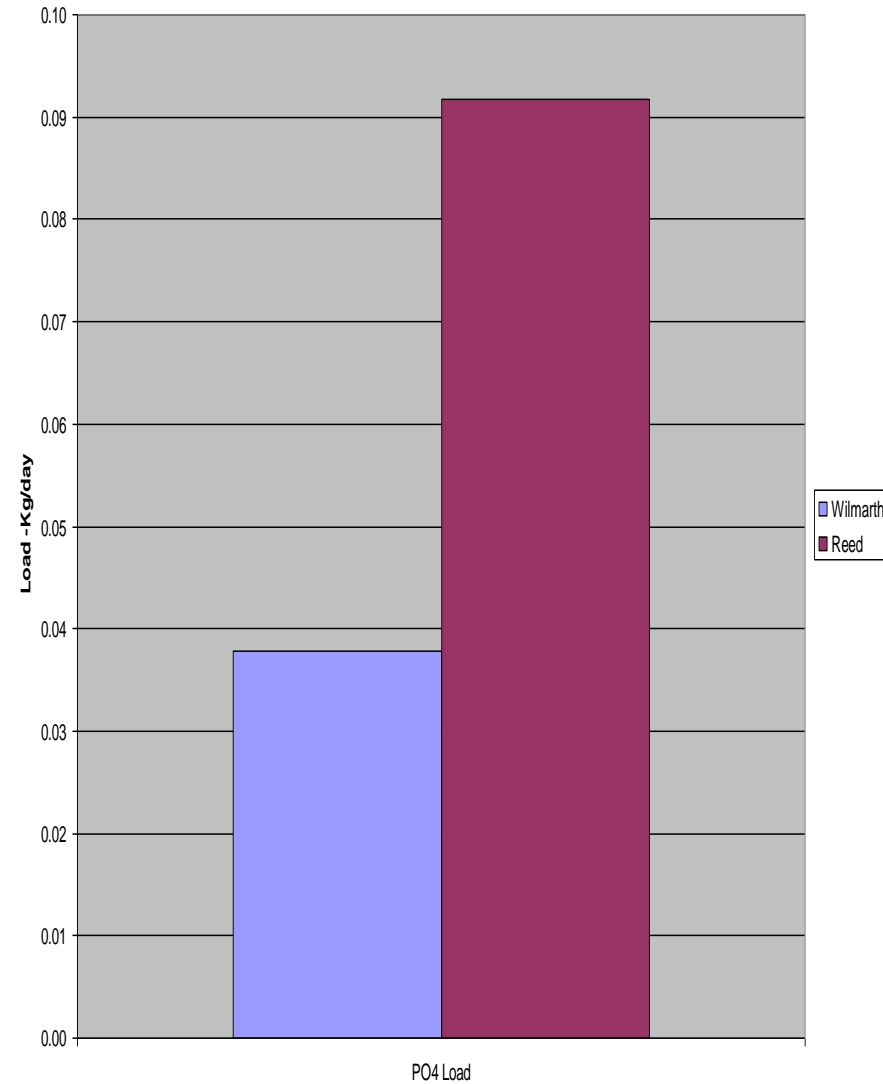
PO4 Load - both sites

- Load is higher at Reed street: This is at least partially (though not proportionally) due to the increased discharge  $\rightarrow Q=w*d*u$
- Lower amounts of  $PO_4$  suggest that this IS a limiting factor in the Palmer River.
- Increased amounts of  $NO_3$  *could be* attributable to runoff from nearby farms &/or the Golf course.
- These levels suggest a low-average level for **BOTH** nutrients examined

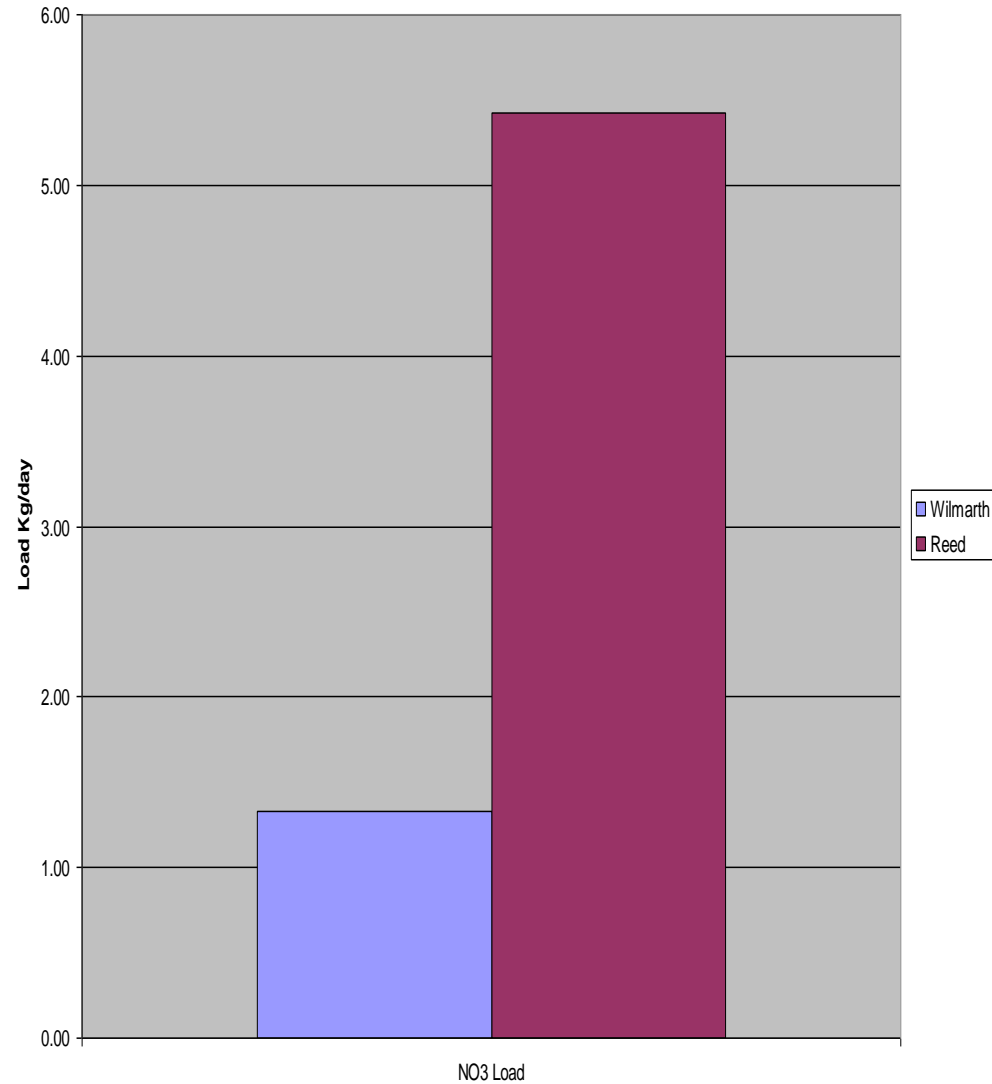
NO3 Load
