### Burr's Pond and Runnins River – An Annual Watershed Survey 2008

# **Burr's Pond & The Runnins River: An Annual Watershed Survey**

**AP Biology Students  
Seekonk High School  
2008**

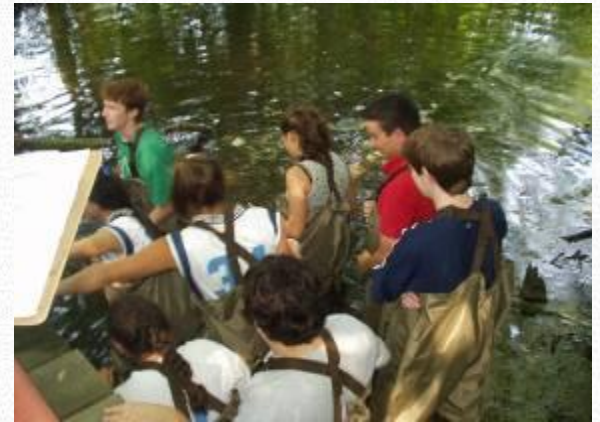
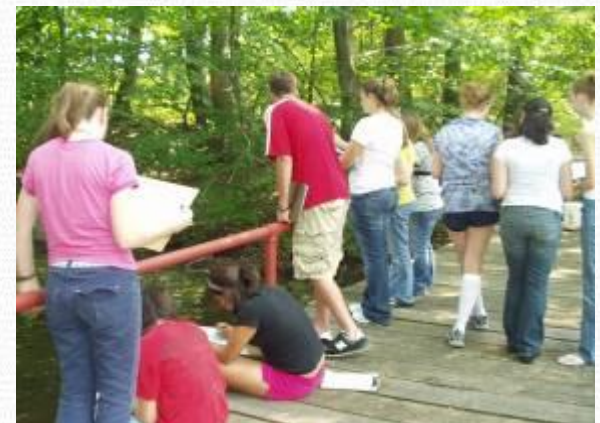
# Runnin's River: Site A

- Site A of the Runnin's River is a spot at the end of the river before the river flows into Burr's Pond.
- The site we chose had a dense canopy, and was located right before the small bridge crossing the river.
- Site A was about 4 or 5 feet deep, and was very blurry, and filled with silt.
- The bottom of the river was soft and mushy, and had many sticks and rocks.
- The sides of the river had gathered with dead branches, and floating organic matter.

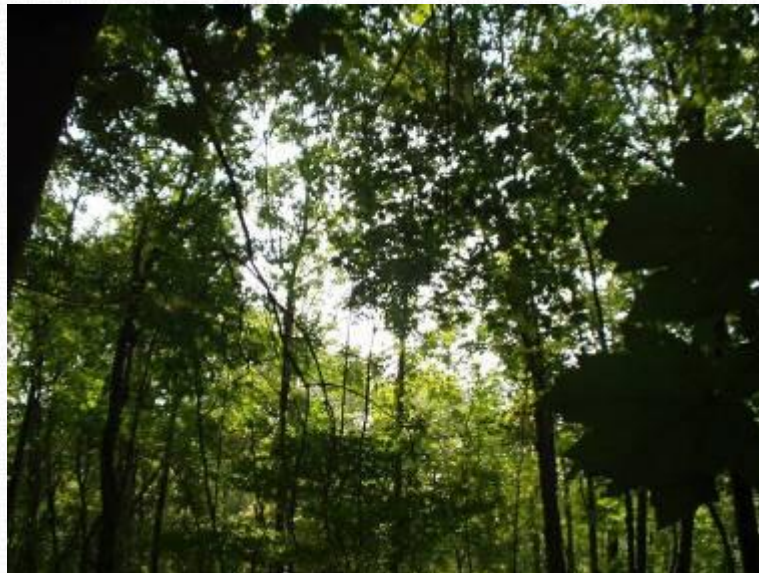
# Runnin's River: Site B

Site B at Runnin's River includes a waterfall flowing into a shallow stream. The primary site is the pond, in which the waterfall comes from. At the bottom of the waterfall, there is shallow water with various green plants and rocks within it. There is also an overhanging canopy casting a shadow on the water. The bottom of the stream is filled with pebbles and not many aquatic animals live within this environment.
