Benthic Macroinvertebrates: An Analysis of the Mashpee River

Mashpee High School, Mashpee, Massachusetts (2008). *Benthic Macroinvertebrates: An Analysis of the Mashpee River*. In Watershed Access Lab Projects. Project 79.
Available at: https://vc.bridgew.edu/wal_projects/79

Benthic Macroinvertebrates

An analysis of the Mashpee River

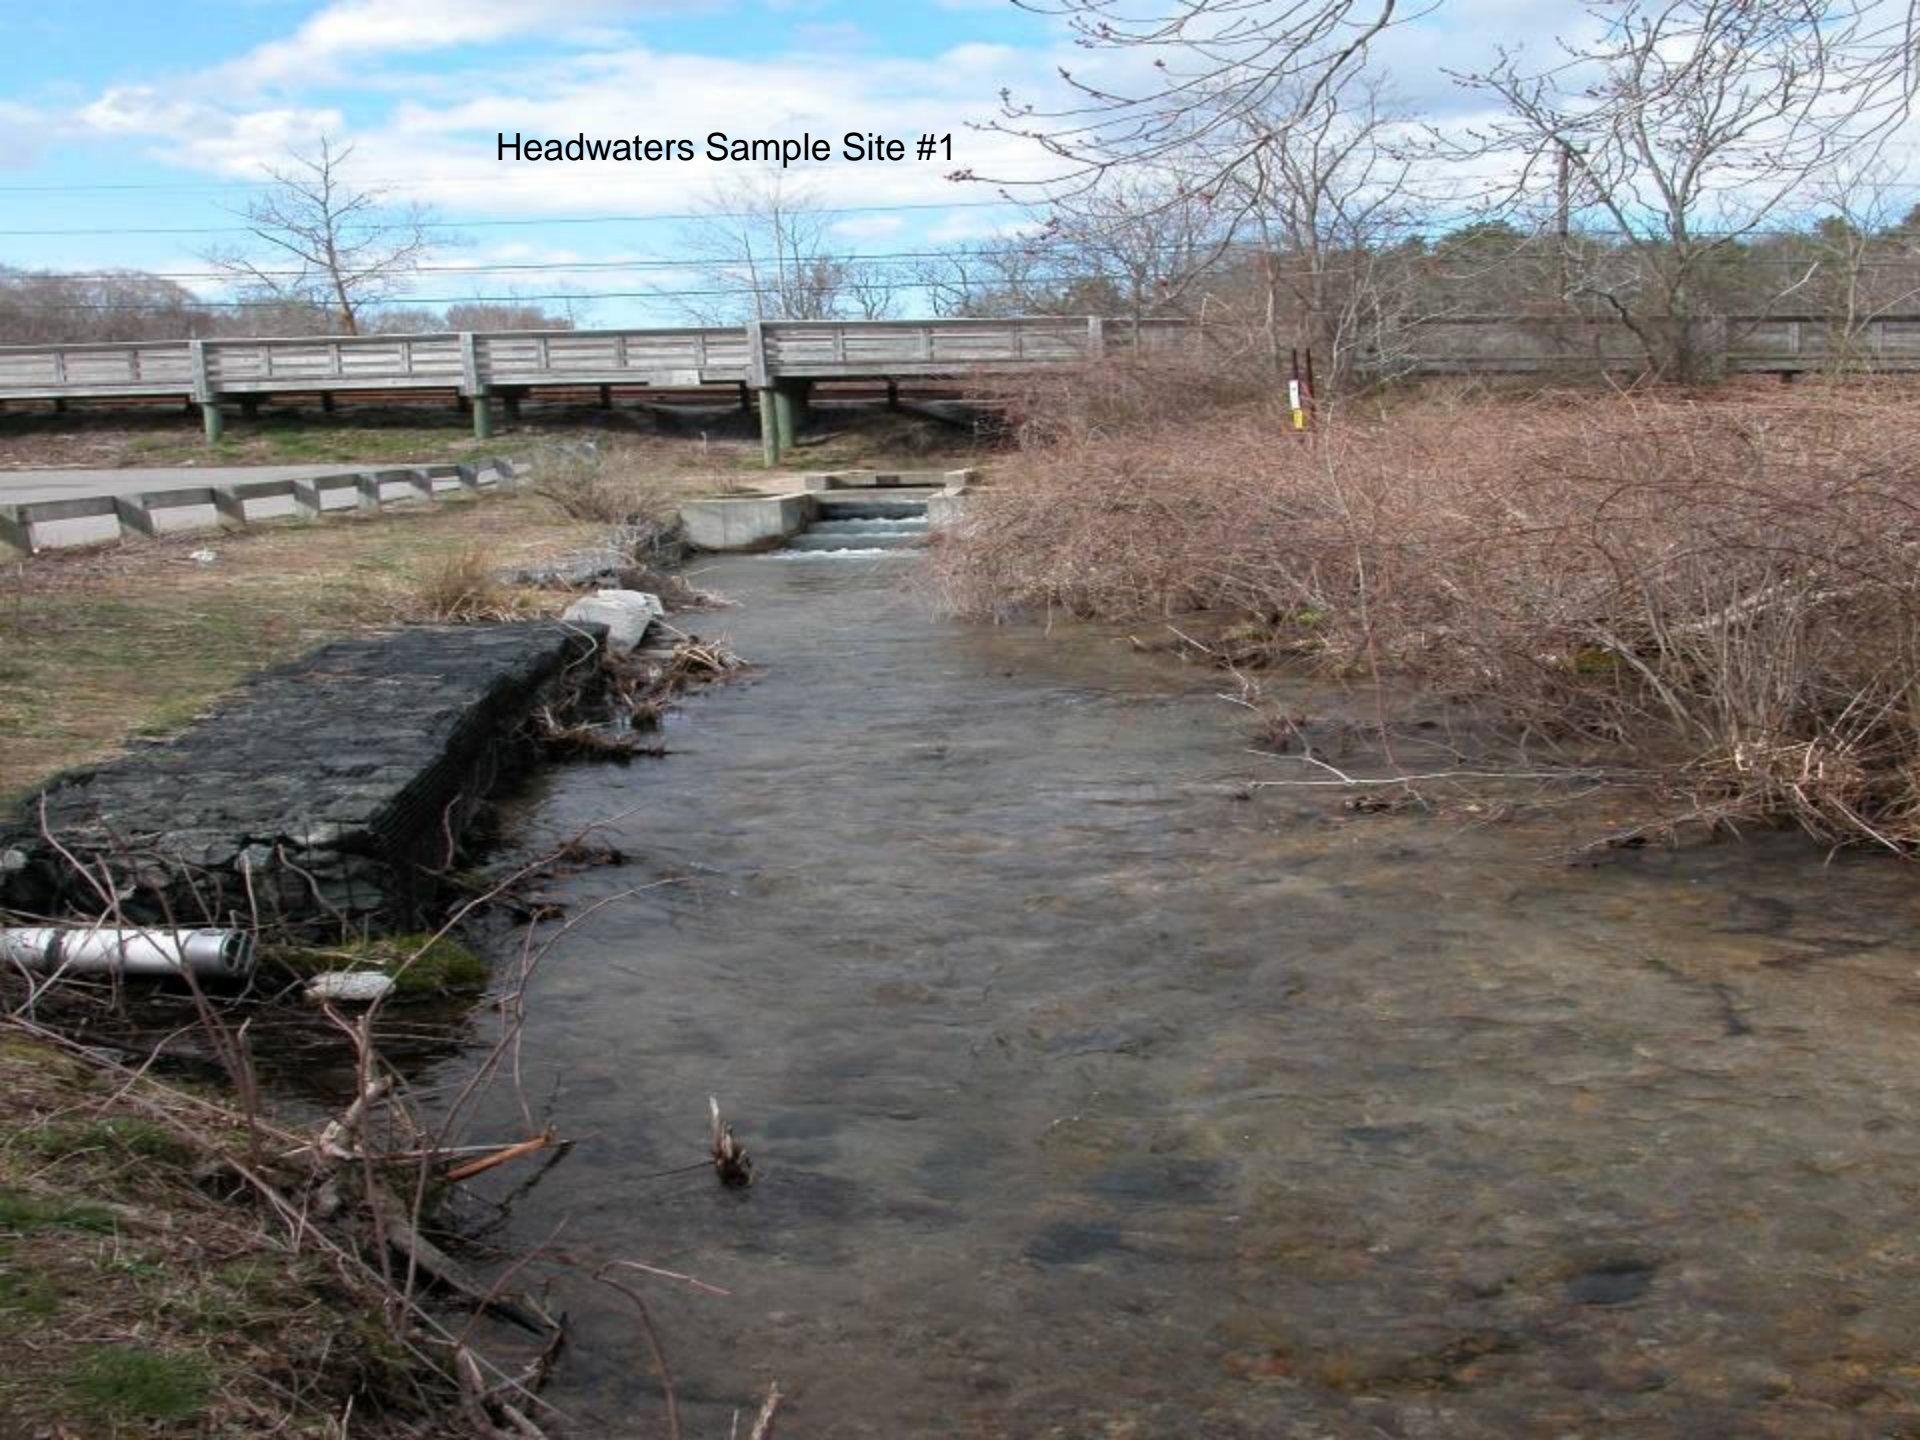
Headwaters Sample Site #1

- Sampling immediately downstream of a fish ladder installed to assist with an anadromous herring run linking Mashpee-Wakeby Lake with Poponneset Bay in Mashpee, MA.

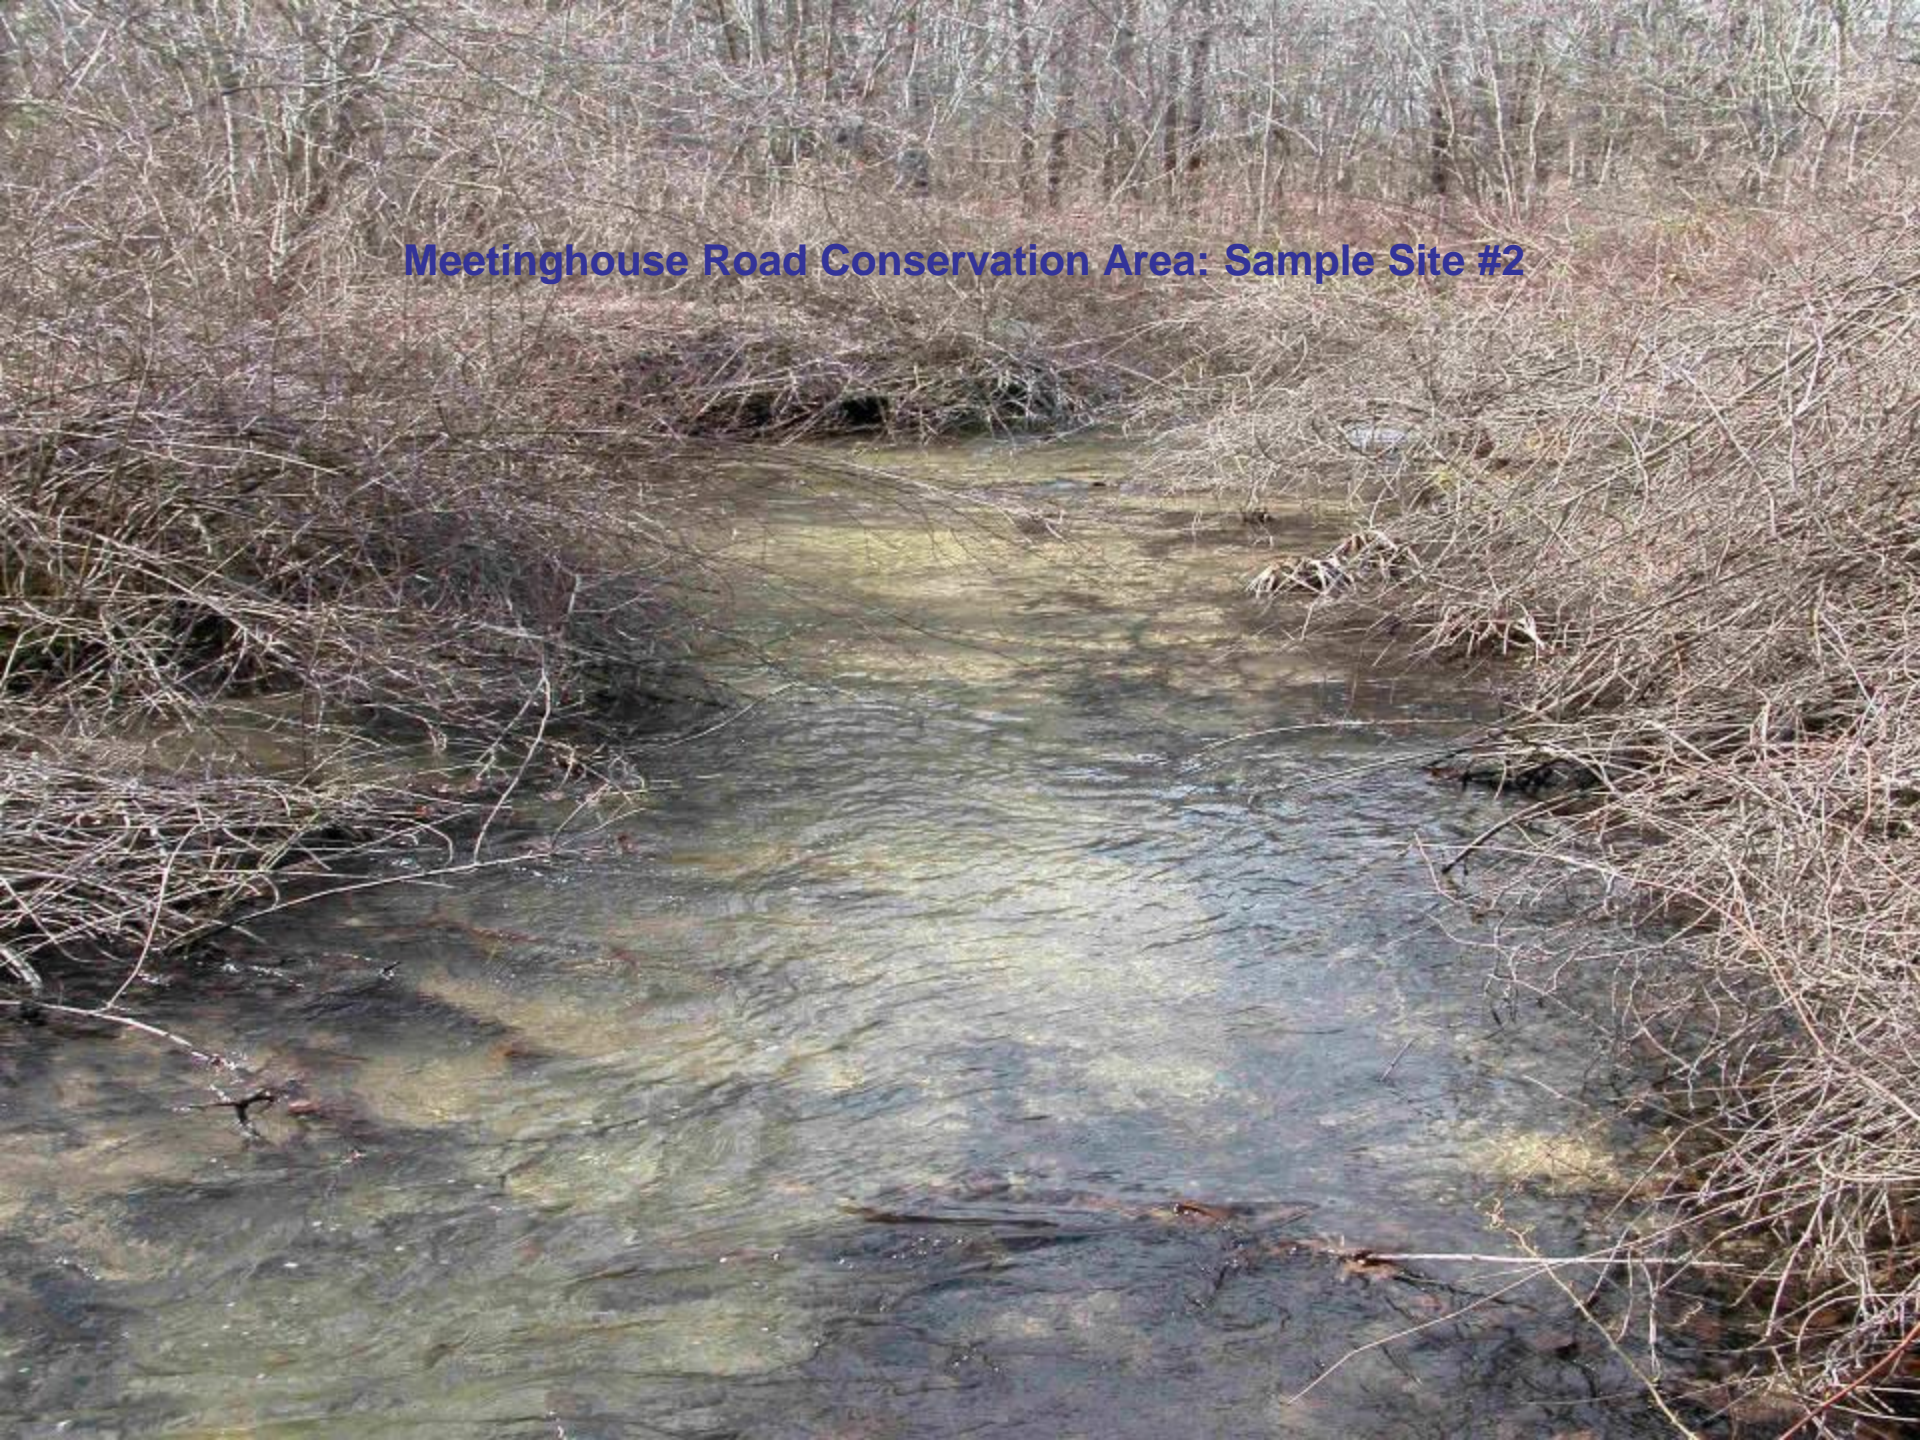
Meetinghouse Road Conservation Area: Sample Site #2

- Sampling occurred within an area managed as a conservation area along both sides of the river and extending from Great Neck Road to the mouth of the river.

A photograph of a stream with a mossy bank and bare tree branches. The stream flows from the upper right towards the lower left. The water is clear, revealing a rocky and sandy substrate. The banks are covered in green moss and some dry, brown vegetation. Bare, light-colored tree branches hang over the water from the left side. The overall scene is a natural, somewhat overgrown stream environment.

**Substrate and Bank Habitat
within the Conservation Corridor
adjacent to Meetinghouse Road**

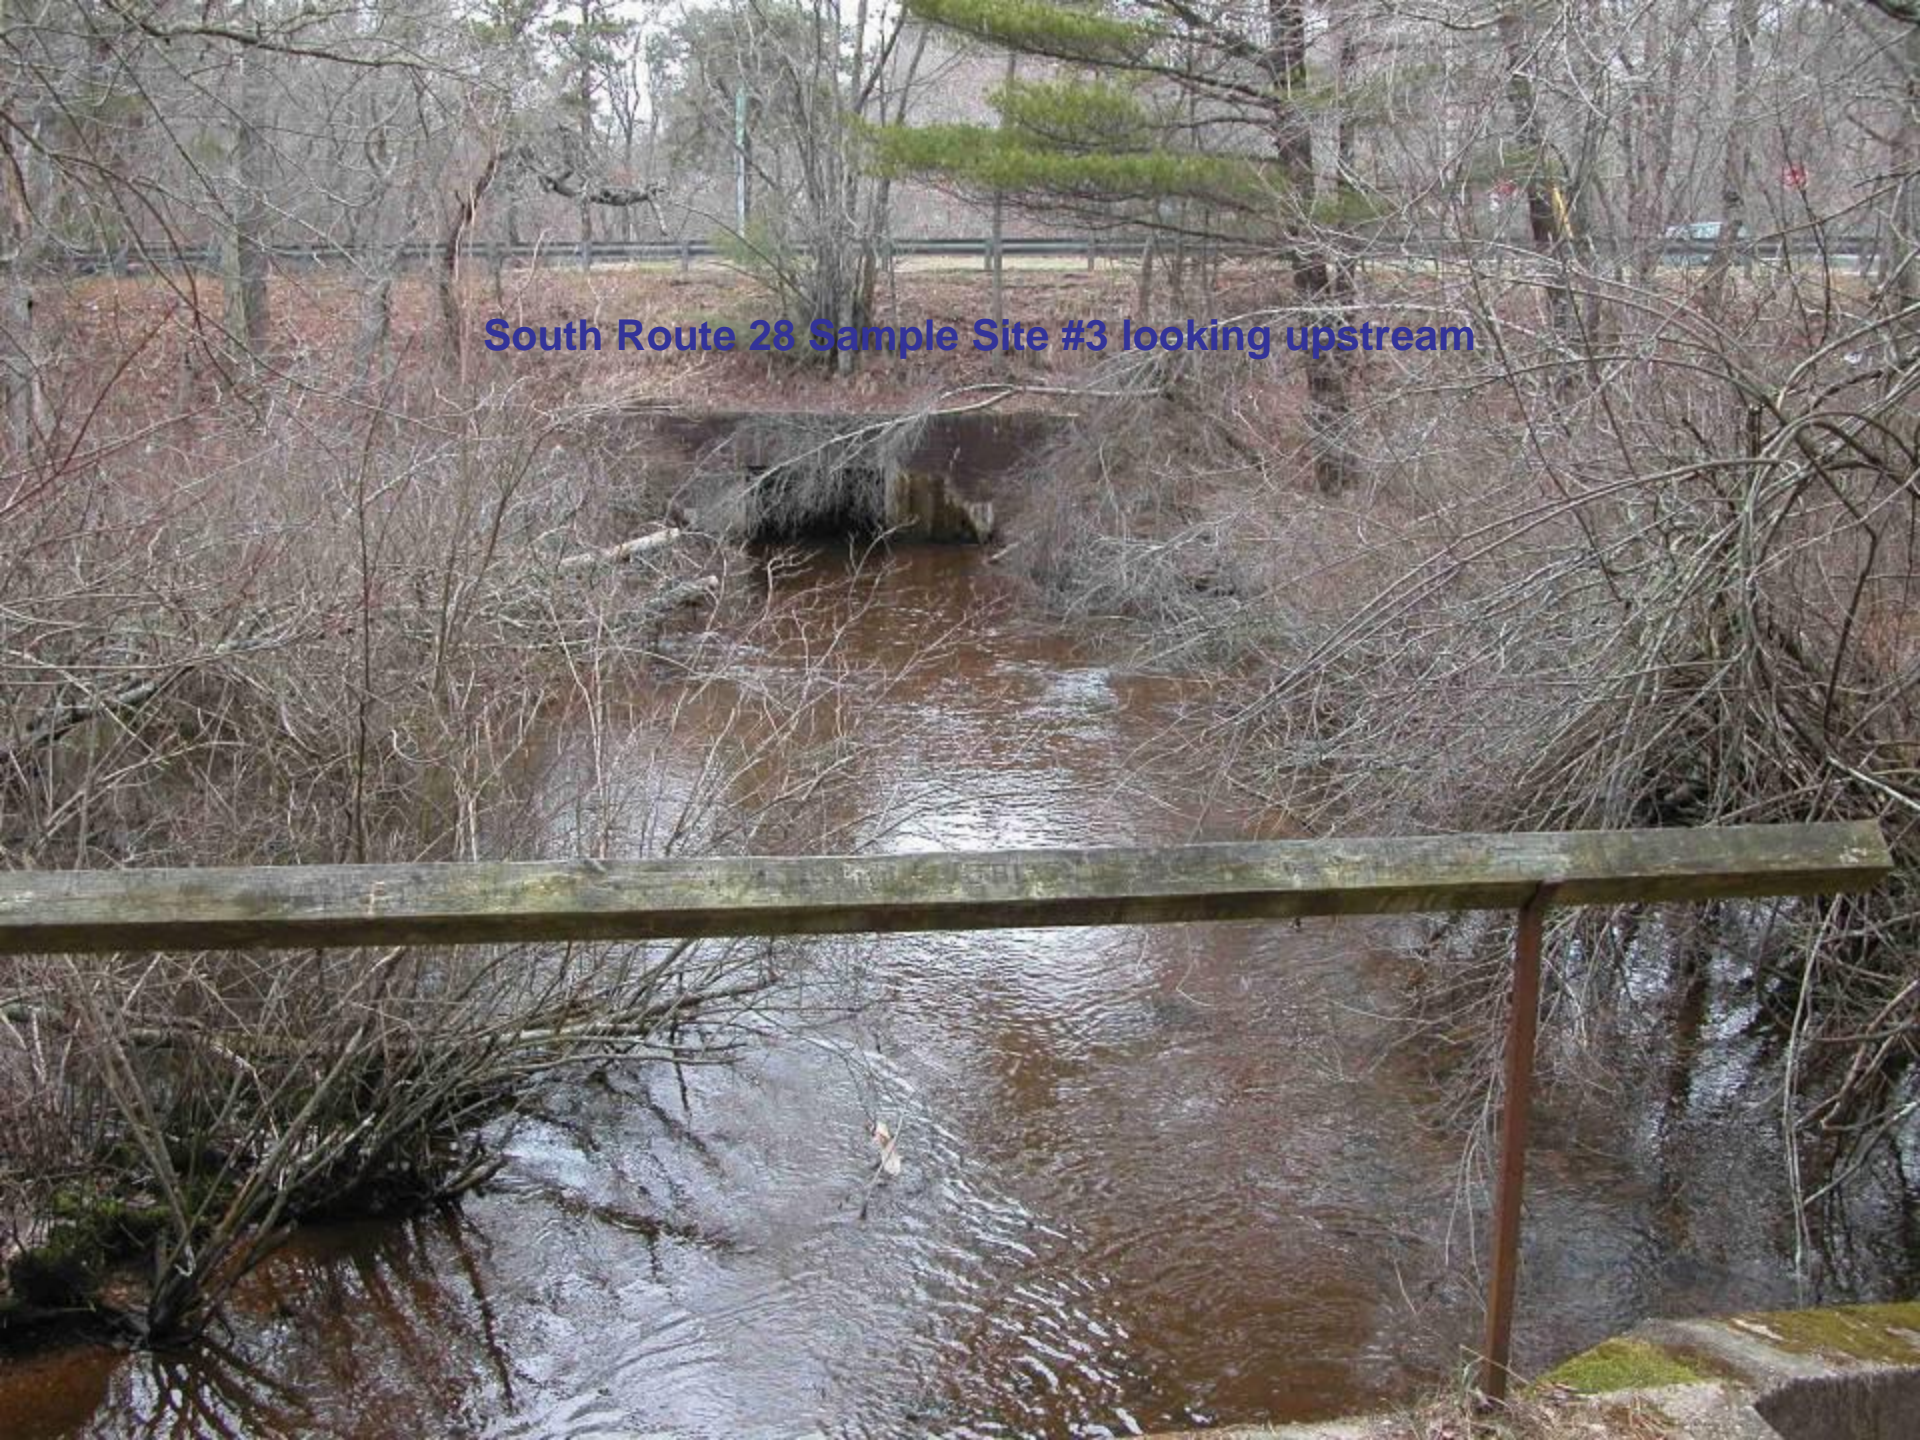
South Route 28 Sample Site #3 looking upstream

- This site is immediately south of State Route 28. It is, like the mid-river site within a conservation corridor, but as suggested it is impacted by stormwater runoff from the State Road.

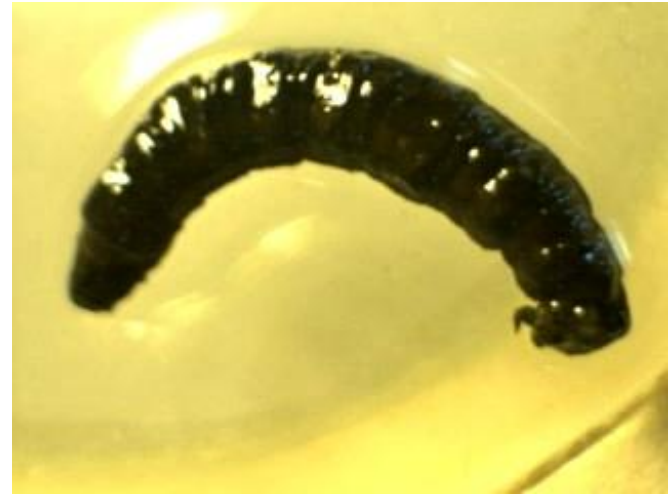
- Crane fly Larva
 - Diptera: Tipulidae
 - Tolerance value – 3
 - This macroinvertebrate has a mild tolerance for pollution and was found in two out of three sites. It was found in both the mid stream site and the lowest site.

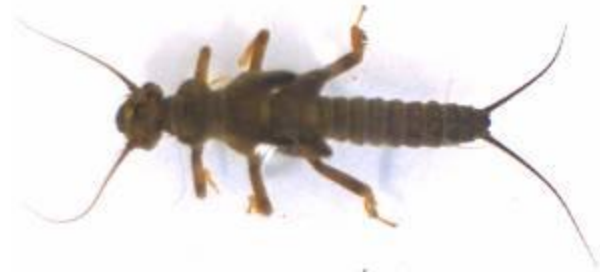
- Stonefly Larva
 - Plecoptera
 - Tolerance value – 1 to 2
 - This organism has a very low tolerance for pollution and was found in abundance only at the mid-river site
