Rumford River Monitoring Project

Norton, MA

Sampling conducted by: Matt Reeves and
Rickie Shaughnessy

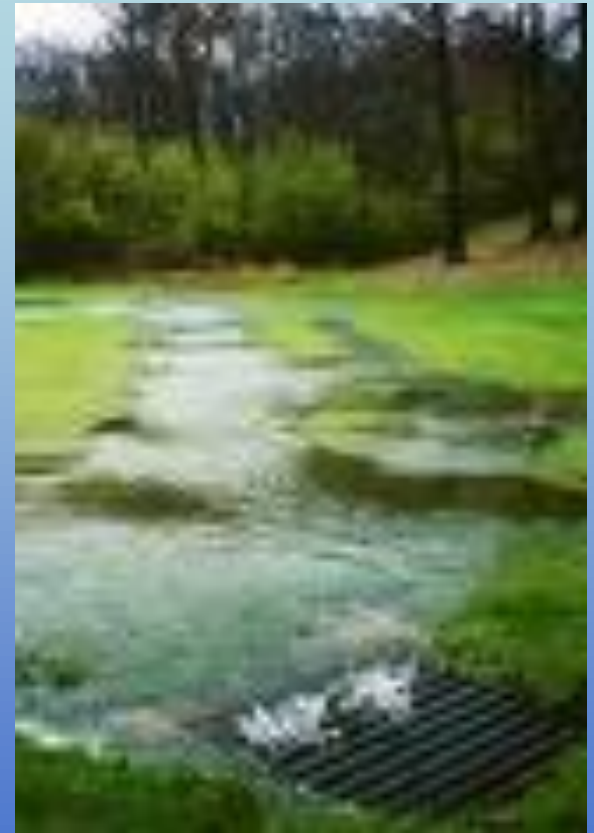
- Run off- precipitation, snow melt, or irrigation water that appears in uncontrolled surface streams, rivers, drains or sewers.
- Run off from impervious surfaces can carry pollutants, such as nitrogen and phosphorus into streams and rivers. These excess nutrients have the potential to degrade water quality.
